# Oregon State University Utility Pole Research Cooperative

29th Annual Report  
October 26, 2009

Department of Wood Science &  
Engineering  
Oregon Wood Innovation Center  
(OWIC)

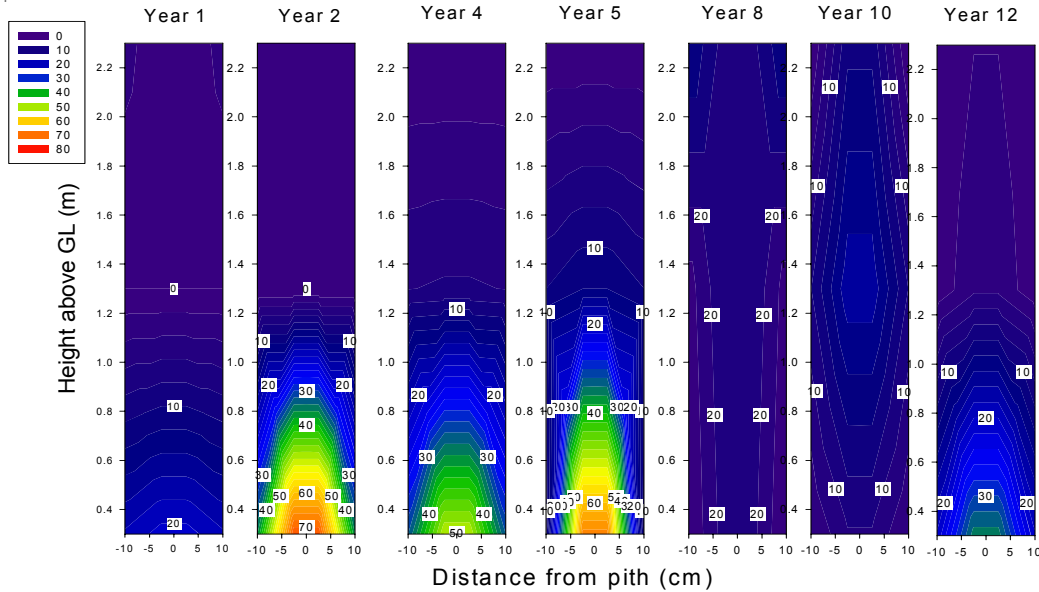
Figure I-2. Distribution of residual MITC in Douglas-fir pole sections 1 to 12 years after treatment with 200 g of dazomet. Dark blue indicates MITC levels below the threshold. Light blue and all other colors indicate MITC levels above that level.

threshold 12 years after treatment, but only at 0.3 m above groundline. Chemical levels at locations above this height were extremely low, suggesting that the treatment effect was confined to a relatively narrow zone around the application point (Table I-2).

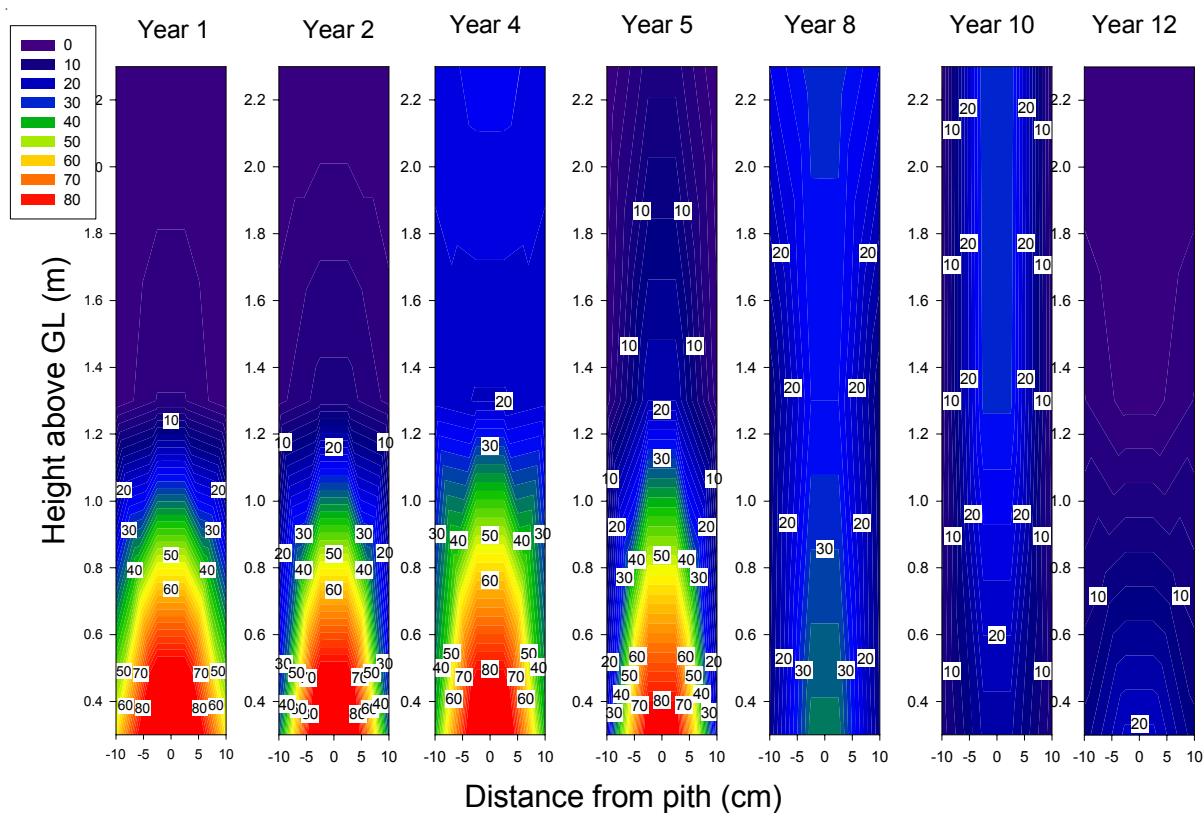
Figure I-3. Distribution of residual MITC in Douglas-fir pole sections 1 to 12 years after treatment with 200 g of dazomet plus 20 g of copper sulfate. Dark blue indicates MITC levels below the threshold. Light blue and all other colors indicate MITC levels above that level.

MITC levels 0.3 m above the groundline one year after treatment were 2 to 5 times higher when copper sulfate was added to the dazomet and these levels continued to remain elevated over the next 4 years (Figure I-3). MITC was also detectable 1.3 and 2.3 m above groundline 4 years after treatment at levels above the threshold. Chemical levels remained elevated 5 years after treatment, but then declined to levels just above the threshold 8 years after chemical application. Threshold levels were only present at four sampling locations 10 years after treatment, although all of these were in copper amended poles. These results clearly support the application of copper sulfate at the time of dazomet treatment to increase initial release rate. Results at 12 years indicated that threshold levels were only present 0.3 m above groundline, while MITC was either barely detectable or not detectable at higher locations. These results indicate that any protective effect of dazomet had been lost except at the application point and that retreatment would be advisable.

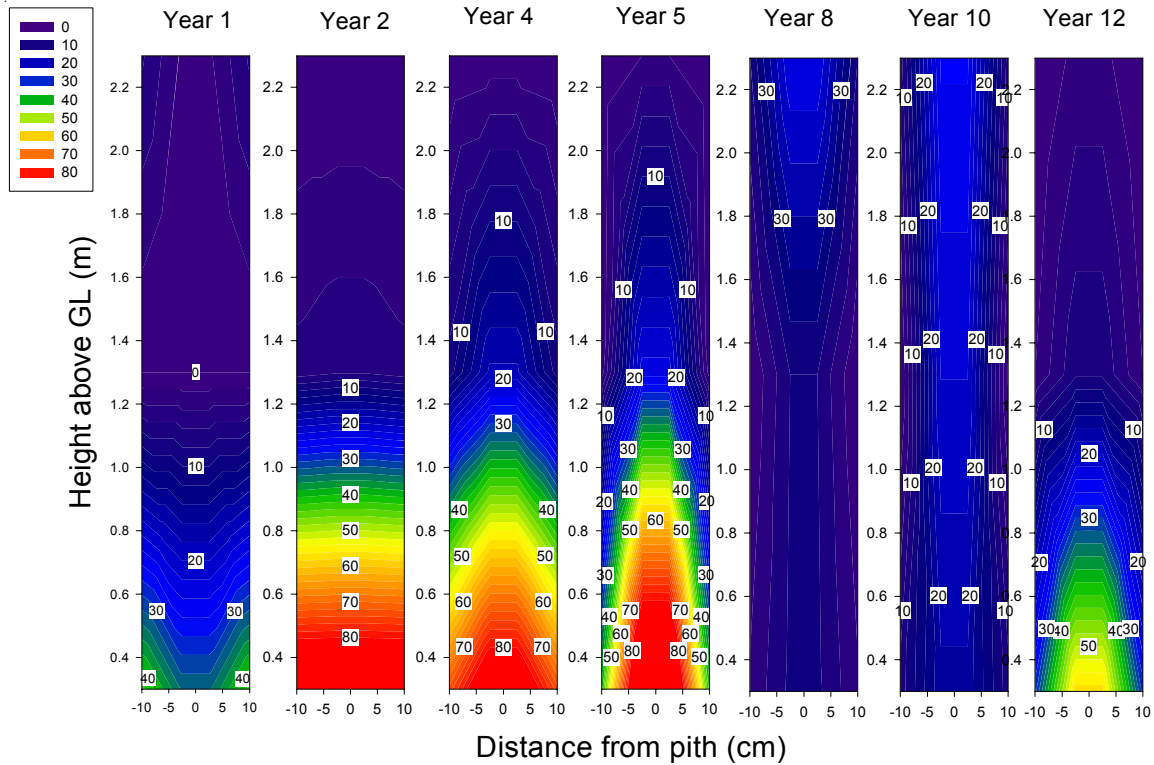
Figure I-4. Distribution of residual MITC in Douglas-fir pole sections 1 to 12 years after treatment with 200 g of dazomet plus 20 g of copper naphthenate. Dark blue indicates MITC levels below the threshold. Light blue and all other colors indicate MITC levels above that level.

production to more rapidly eliminate any decay fungi established in the wood. As with copper sulfate, MITC levels have declined at the 12 year sampling, but were similar to those found with the copper sulfate and non-copper amended controls.

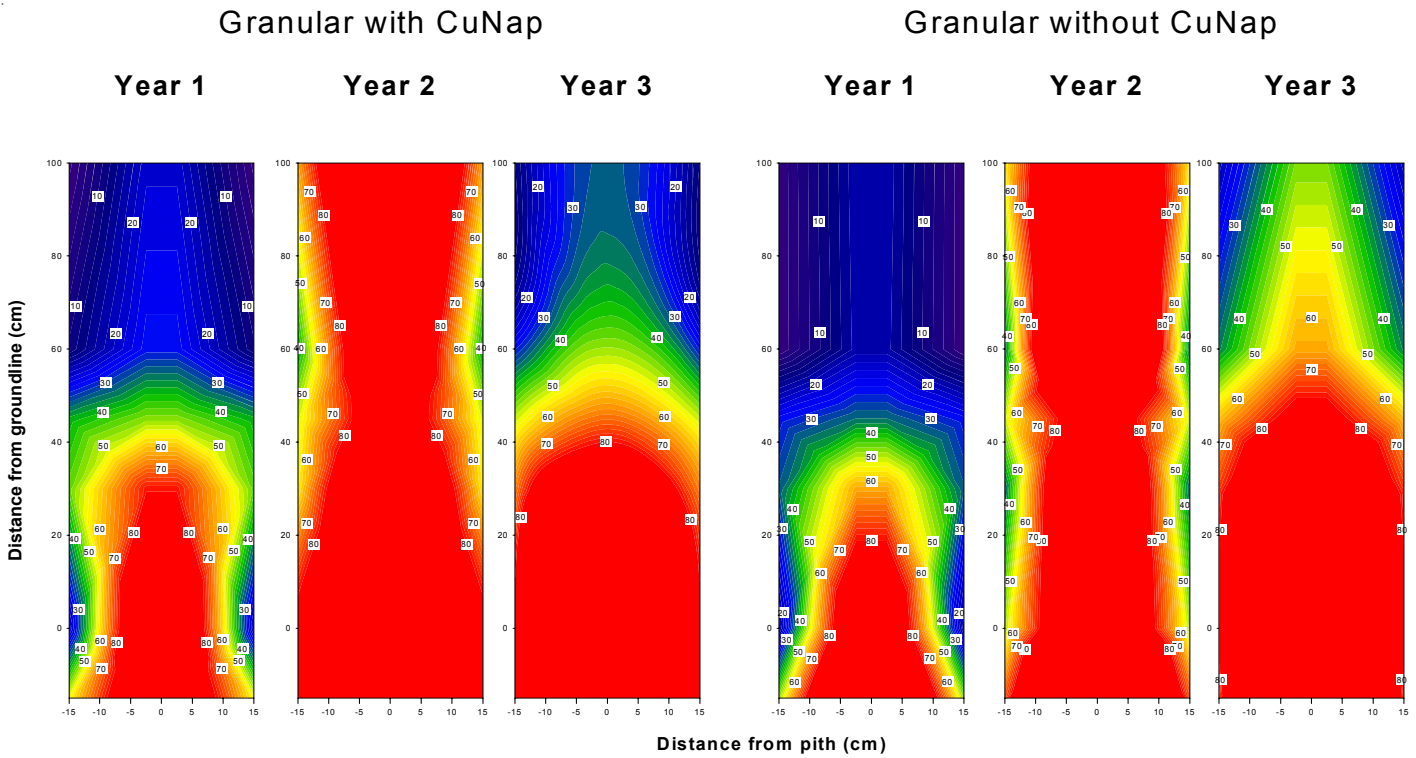
Figure I-5. MITC levels in pentachlorophenol treated Douglas-fir pole sections 1, 2, and 3 years after treatment with granular dazomet with and without copper naphthenate. Dark blue indicates MITC levels below the threshold for fungal attack. Light blue and other colors indicate MITC levels above the lethal threshold.

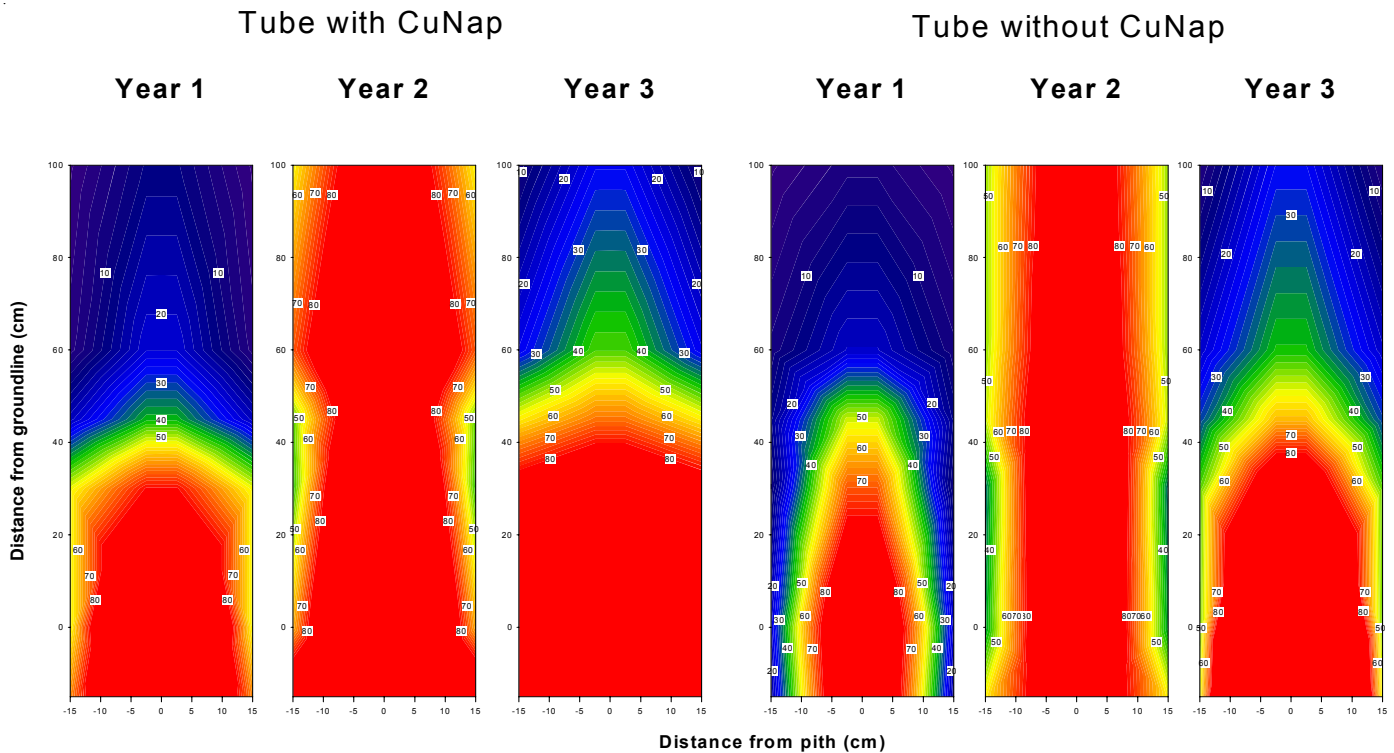
Figure I-6. MITC levels in pentachlorophenol treated Douglas-fir pole sections 1, 2, and 3 years after treatment with granular dazomet in paper tubes with and without copper naphthenate. Dark blue indicates MITC levels below the threshold for fungal attack. Light blue and other colors indicate MITC levels above the lethal threshold.

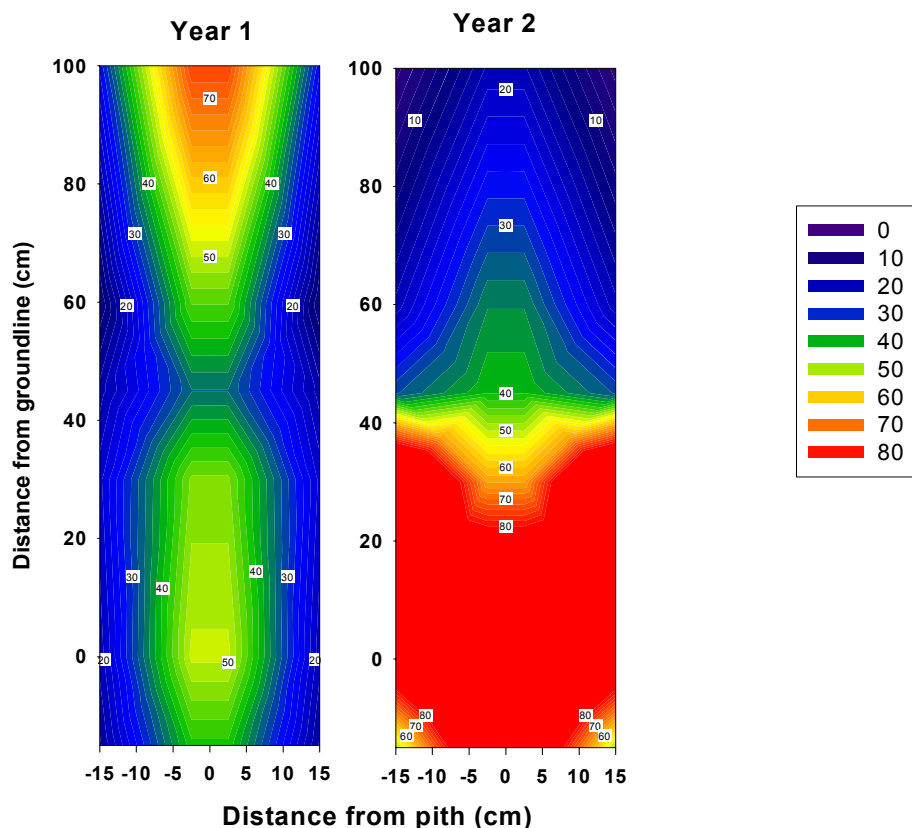
Figure I-7. MITC levels in pentachlorophenol treated Douglas-fir pole sections 1 and 2 years after treatment with granular dazomet in a newly designed plastic tube plus copper naphthenate. Dark blue indicates MITC levels below the threshold for fungal attack. Light blue and other colors indicate MITC levels above the lethal threshold.

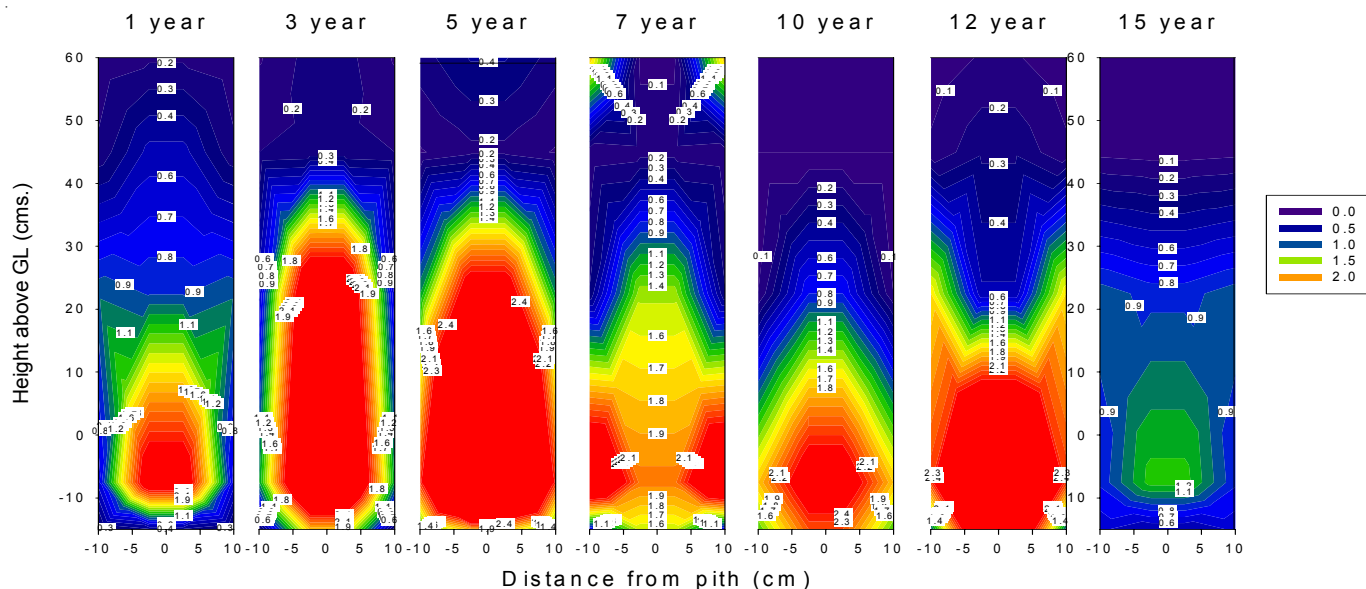
Figure I-8. Boron levels in pentachlorophenol treated Douglas-fir pole sections 1 to 15 years after treatment with 180 g of fused boron rod. Dark blue indicates boron levels below the threshold for fungal attack. Light blue and other colors indicate boron levels above the lethal threshold.

Boron levels in the outer zones tended to be more variable 150 mm below ground as well as 70 and 225 mm above ground. These results are consistent with a tendency for the rods to direct chemical toward the pole center though the steeply drilled treatment holes. Despite this variability, boron levels were still above the threshold up to 225 mm above groundline 15 years after treatment.

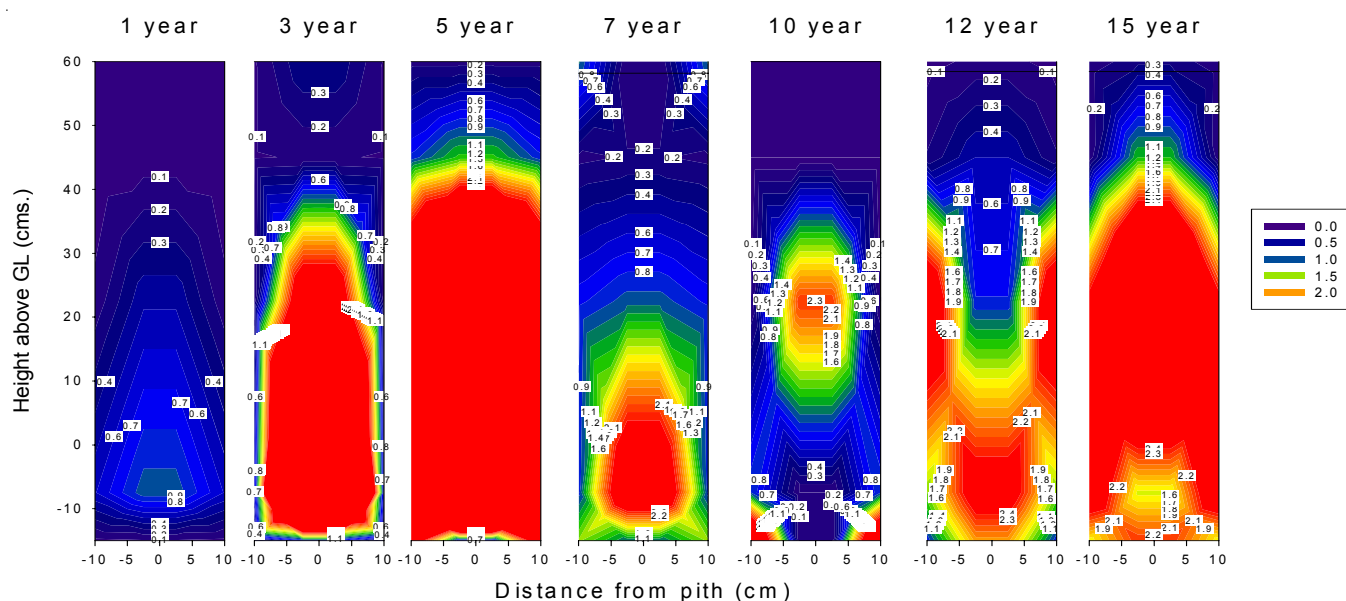
Figure I-9. Boron levels in pentachlorophenol treated Douglas-fir pole sections 1 to 15 years after treatment with 360 g of fused boron rod. Dark blue indicates boron levels below the threshold for fungal attack. Light blue and other colors indicate boron levels above the lethal threshold.

Boron levels in poles treated with 360 g of boron rod followed similar trends to those for the 180 g treatment, although the levels of boron detected were sometimes much greater, particularly in the inner zone 75 mm above groundline (Figure I-9). This area corresponded to the heart of the treated zone. We often observe the absence of a dosage effect with boron rods and have attributed this lack of effect to the lack of adequate moisture; however, there did appear to be some difference in boron levels between the two dosages early in the test. This effect disappeared after five years but appeared again 15 years after treatment.

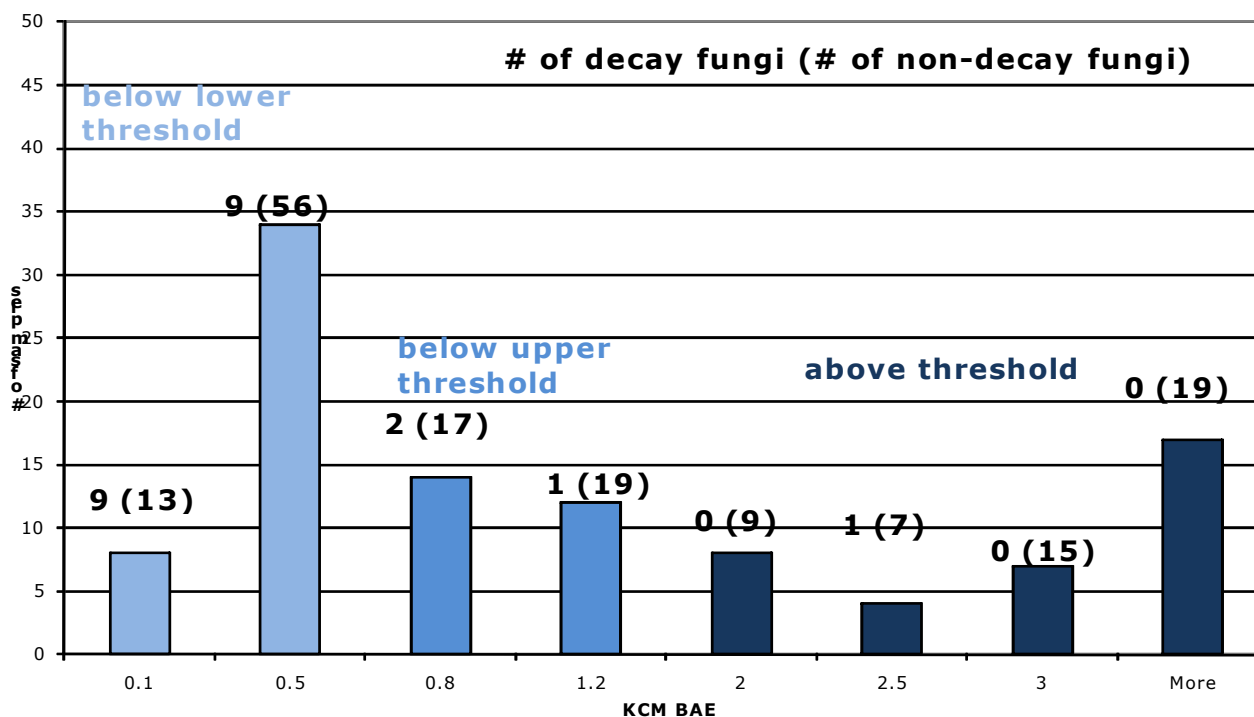
Figure I-10. Comparison between fungal isolation frequency and boron levels in cores removed from Douglas-fir poles 15 years after application of fused borate rods.

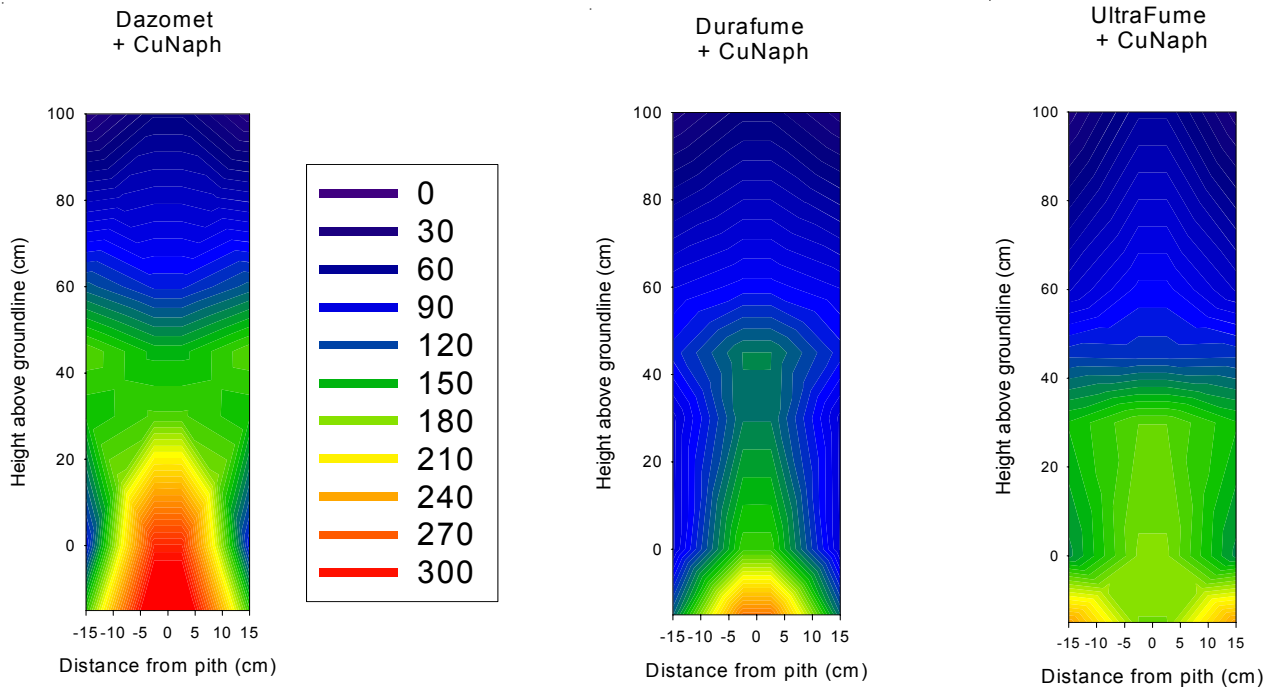
Figure I-11. Distribution of MITC in Douglas-fir poles sections 18 months after treatment with dazomet plus copper naphthenate, DuraFume plus copper naphthenate or UltraFume plus copper naphthenate. Dark blue indicates MITC levels below threshold, while all other colors indicate above-threshold values.

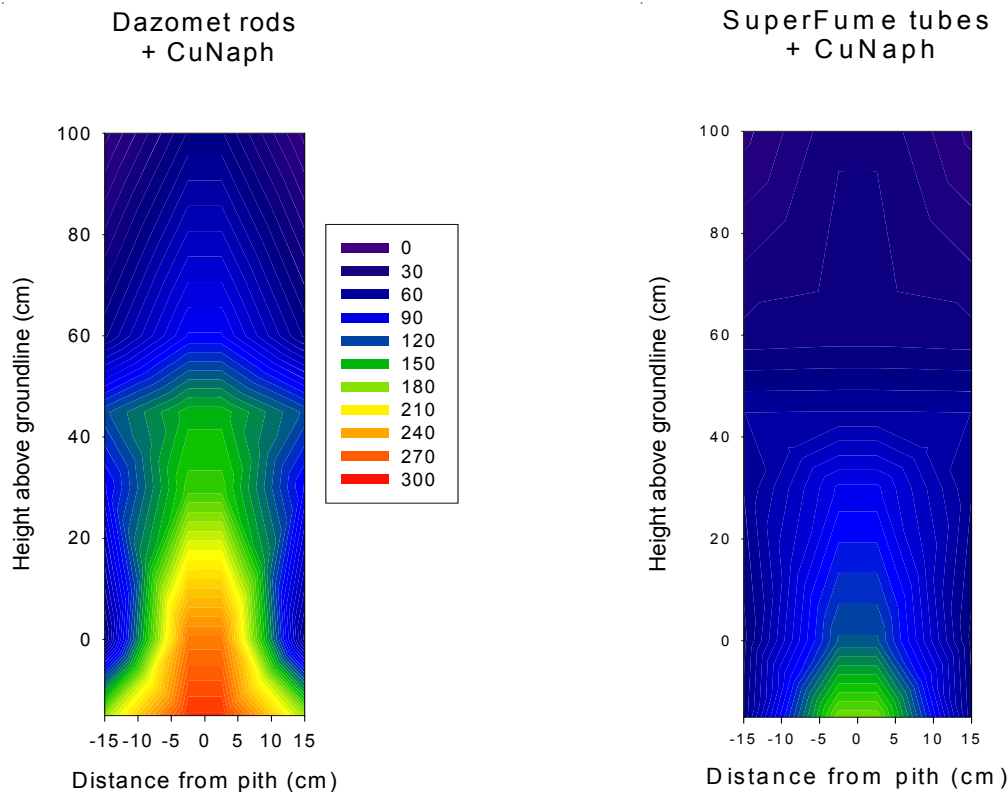
Figure I-12. Distribution of MITC in Douglas-fir poles sections 18 months after treatment with dazomet rods plus copper naphthenate or SUPER-FUME tubes plus copper naphthenate. Dark blue indicates MITC levels below threshold, while all other colors indicate above-threshold values.

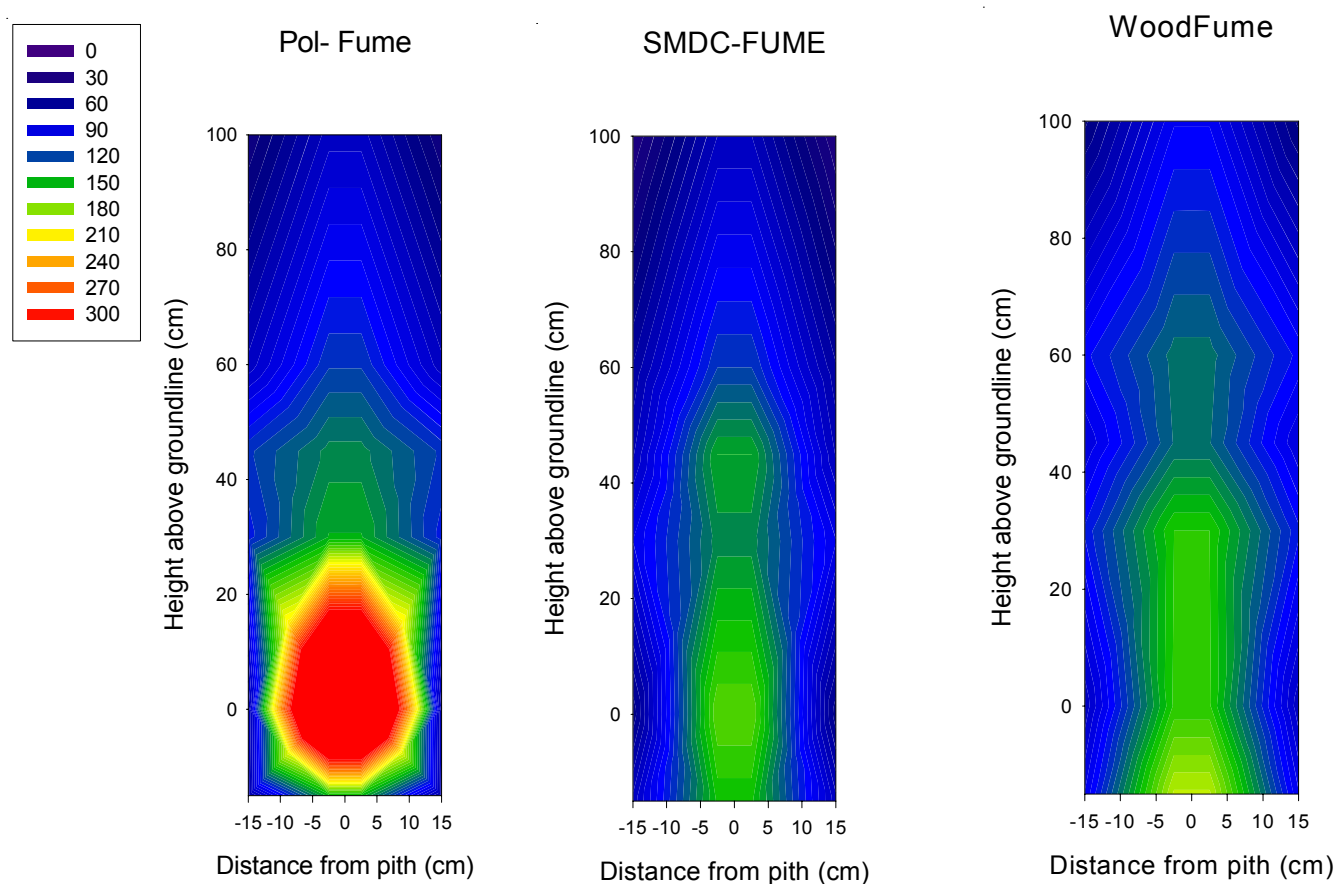
Figure I-14. Distribution of MITC in Douglas-fir poles sections 18 months after treatment with Pol-Fume, SMDC-Fume, or WoodFume. Dark blue indicates MITC levels below threshold, while all other colors indicate above-threshold values.

The results indicate that the SMDC systems have all decomposed at levels capable of producing wood protection in a zone from 150 mm below groundline to 1 m above that line. These results are consistent with previous field trials.

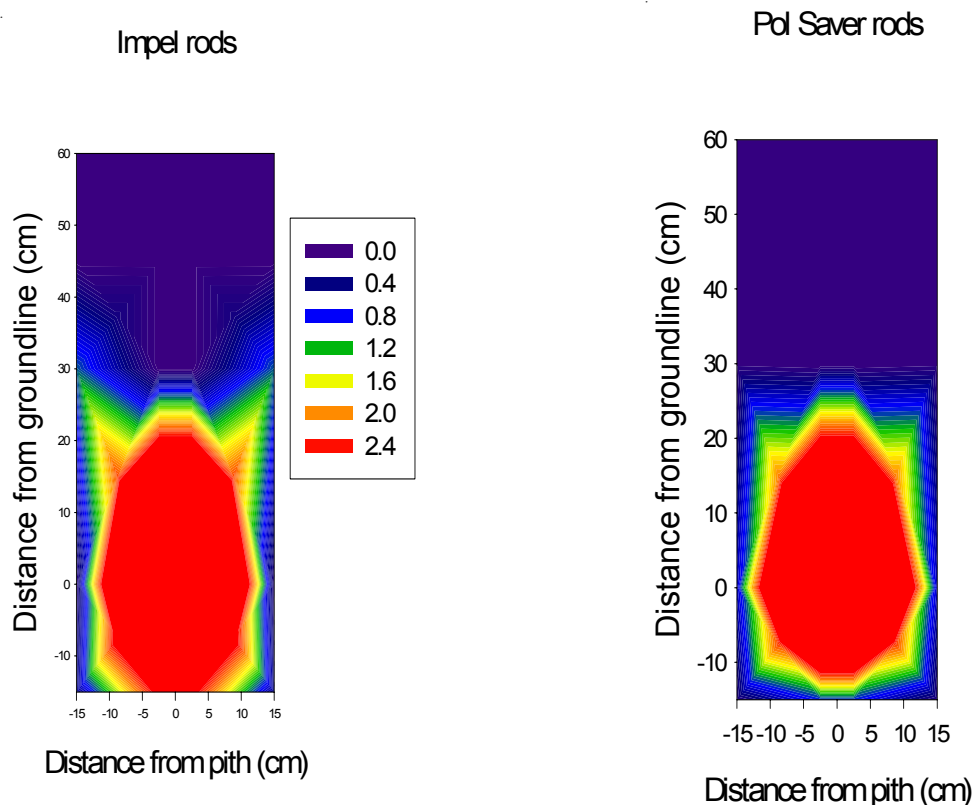
Figure I-15. Boron distribution in Douglas-fir poles 18 months after application of Impel or Pol Saver rods. Blue areas contain boron levels below the threshold, while areas with all other colors contain increasing levels of boron.

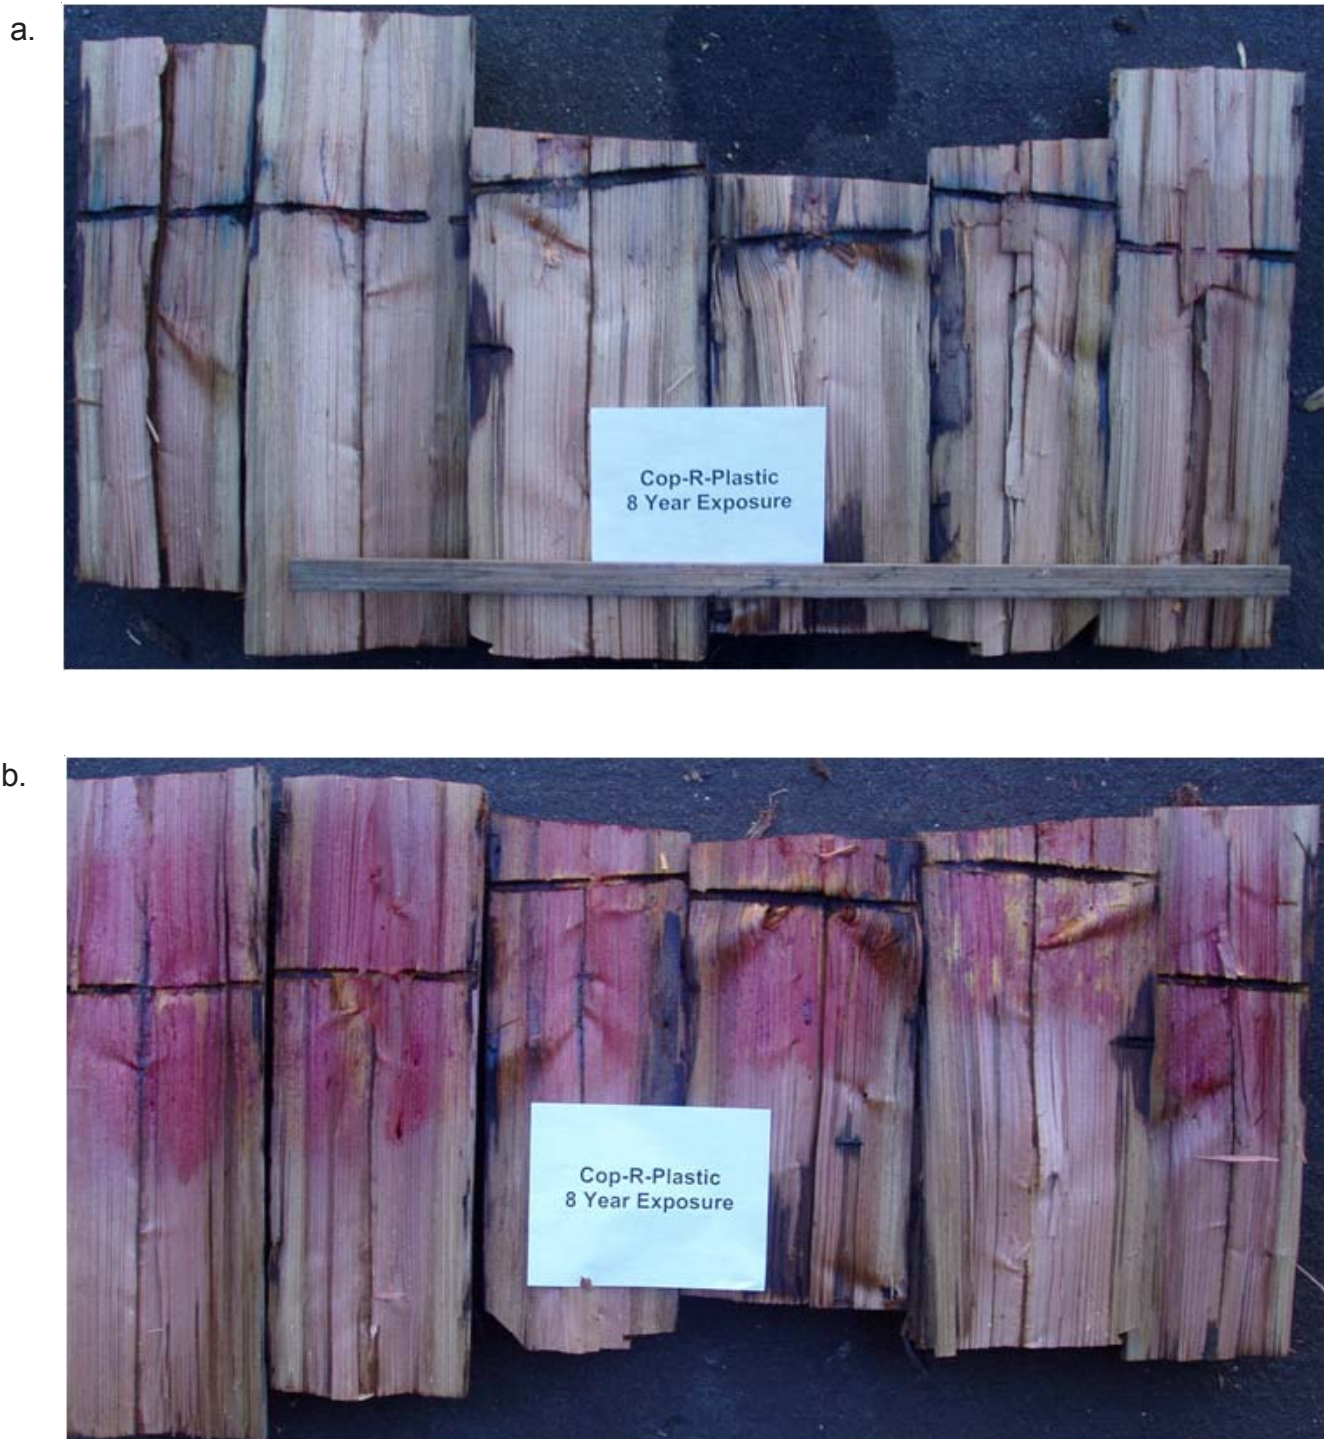
Figure II-1. Degree of a) copper and b) fluoride movement away from the sites in Douglas-fir pole stubs where Cop-R-Plastic coated galvanized threaded rods were installed 8 years earlier.

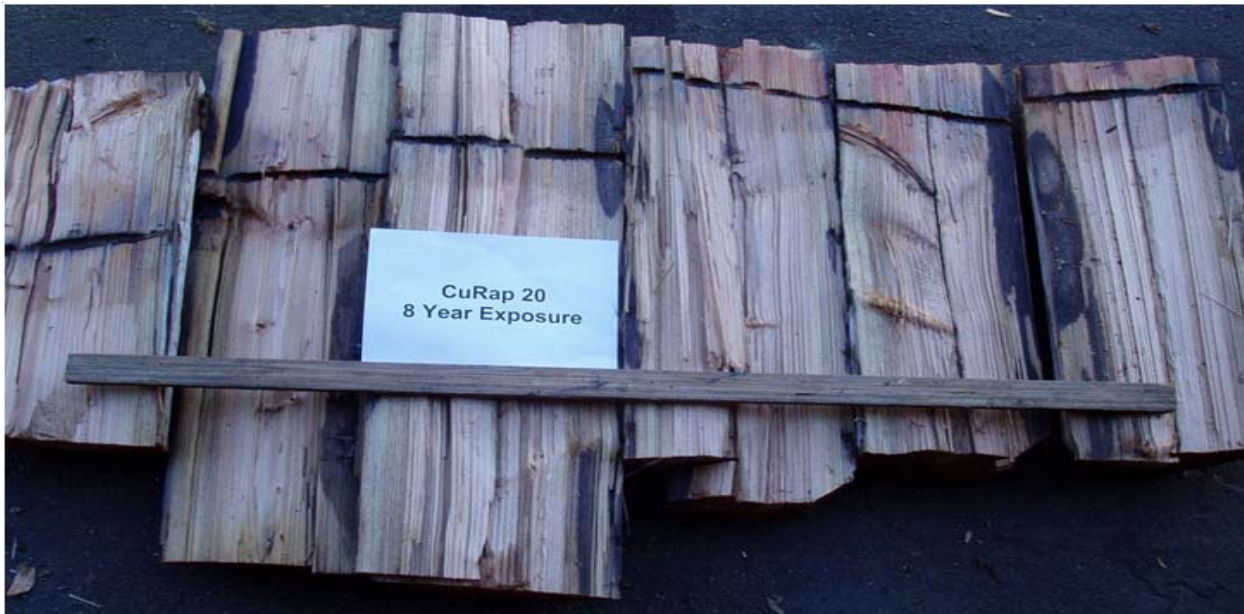
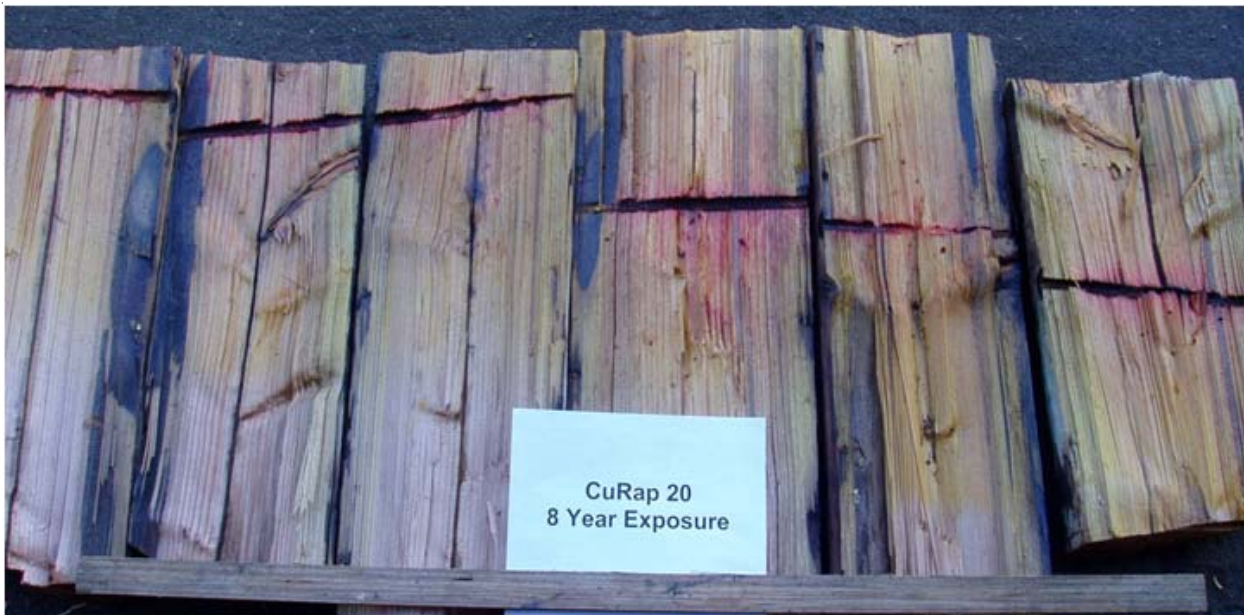
Figure II-2. Degree of a) copper and b) boron movement away from the sites in Douglas-fir pole stubs where CuRap 20 coated galvanized threaded rods were installed 8 years earlier.

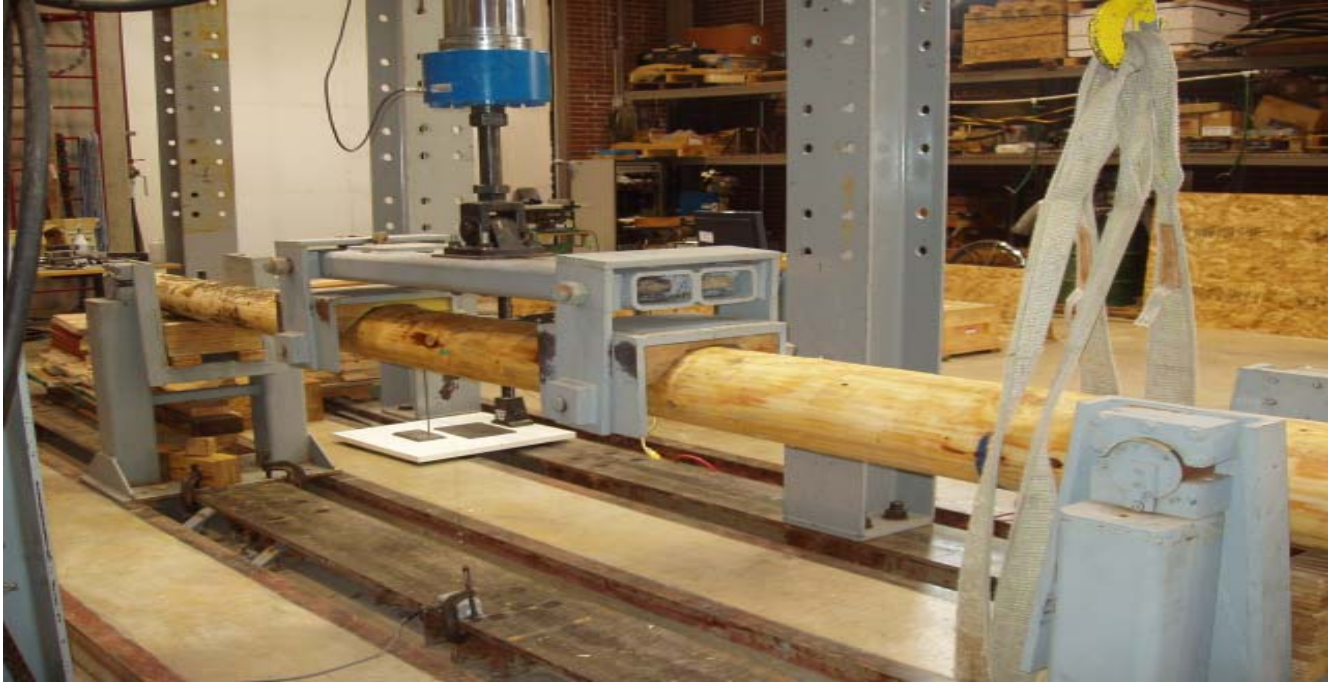
Figure III-1. Photograph showing a pole in the test set-up.

test specimen (L) was 144 inches with a minimum 1-ft overhang on each end (Figure III-1).

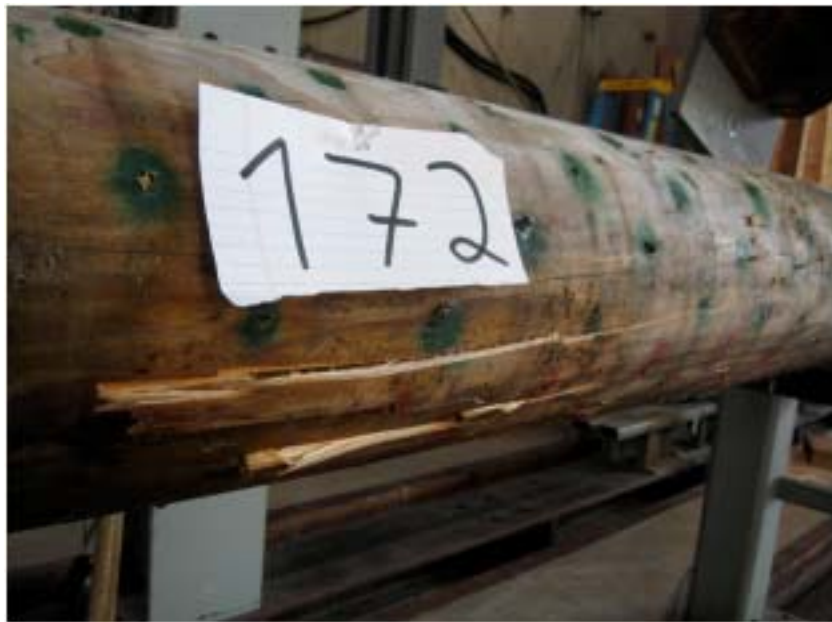
Figure III-2. Example of a typical tension failure on a through-bored Douglas-fir pole.

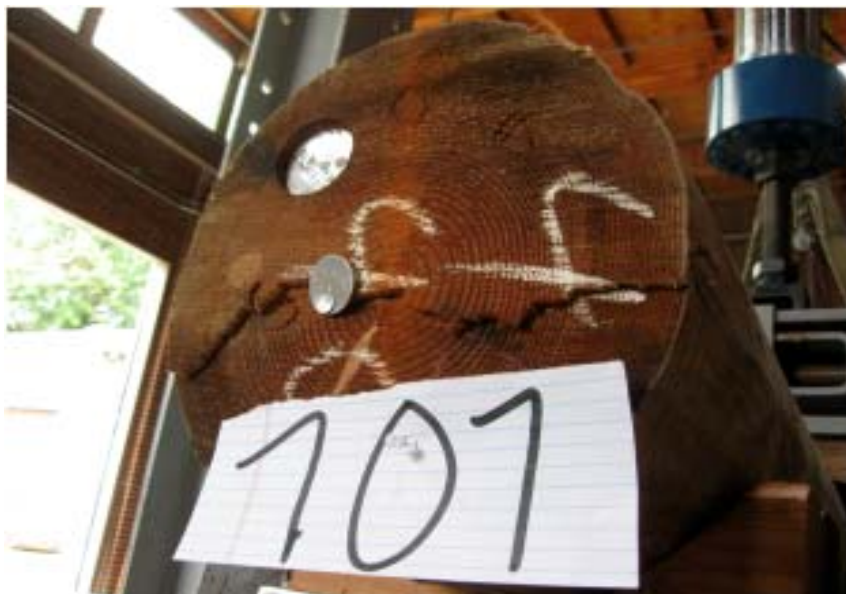
Figure III-3. Example of a shear failure on a deep incised Douglas-fir pole.

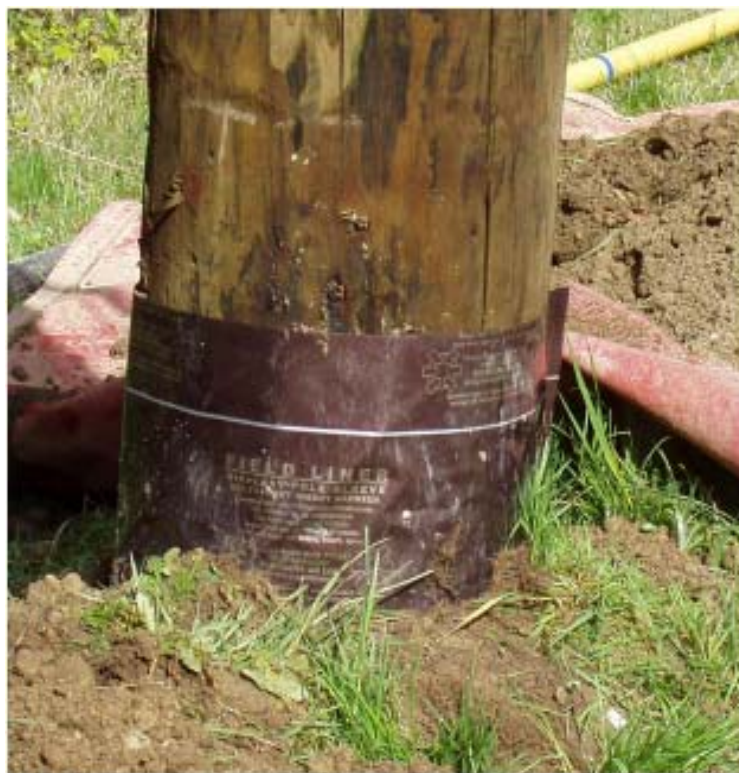
Figure III-5. Example of external barrier assessed on Douglas-fir poles.

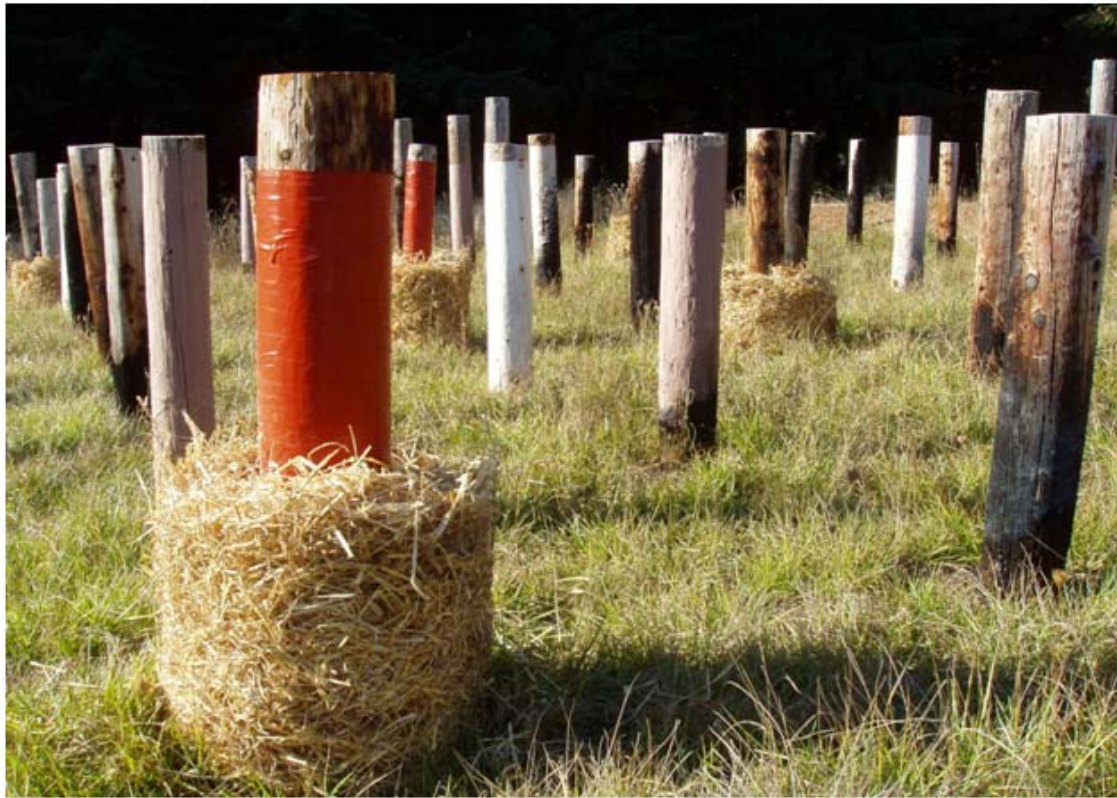
Figure III-6. Example of a pole section with straw in cage prior to ignition.

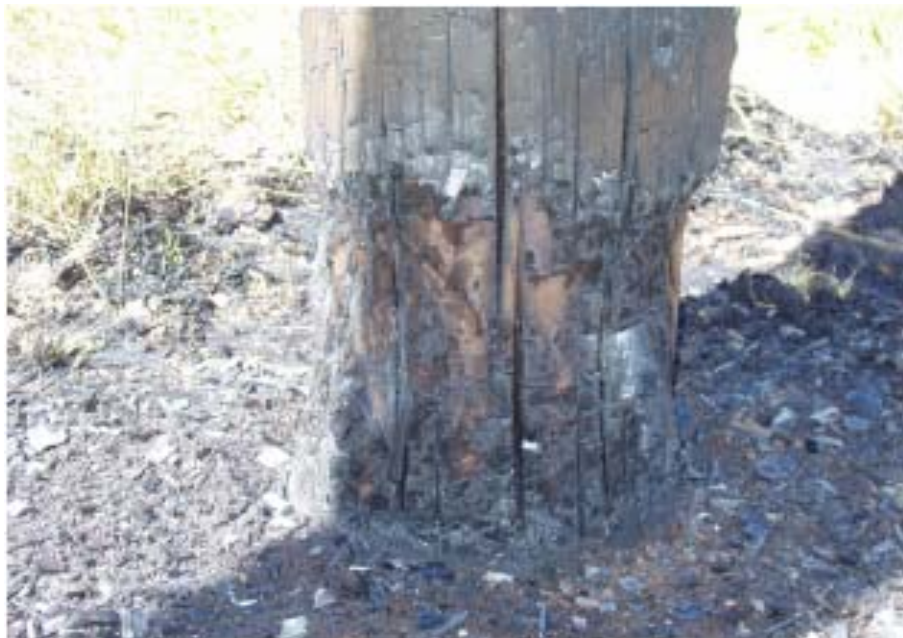
Figure III-7. Example of char around a pole following a fire test.

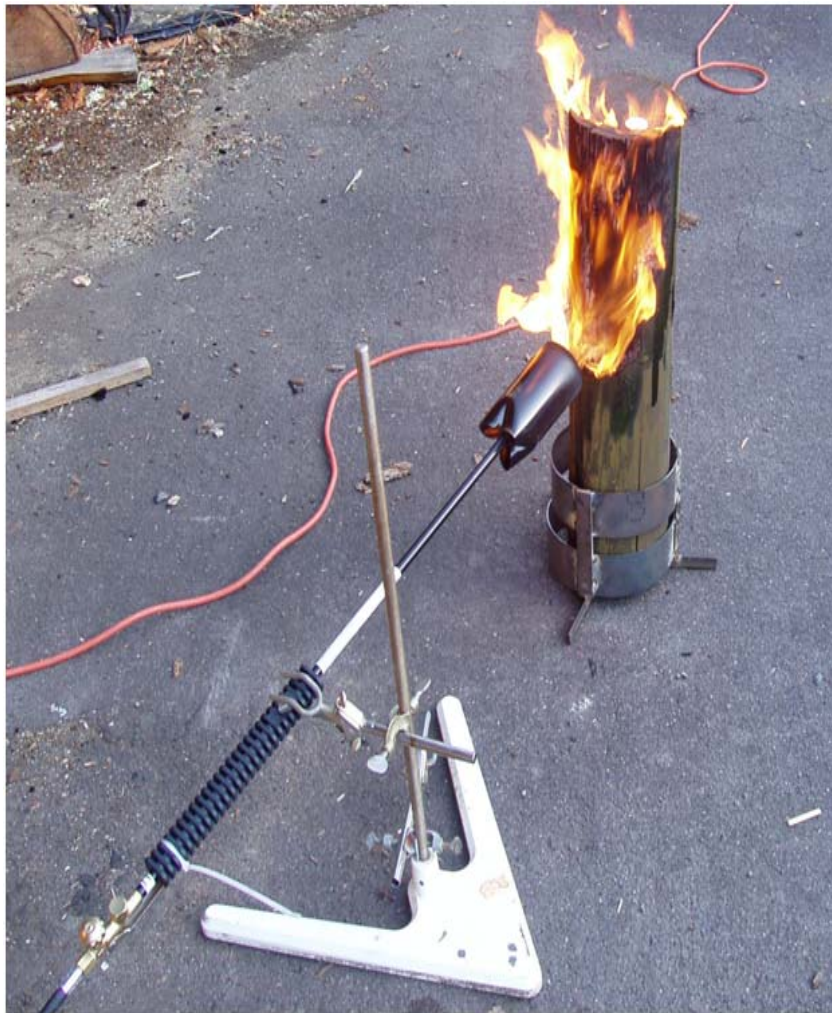
Figure III-8. Apparatus used to evaluate fire resistance of post sections treated with pentachlorophenol in various P9 Type A solvents.

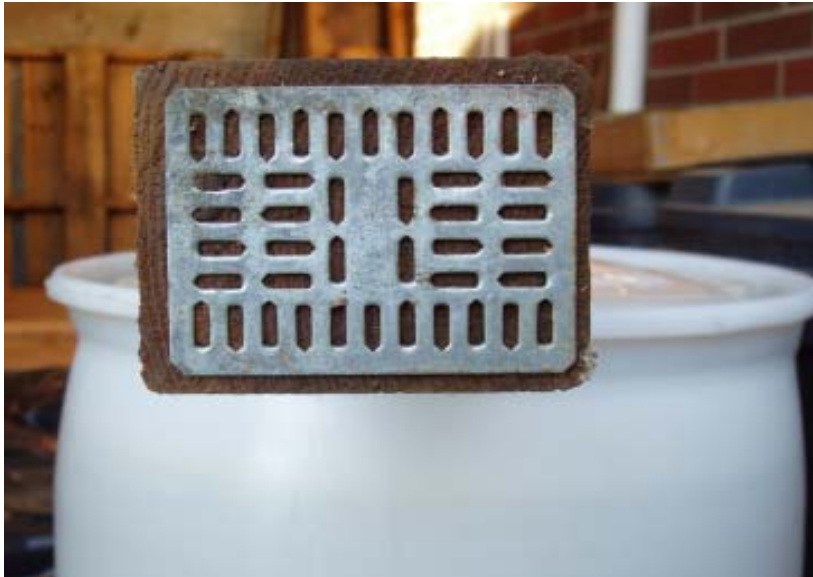
Figure III-9. Example of an end-plate on a penta treated Douglas-fir cross arm.

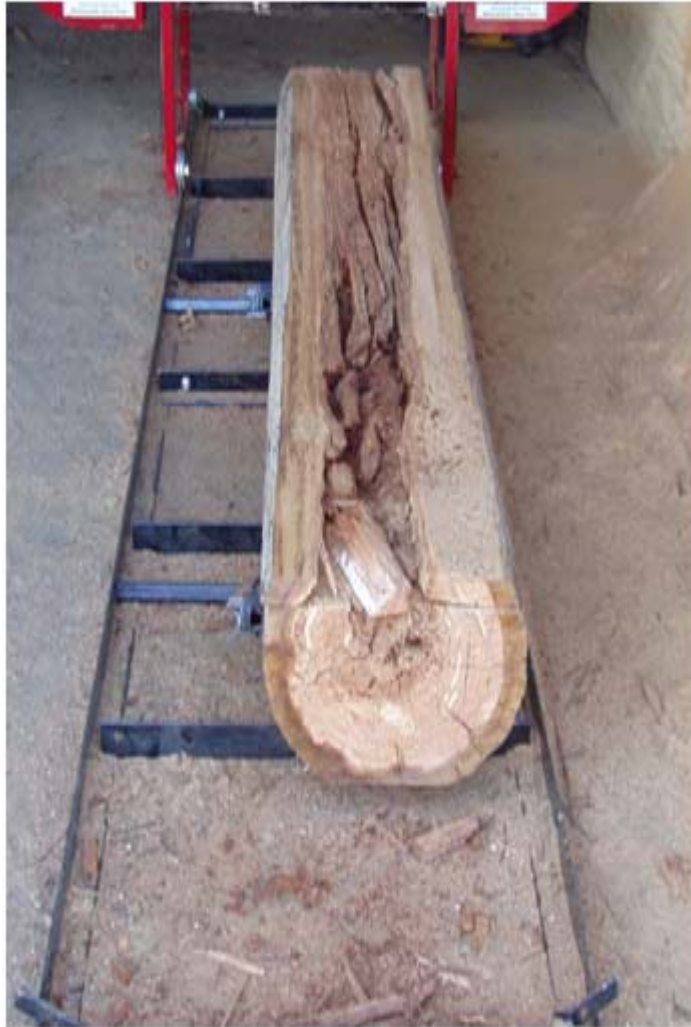
Figure III-11. Example of a section through a Douglas-fir pole showing internal decay.
