# Oregon State University Utility Pole Research Cooperative

29th Annual Report  
October 26, 2009

Department of Wood Science &  
Engineering  
Oregon Wood Innovation Center  
(OWIC)

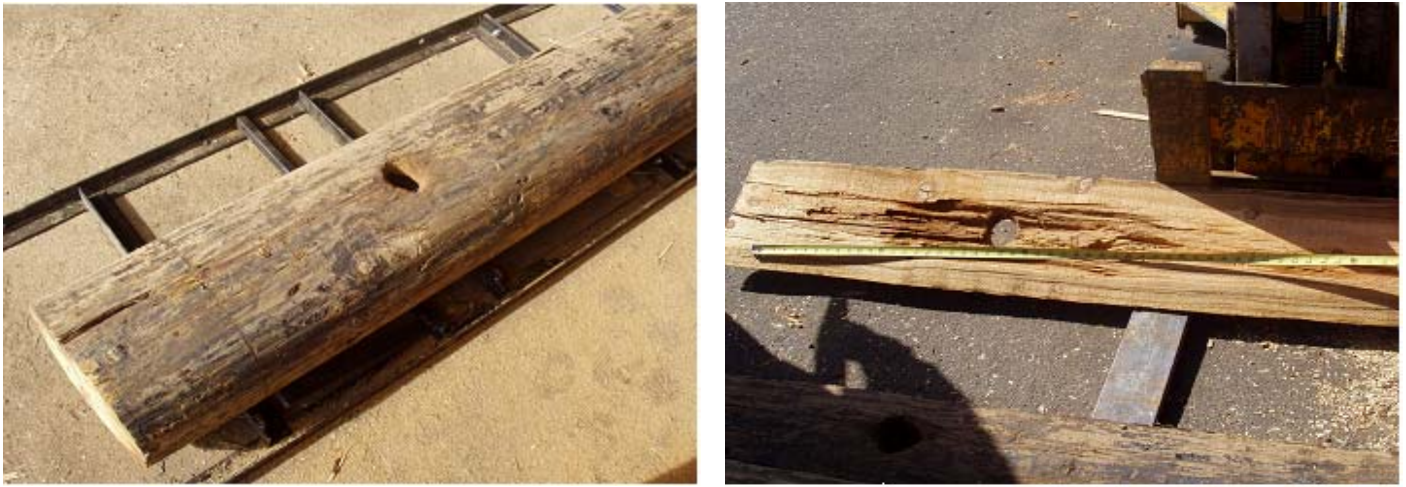
Figure III-12. Example of sections through a Douglas-fir pole showing a woodpecker hole on the surface and the extent of the internal damage associated with the hole.

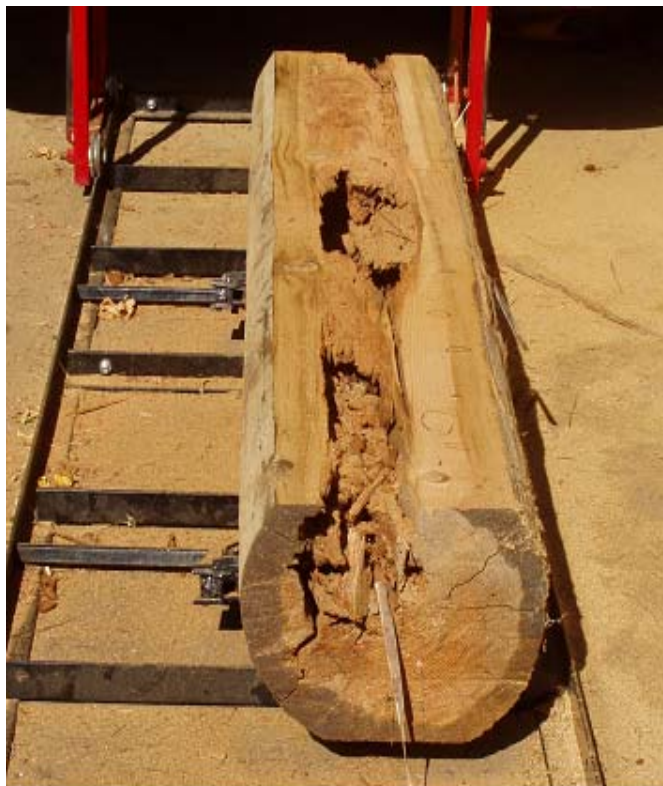
Figure III-13. Example of a section through a Douglas-fir pole showing an association between golden buprestid galleries (circled areas) and dampwood termites.

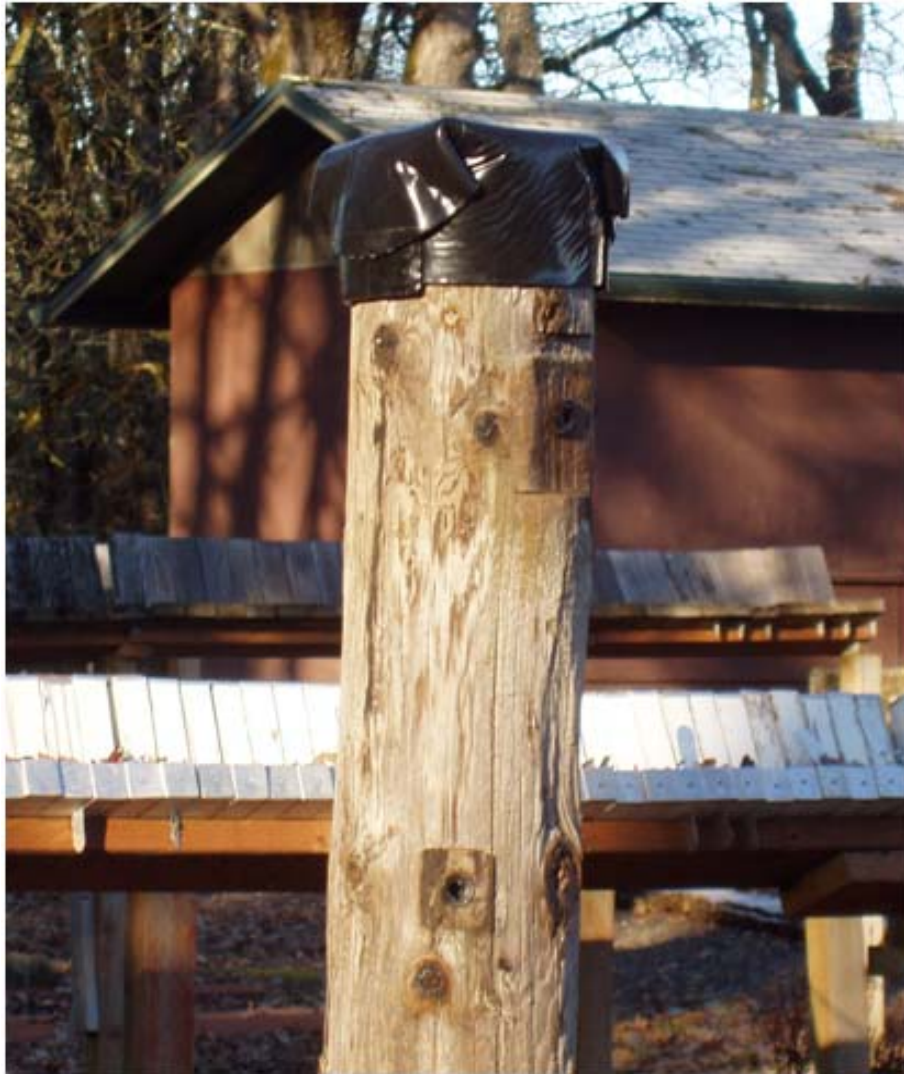
Figure III-15. Example of a capped pole used to assess the effects of capping on wood moisture content.

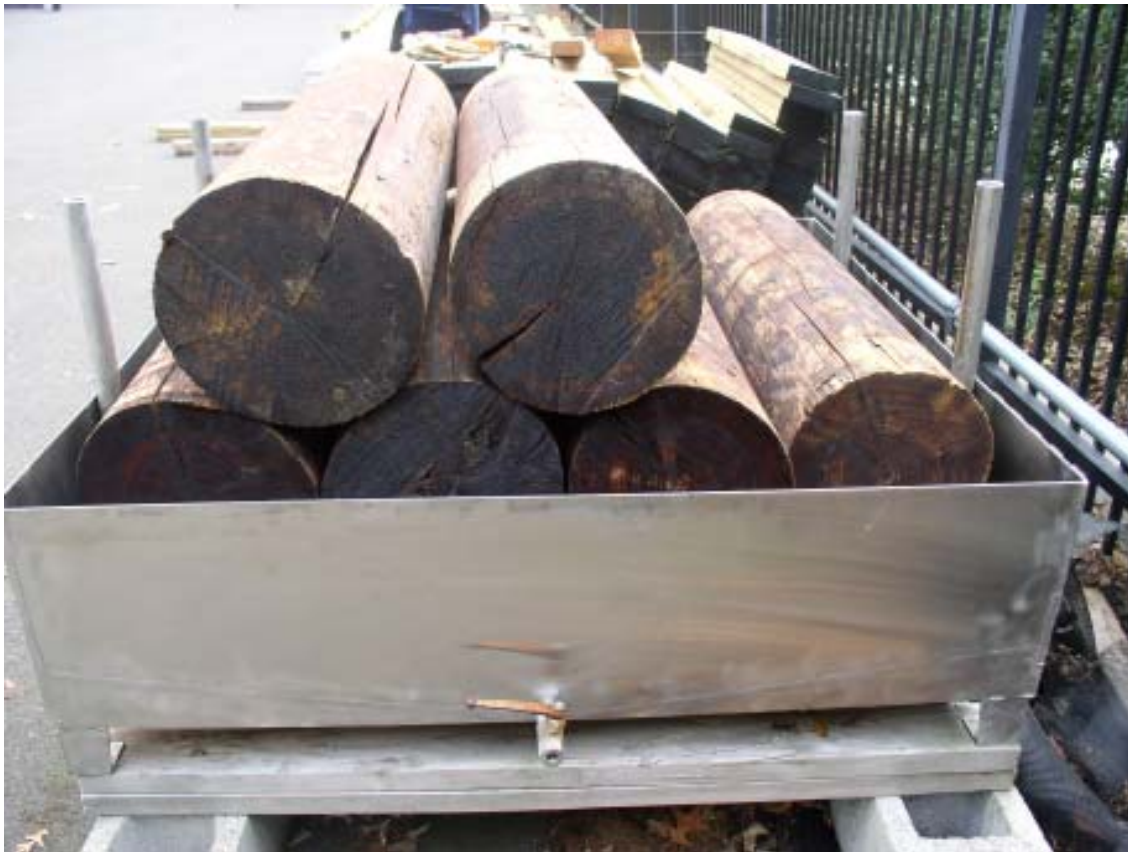
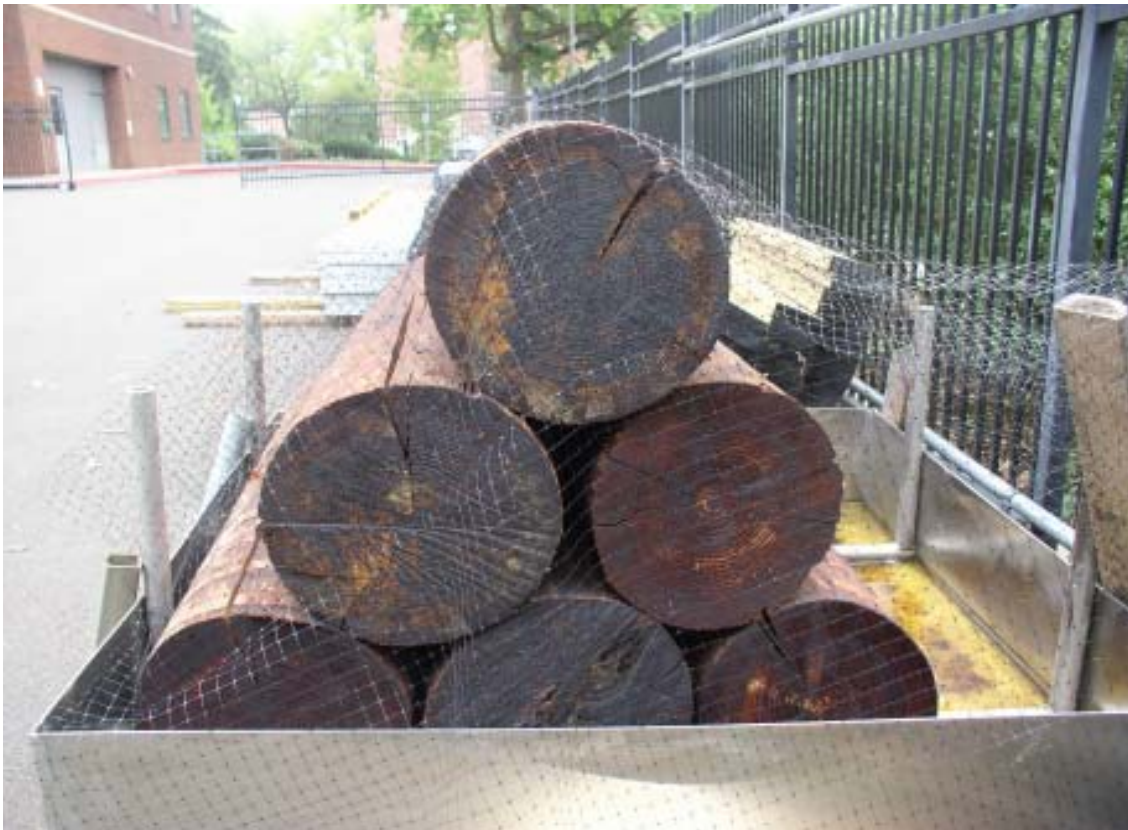
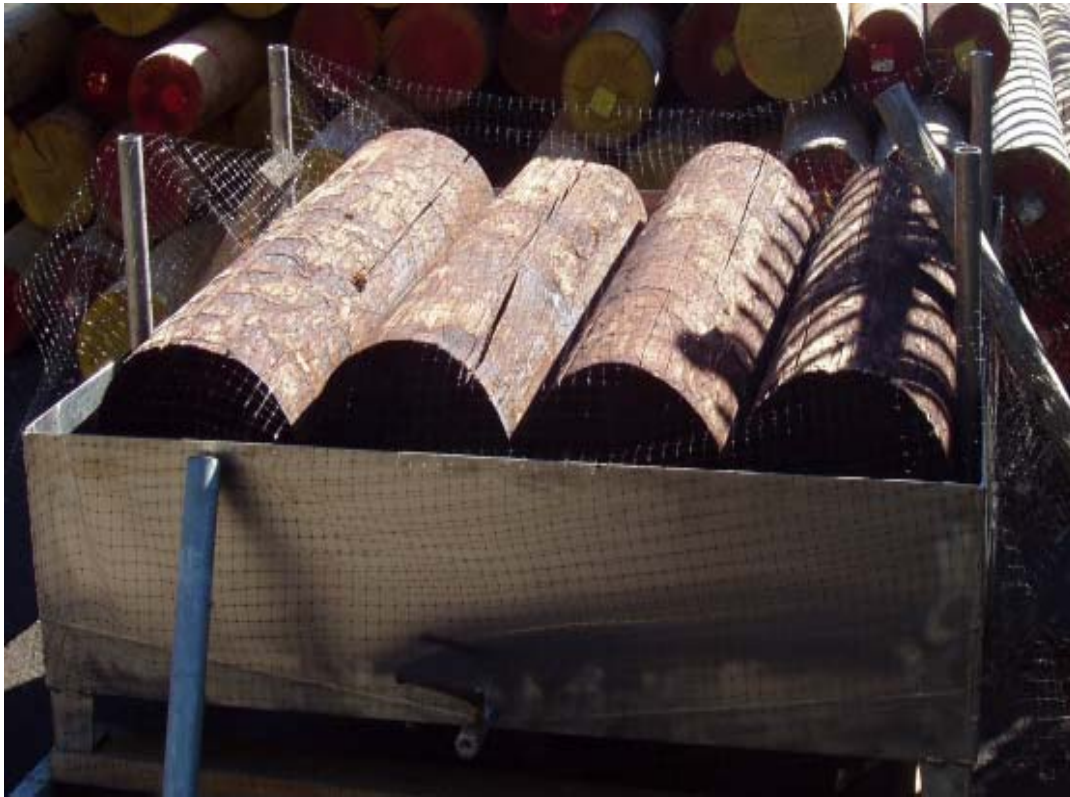
Figure VI-1. Photo showing the two six-pole configurations a) configuration 1, b) configuration 2, and c) the four-pole configuration evaluated in our small scale preservative migration chamber.

Figure VI-1 (cont.). Photo showing the two six-pole configurations a) configuration 1, b) configuration 2, and c) the four-pole configuration evaluated in our small scale preservative migration chamber.

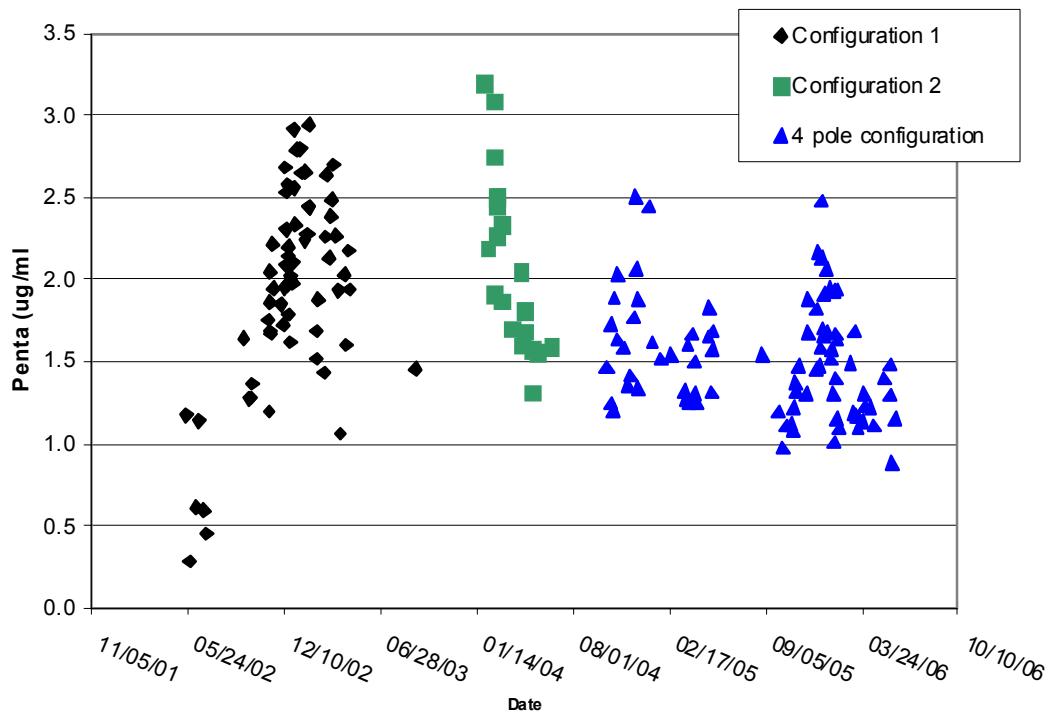
Figure VI-2. Penta concentrations as a function of sampling date in leachate collected from penta treated Douglas-fir poles following rainfall events over a 4.5 year exposure period showing data for three stacking configurations of poles.

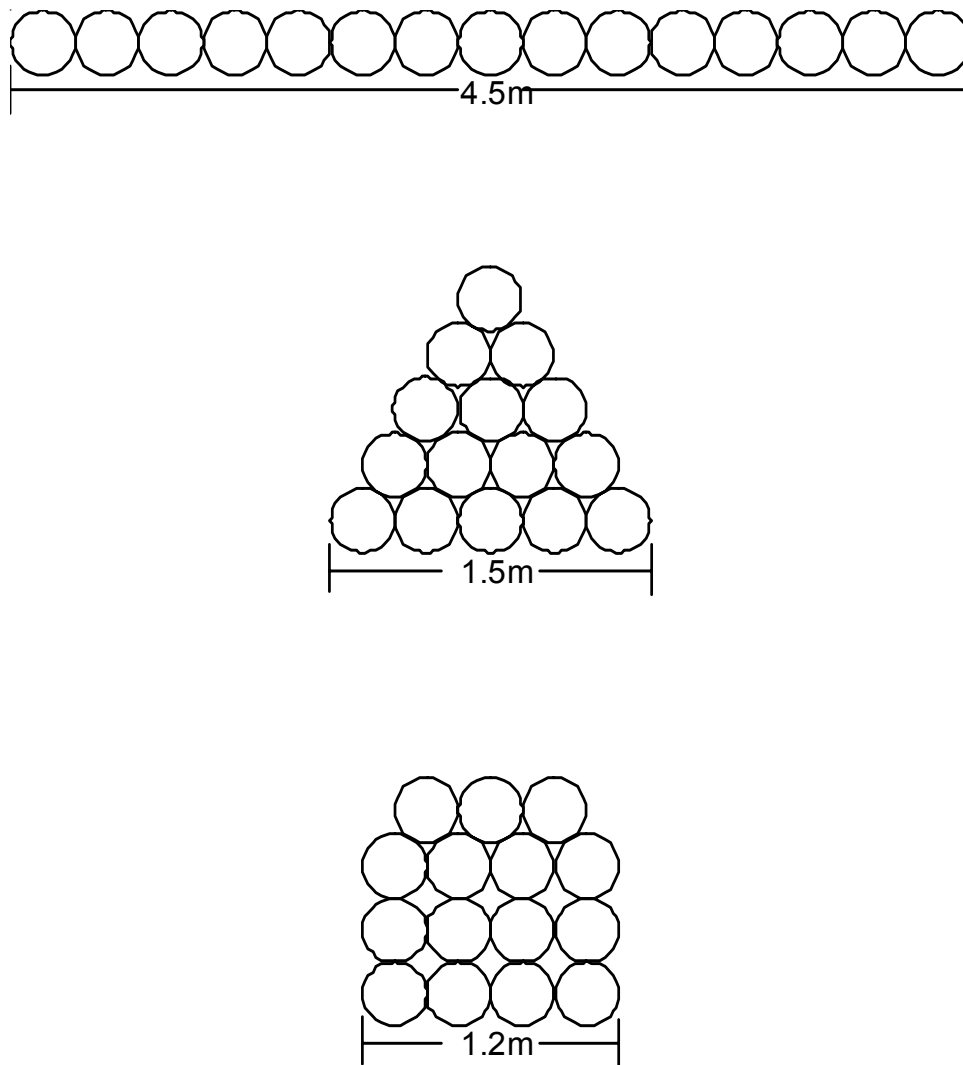
Figure VI-3. Configurations of 15 Class 4 forty foot long poles used to model predicted penta concentrations in soil beneath the poles as a result of rainwater runoff. Poles were configured as 15 individual poles, poles in a triangular stack and poles in four courses with stickers in between each course.

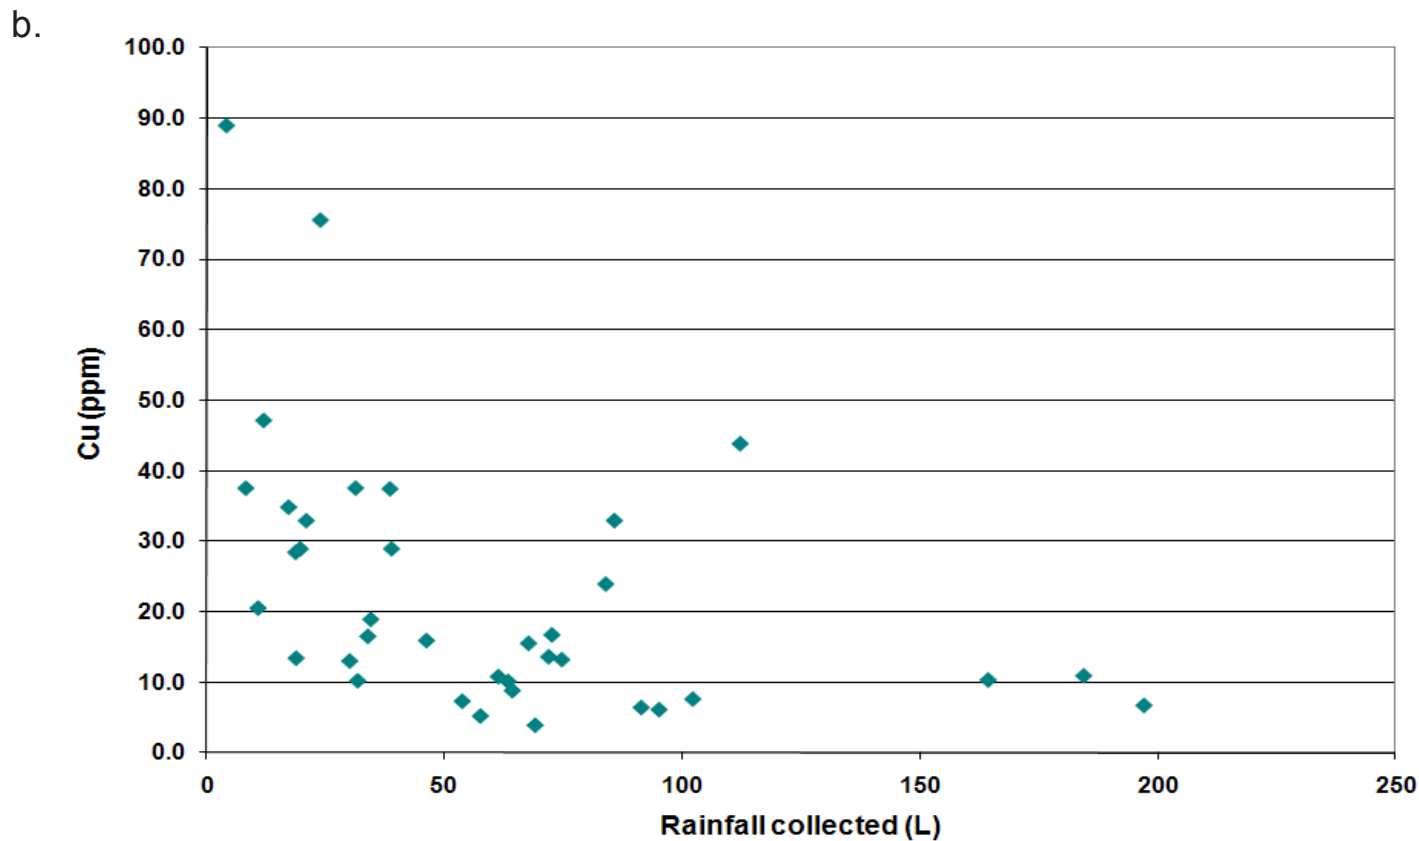
Figure VI-10. Zinc a) and copper b) levels in rainwater runoff from poles treated with ammoniacal copper zinc arsenate as a function of total rainfall collected.
