Oregon State University Utility Pole Research Cooperative

33rd Annual Report
October 9th 2013

J.J. Morrell, C. Love, C. Freitag,
J. Schindler and S. Leavengood

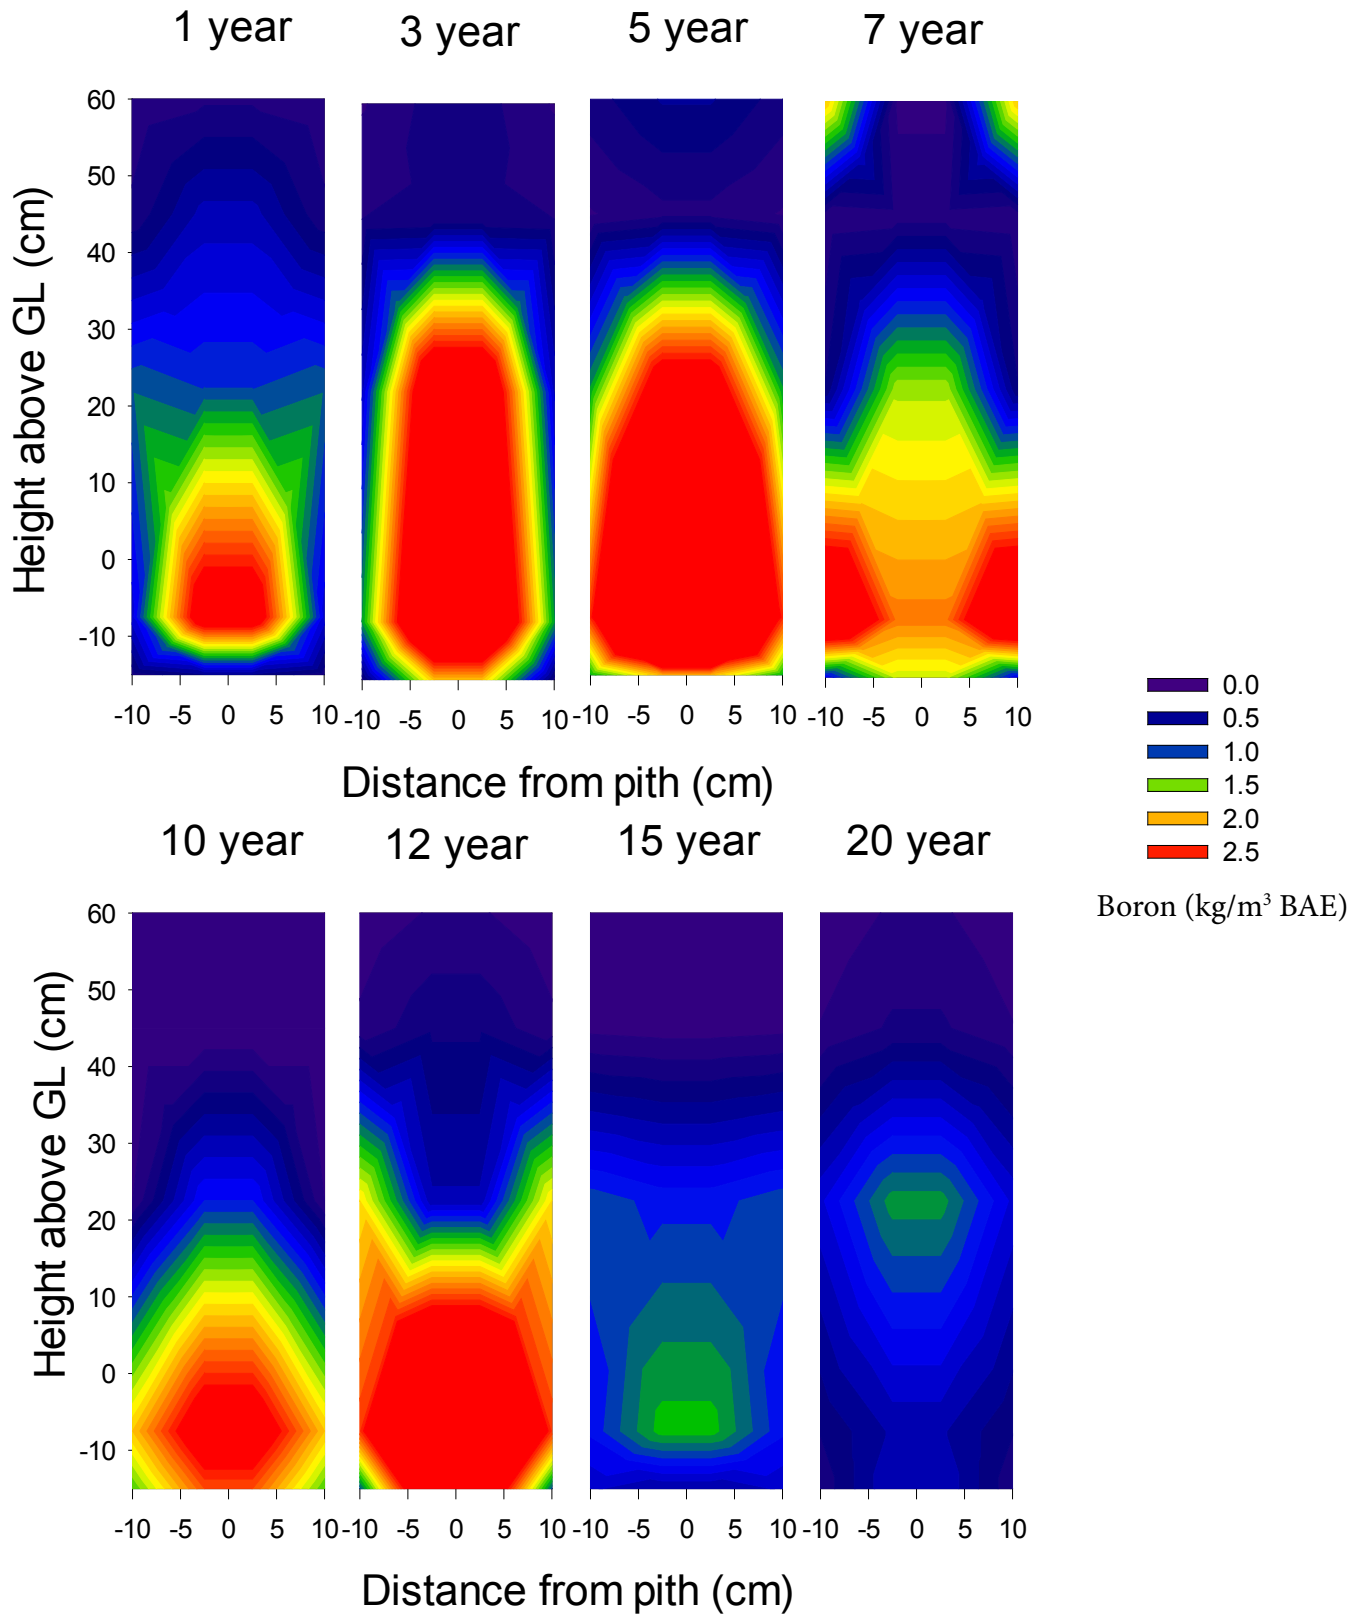
Figure I-11. Maps showing relative levels of boron in Douglas-fir poles 1 to 20 years after treatment with 180 g of fused borate rod.

to 0.27 kg/m³ (Table I-8). These levels are well below the threshold for protection. Boron levels in the inner zones of poles treated with 180 g of boron rod were at or above the threshold 150 mm below ground as well as 75 and 225 mm above the groundline throughout the test (Figure I-11). Levels in these inner zones were still 0.5 to 1.15 kg/m³ 20 years after treatment. Boron is traditionally viewed as extremely water soluble and likely to rapidly diffuse from treated wood in soil contact; however, it is likely that the oil treated shell limited the ability of boron to diffuse outward. Boron levels 450 and 600 mm above groundline were much lower and generally below the

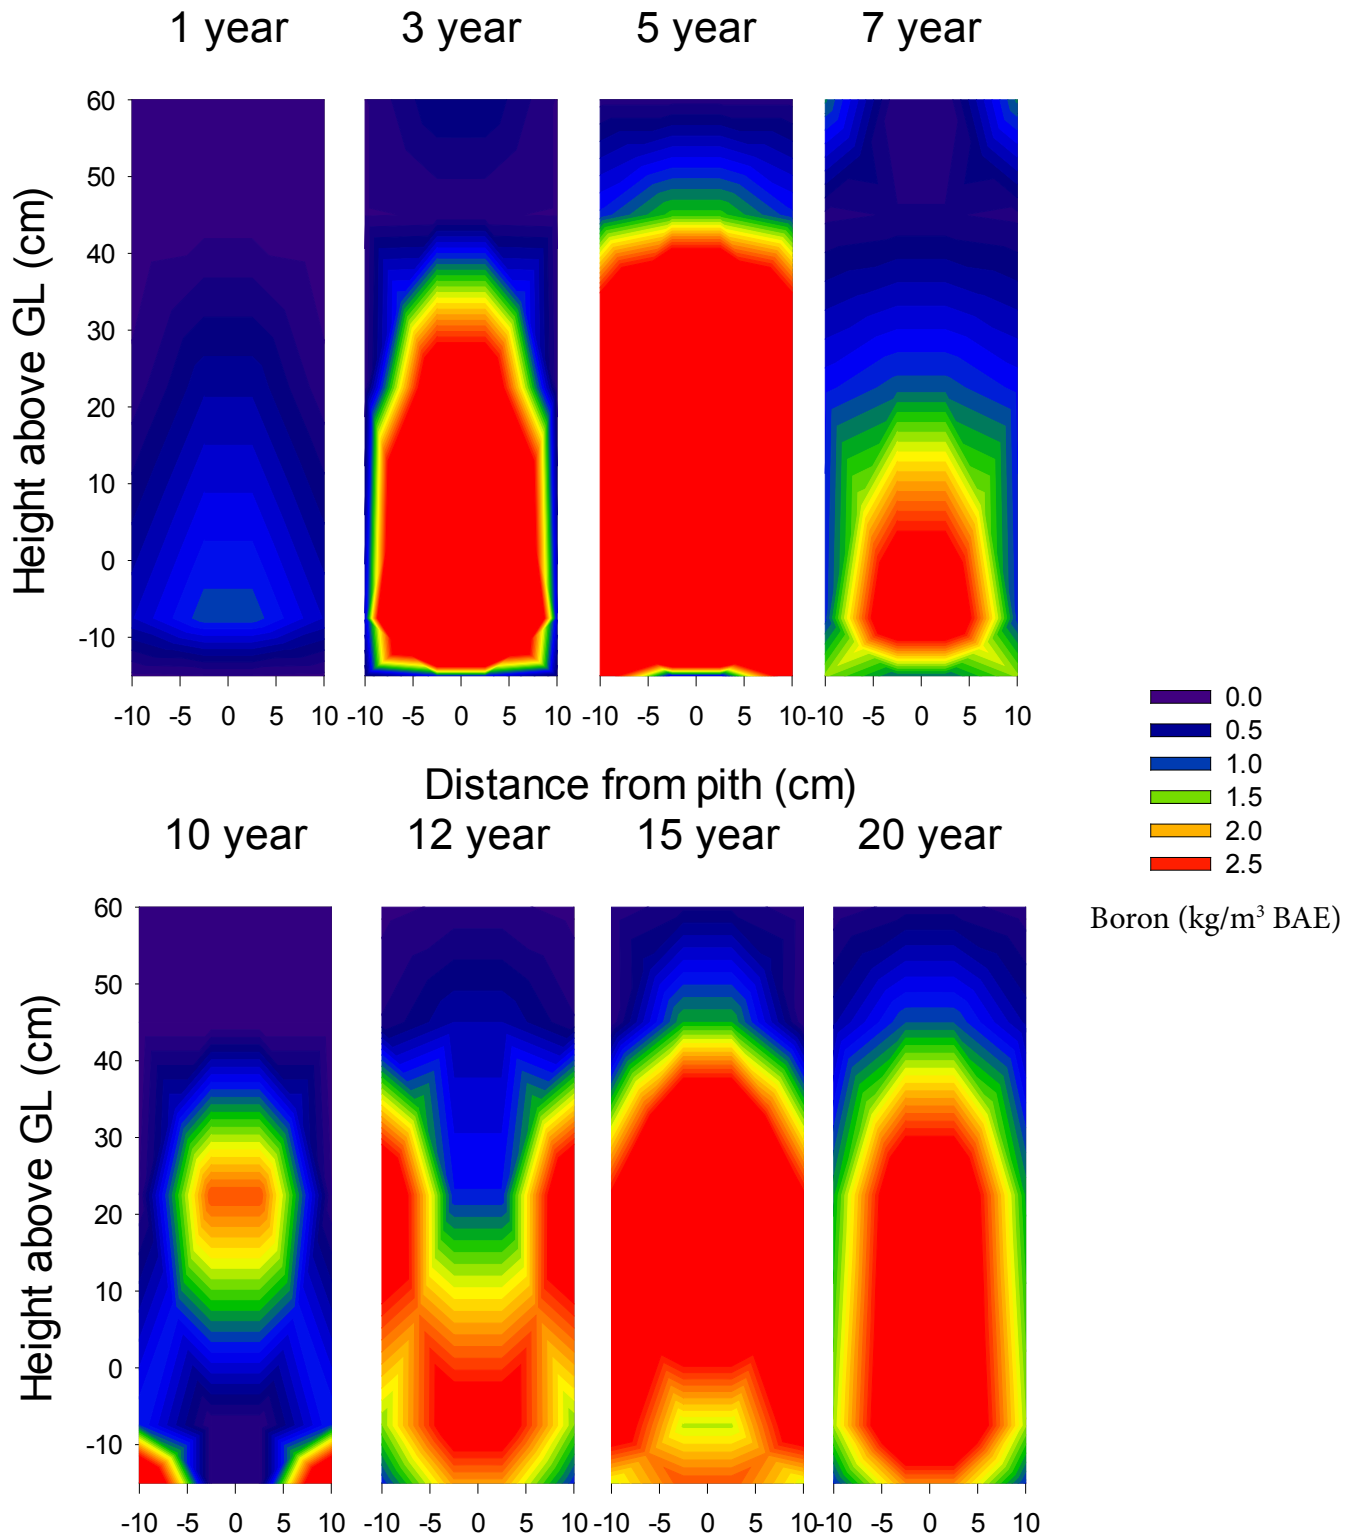
Figure I-12. Maps showing relative levels of boron in Douglas-fir poles 1 to 20 years after treatment with 360 g of fused borate rod.

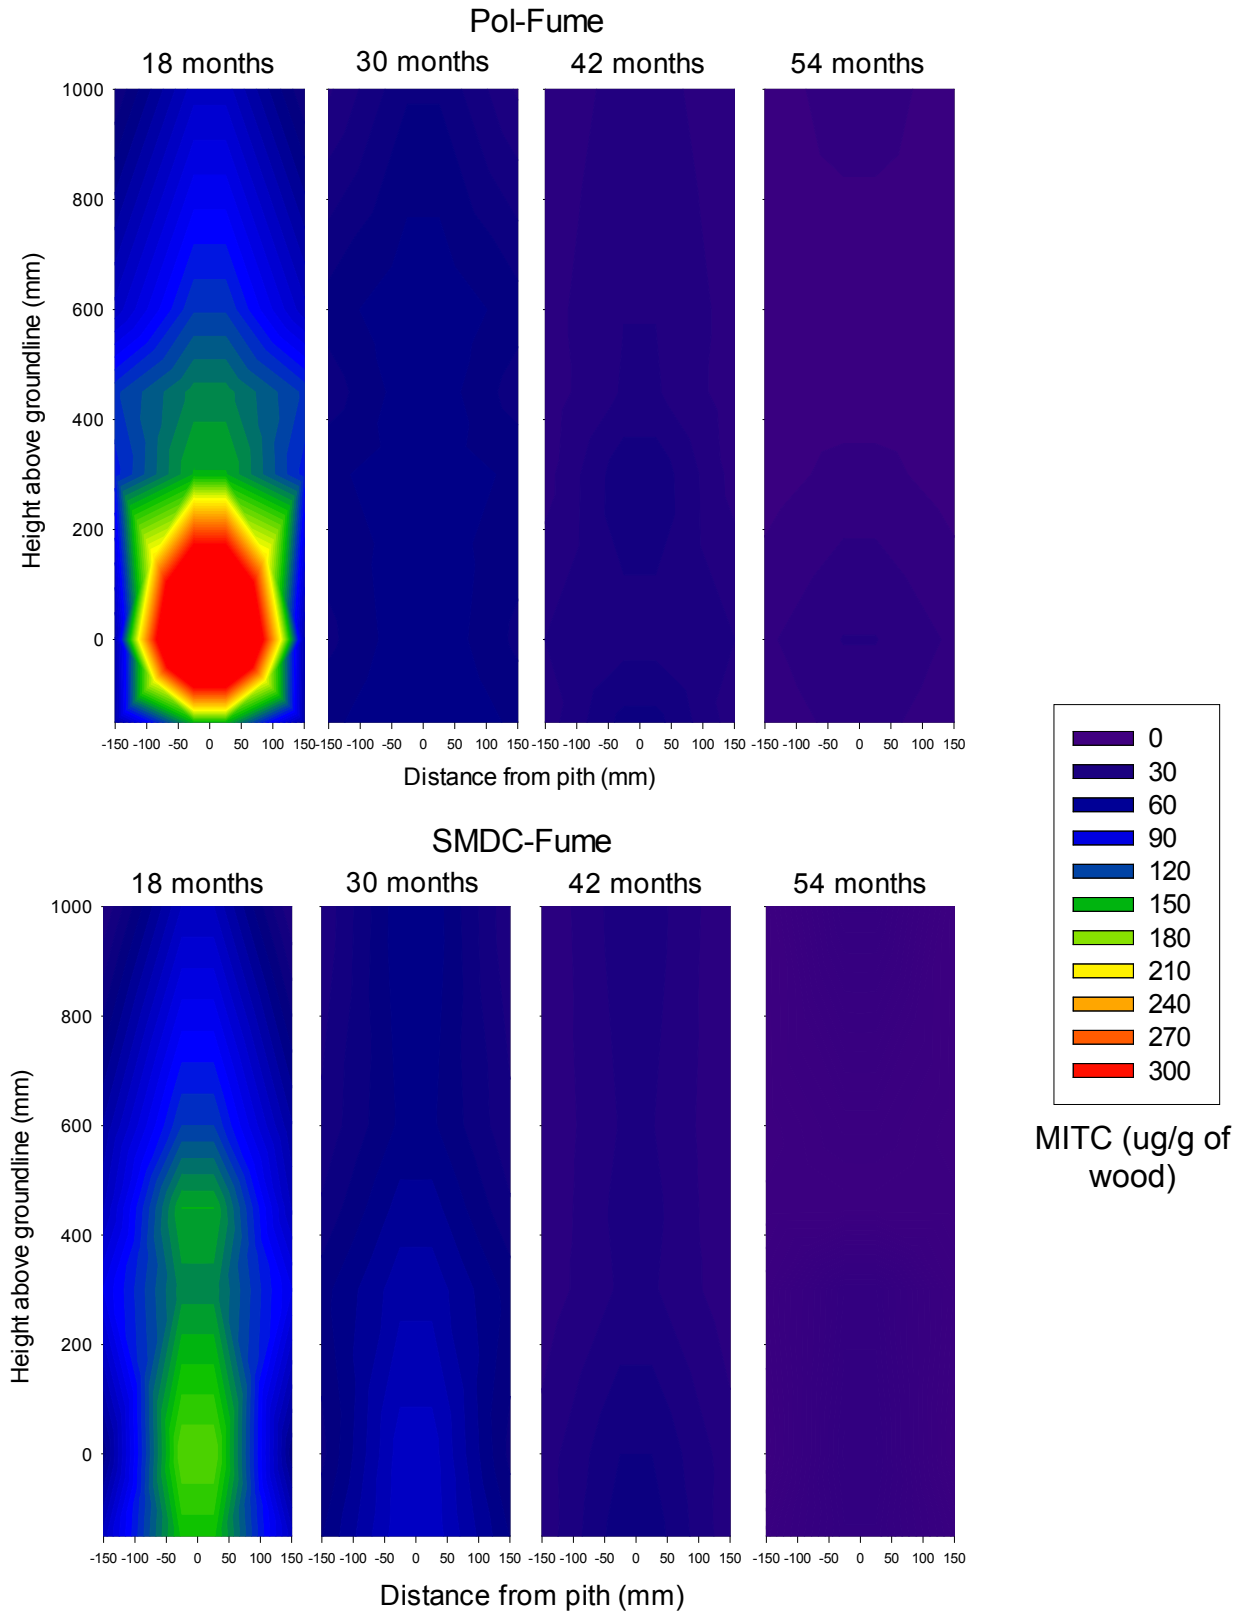
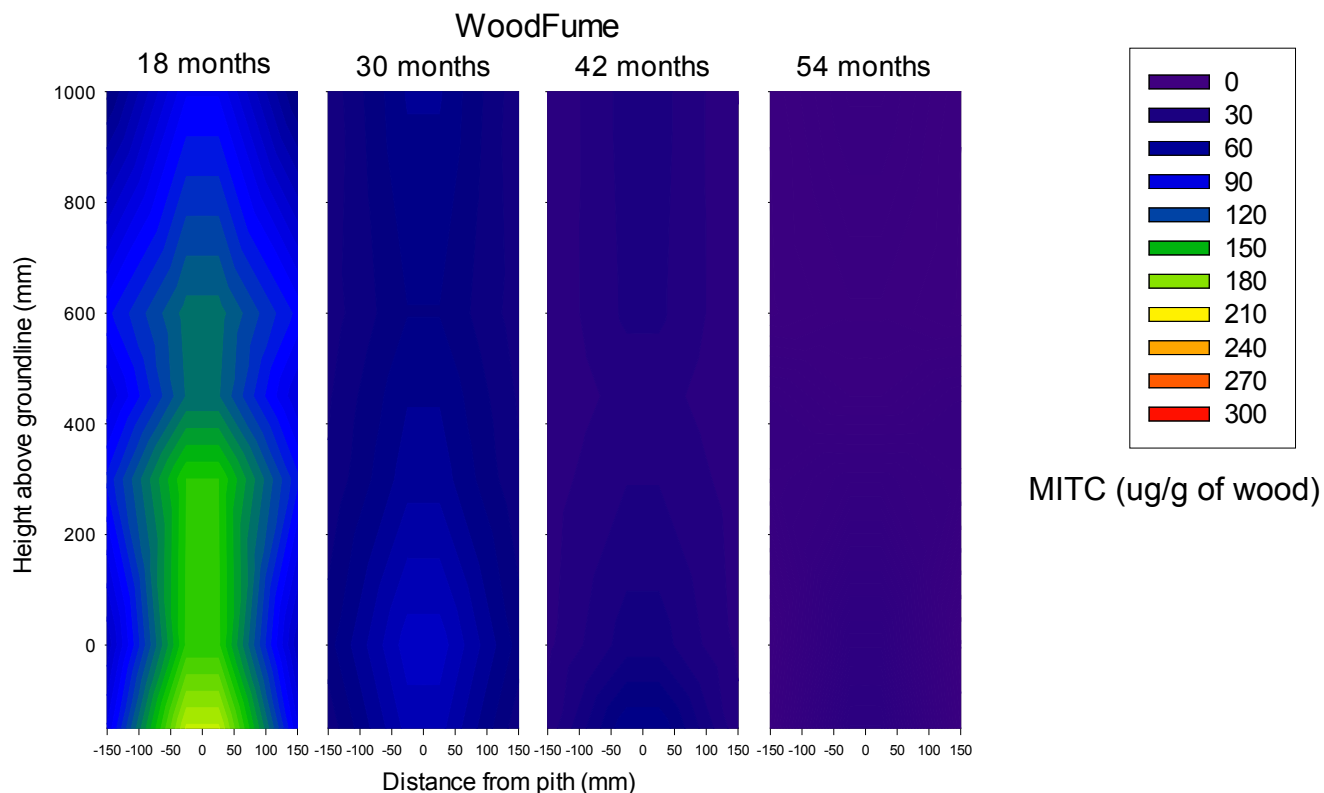
Figure I-13 Distribution of MITC in Douglas-fir poles sections 18 to 54 months after treatment with Pol-Fume, SMDC-Fume, or WoodFume.

Figure I-13 continued Distribution of MITC in Douglas-fir poles sections 18 to 54 months after treatment with Pol-Fume, SMDC-Fume, or WoodFume.

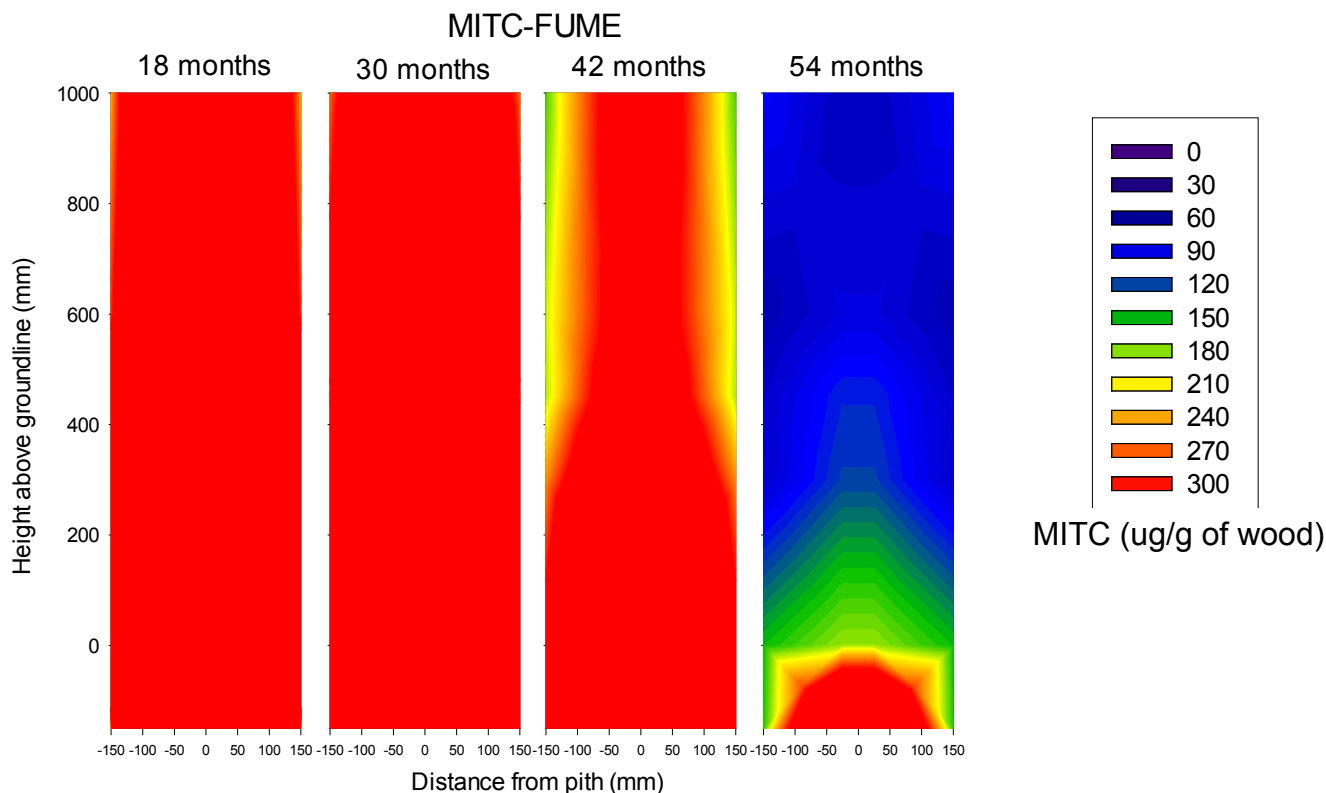
Figure I-14 Distribution of MITC in Douglas-fir poles sections 18 to 54 months after treatment with MITC-FUME.

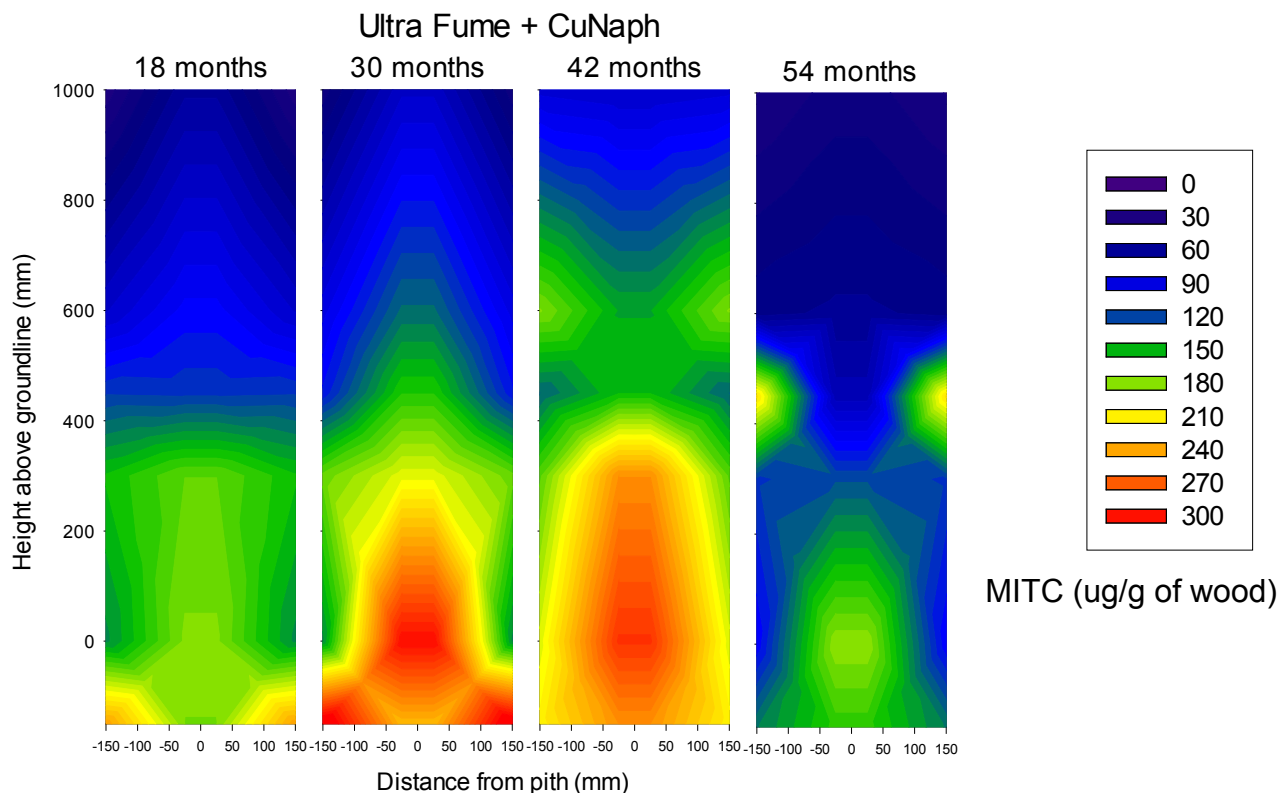
Figure I-15. Distribution of MITC in Douglas-fir poles sections 18 to 54 months after treatment with dazomet, DuraFume or UltraFume plus copper naphthenate.

Figure I-15 continued. Distribution of MITC in Douglas-fir poles sections 18 to 54 months after treatment with dazomet, DuraFume or UltraFume plus copper naphthenate.

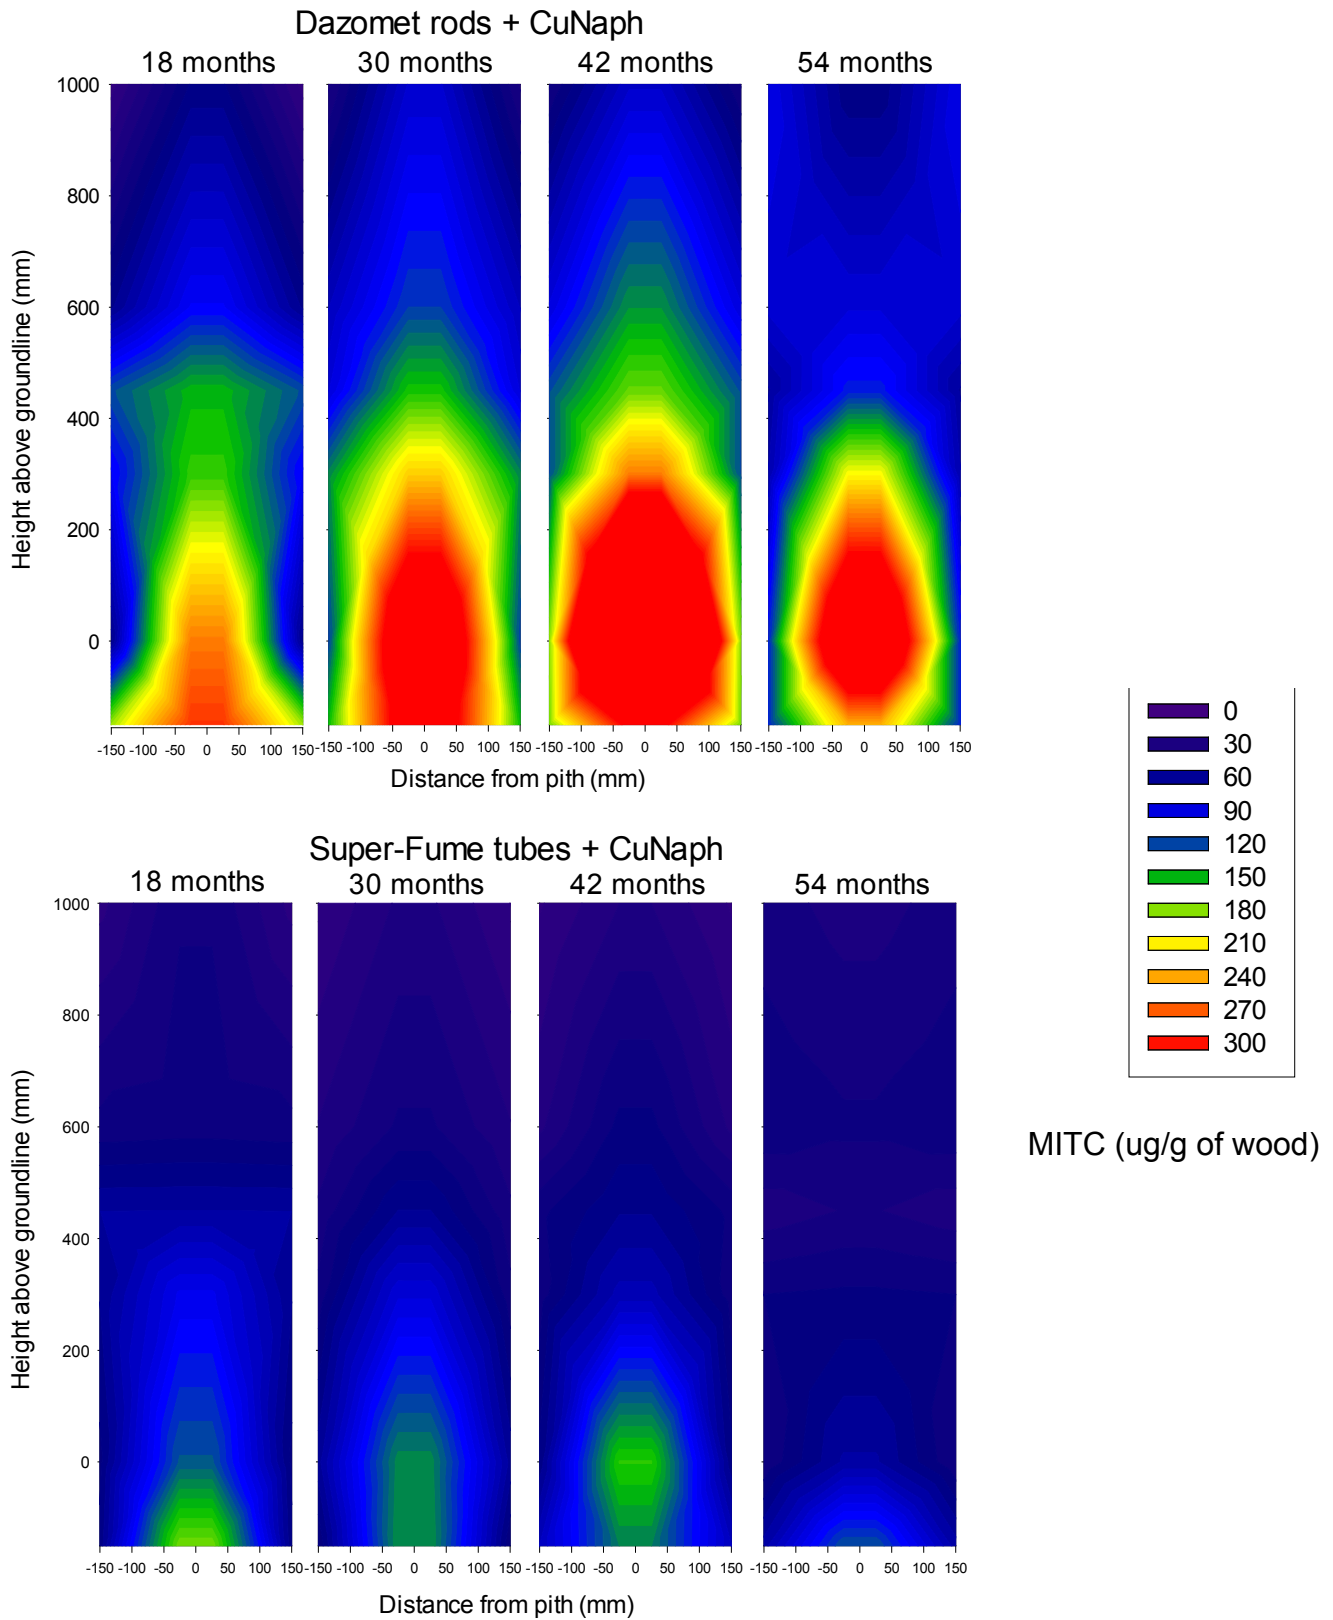
Figure I-16. Distribution of MITC in Douglas-fir poles sections 18 to 54 months after treatment with dazomet rods or Super-Fume tubes plus copper naphthenate.

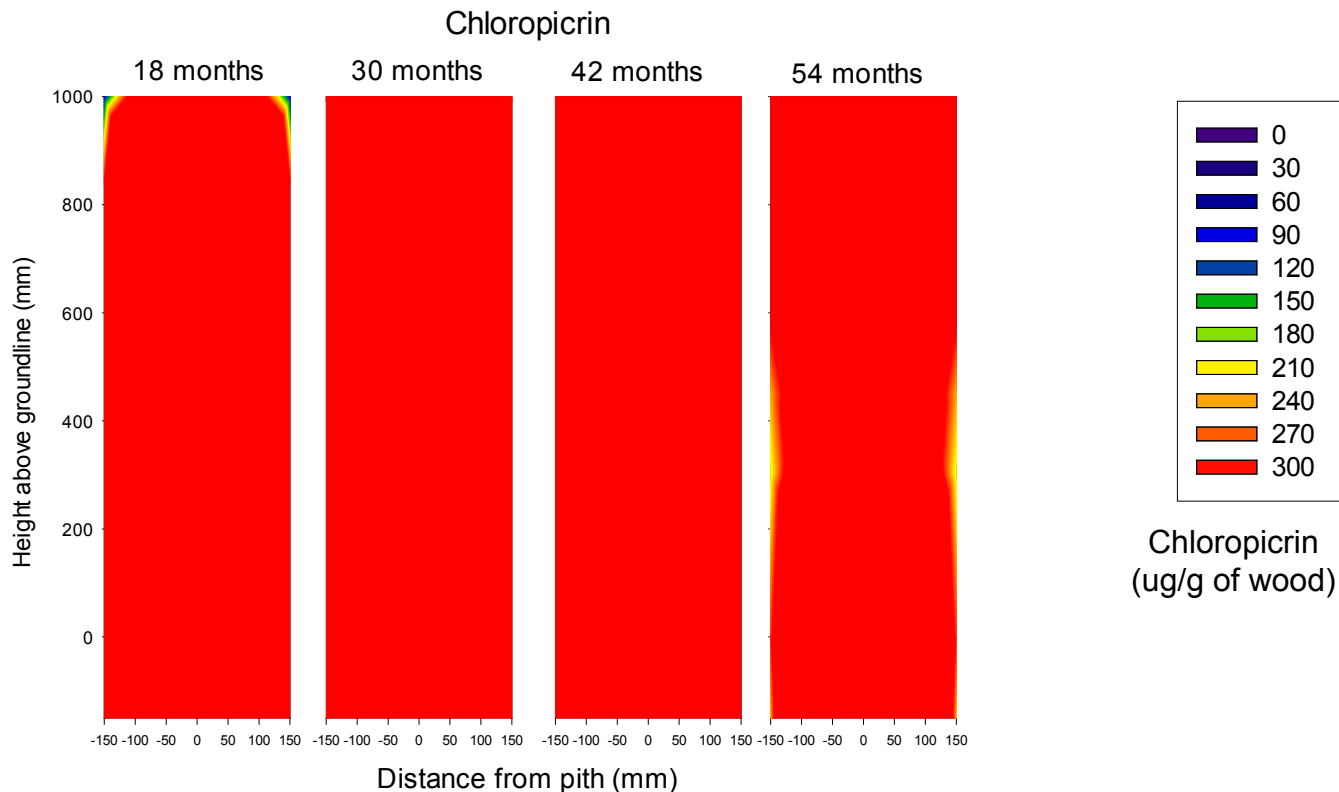
Figure I-17. Distribution of chloropicrin in Douglas-fir poles sections 18 to 54 months after treatment showing uniformly high chemical levels in the test zone.

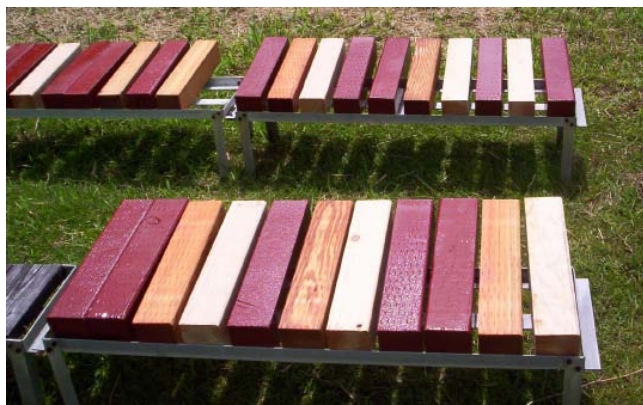
Figure III-13. Examples of Douglas-fir crossarm sections with and without polyurea coating immediately after exposure near Hilo, Hawaii.

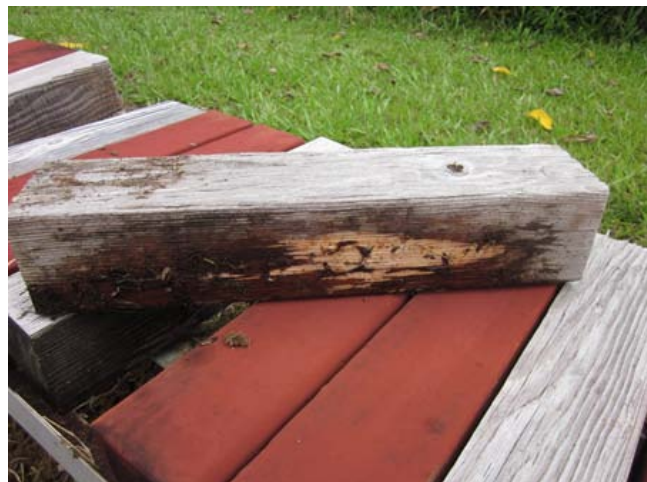
Figure III-14. Example of a non-treated Douglas-fir crossarm section with visible decay after 4 years of exposure in Hilo, Hawaii.

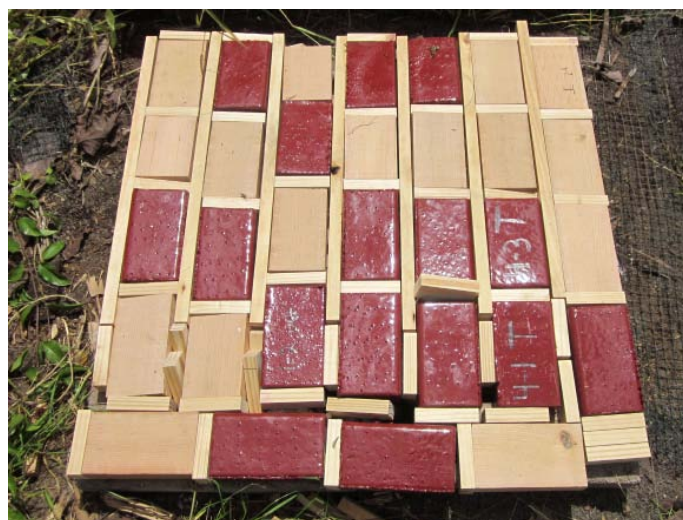
Figure III-15. Example of a termite array containing coated and non-coated Douglas-fir lumber sections at the time of exposure.

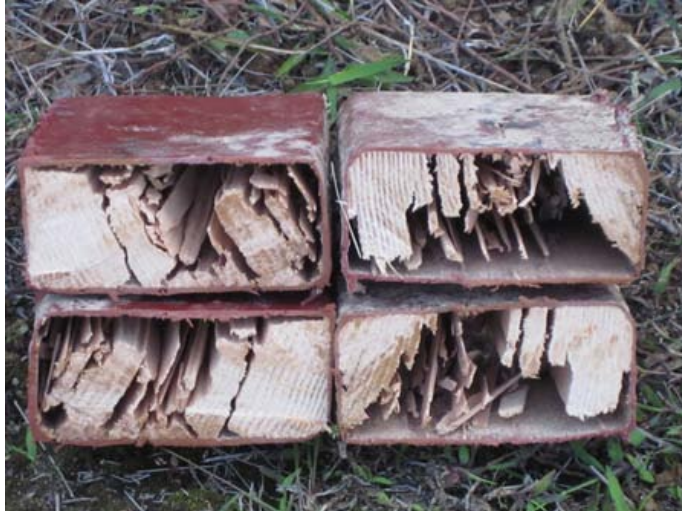
Figure III-17. Cross sections cut through polyurea coated sections of non-treated Douglas-fir (left) and Douglas-fir dip-diffusion treated with borates prior to coating (right) after 1 year of exposure to Formosan termite attack.

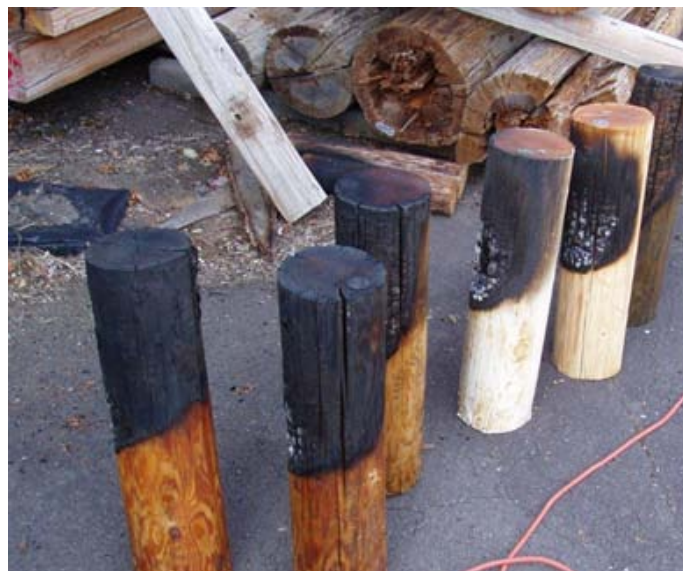
Figure III-19. Examples of penta (left) and non-treated (right) Douglas-fir pole sections after burning showing charring.

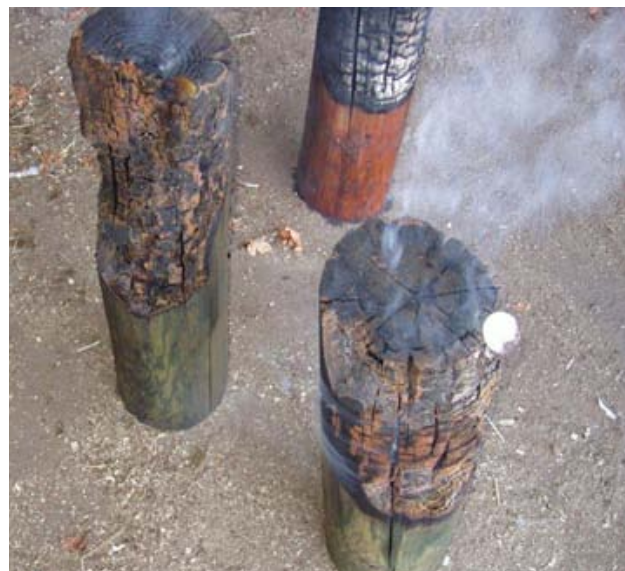
Figure III-20. Examples of copper naphthenate treated Douglas-fir pole sections after a burn exposure test.

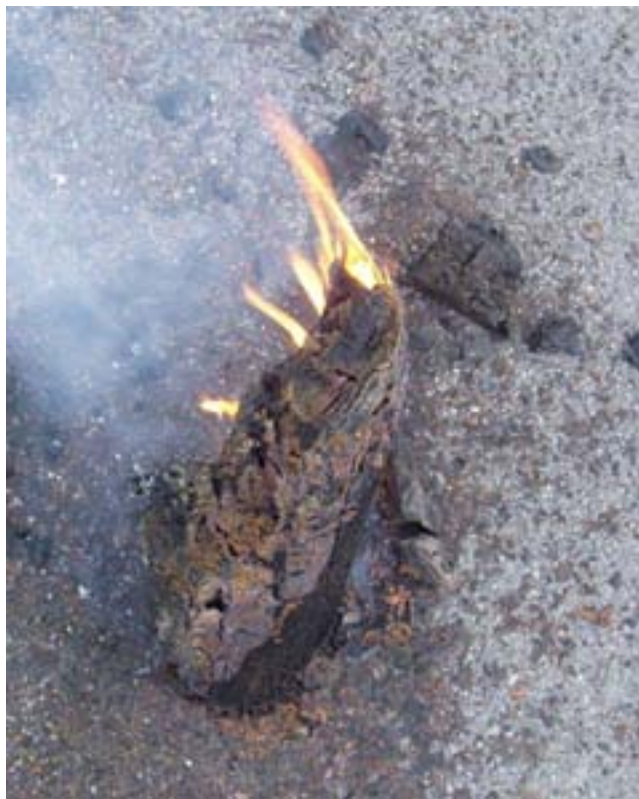
Figure III-21. Example of a copper naphthenate treated Douglas-fir pole subjected to burning that completely burned.

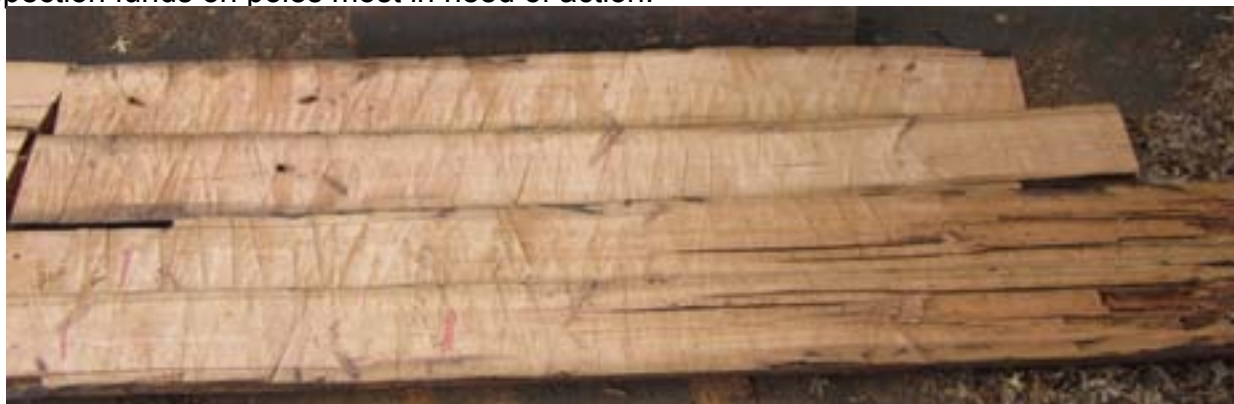
Figure III-27. Longitudinal cross section through a two part of a pole showing clear wood near the butt (top section) and extensive internal decay near the top (bottom section).

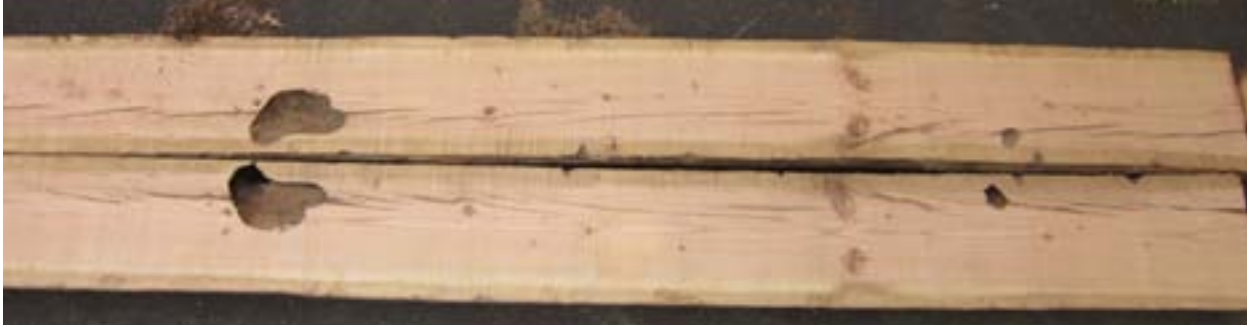
Figure III-28 Longitudinal cross section through a two part of a pole showing clear wood near the butt (top section) and extensive internal decay near the top (bottom section).

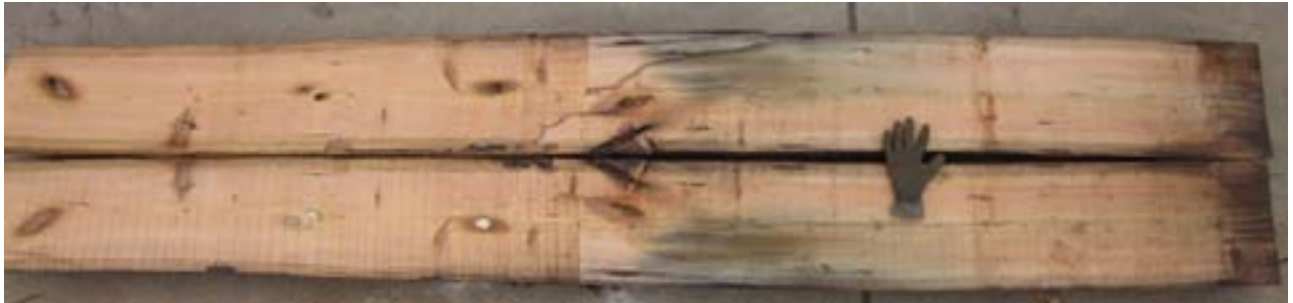
Figure III-29 Longitudinal section cut through the butt of a pole showing preservative end-penetration (left) and the sloping hole from a inspection/remedial treatment site, but no evidence of internal decay.

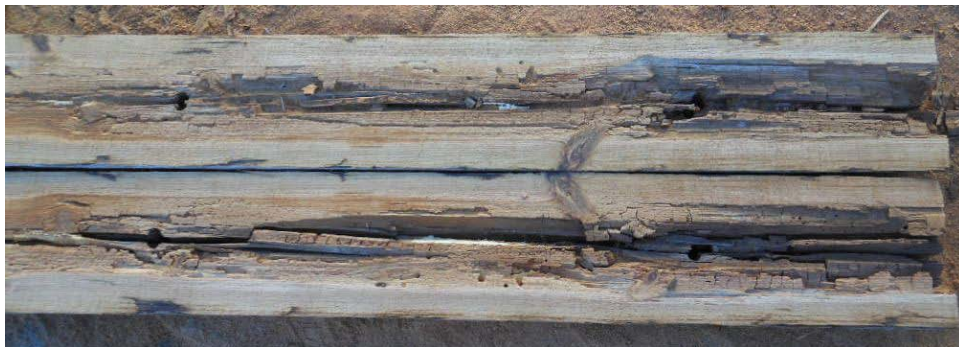
Figure III-30. Longitudinal section through a pole showing a woodpecker gallery associated with extensive internal decay.

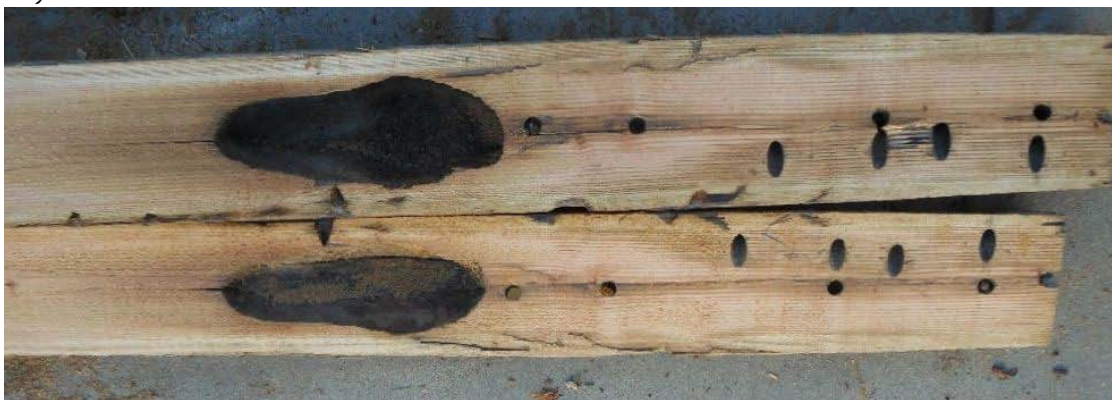
Figure III-31. Longitudinal section through a pole showing a wood pecker entry point and some associated damage. This pole corresponds to the images in Figure III-c.

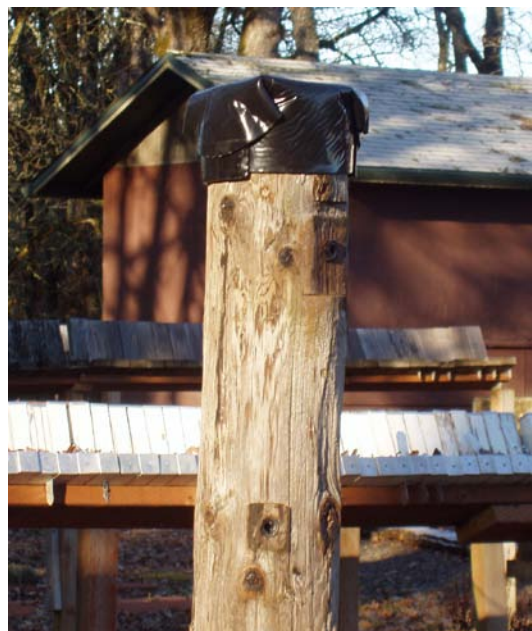
Figure III-33. Example of a capped pole used to assess the effects of capping on wood moisture content.

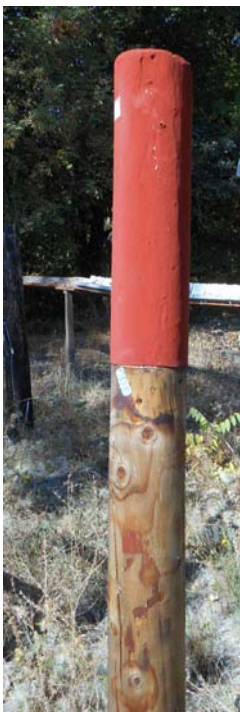
Figure III-35. Example of a polyurea coated pole top.

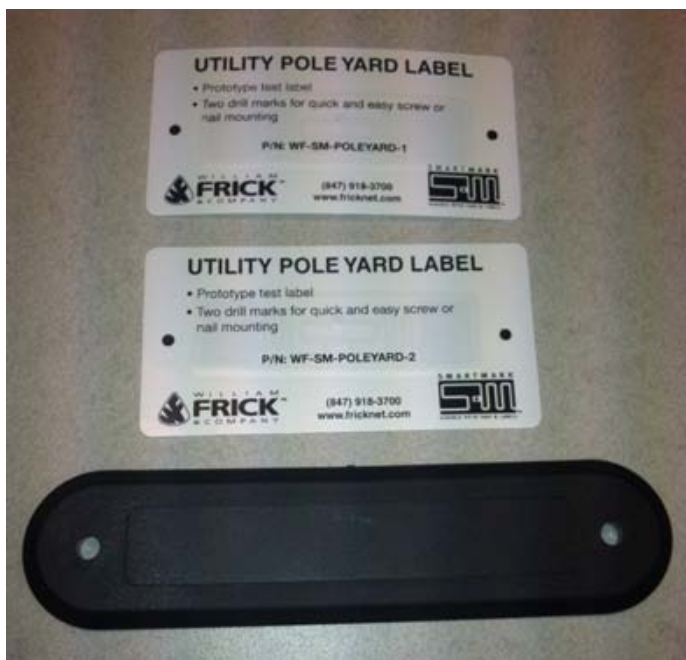
Figure III-37 Examples of several RFID tags that will be evaluated in treatment trials.
