# Oregon State University Utility Pole Research Cooperative

28th Annual Report  
October 16, 2008

Department of Wood Science &  
Engineering  
Oregon Wood Innovation Center  
(OWIC)

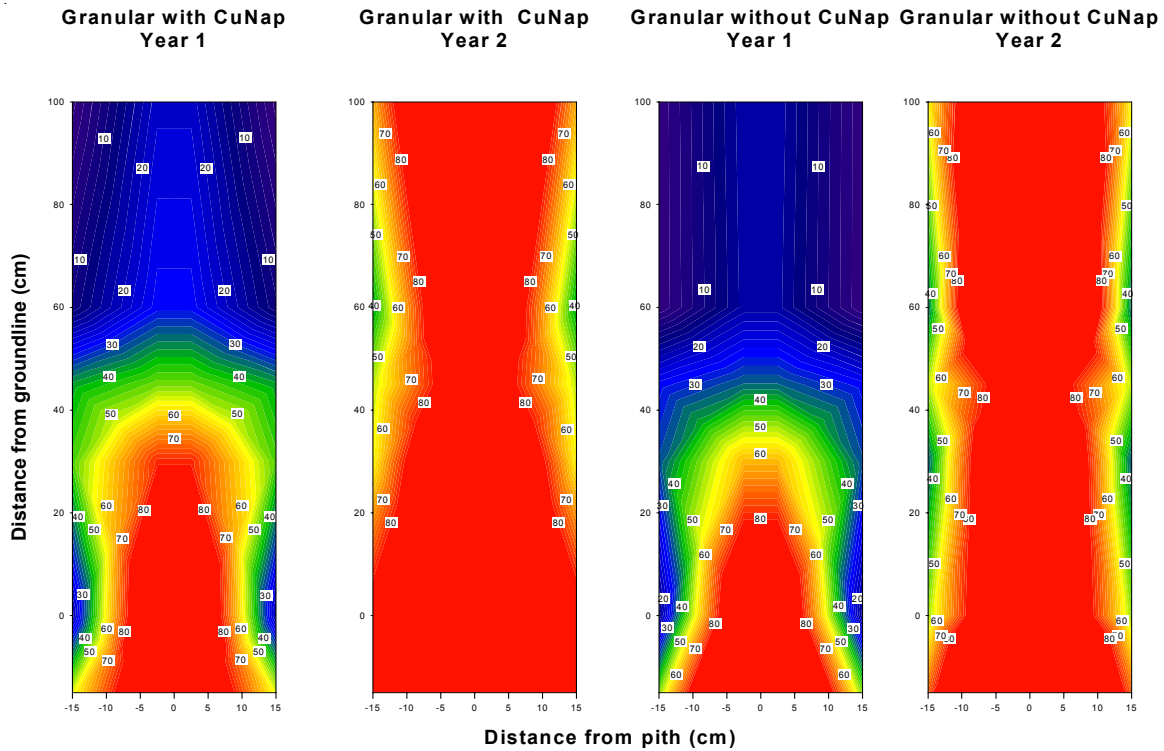
Figure I-13. MITC levels in pentachlorophenol treated Douglas-fir pole sections 1 and 2 years after treatment with granular dazomet with and without copper naphthenate. Dark blue indicates MITC levels below the threshold for fungal attack. Light blue and other colors indicate MITC levels above the lethal threshold.

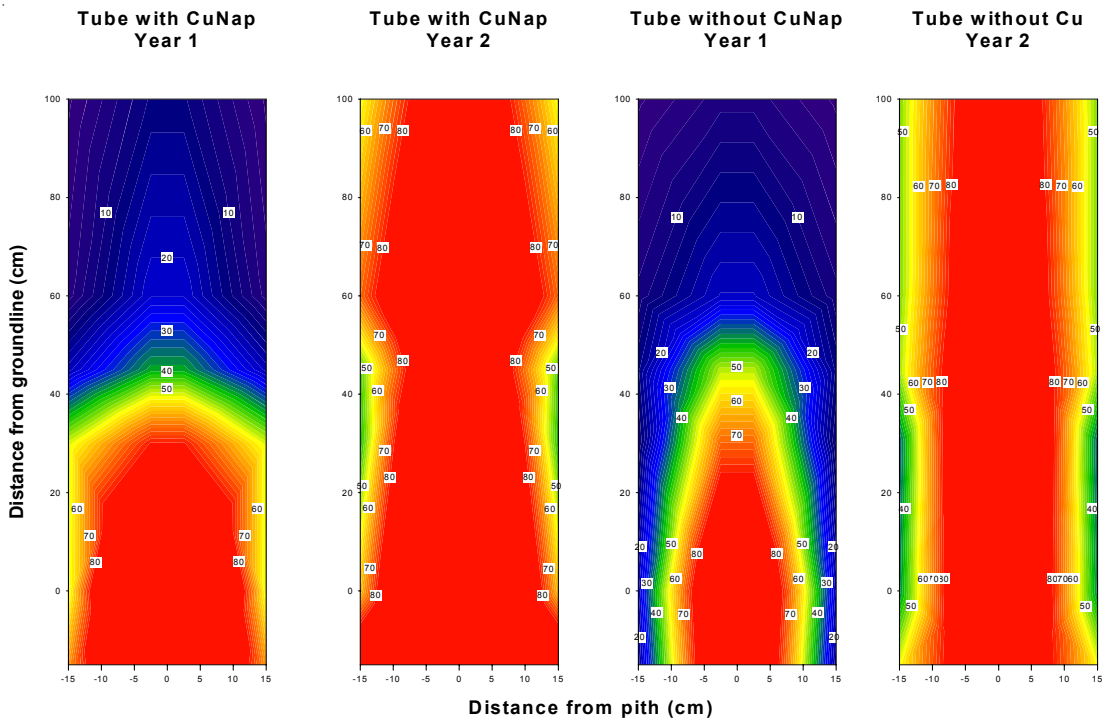
Figure I-14. MITC levels in pentachlorophenol treated Douglas-fir pole sections 1 and 2 years after treatment with granular dazomet in paper tubes with and without copper naphthenate. Dark blue indicates MITC levels below the threshold for fungal attack. Light blue and other colors indicate MITC levels above the lethal threshold.

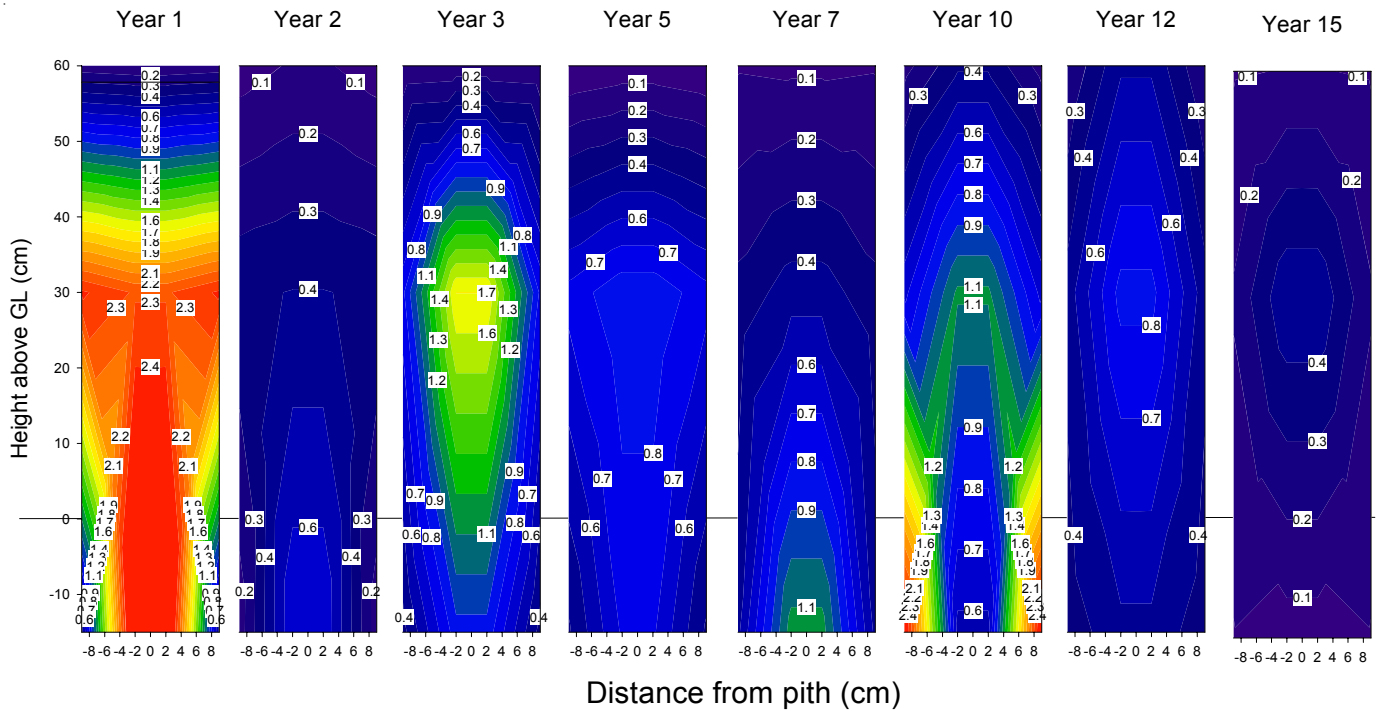
Figure I-18. Boron content in Douglas-fir pole sections 1 to 15 years after treatment with 3 fluoride/boron rods applied to holes at a 90 degree spacing. Dark blue indicates boron levels below the threshold for fungal attack. Light blue and other colors indicate boron levels above the lethal threshold.

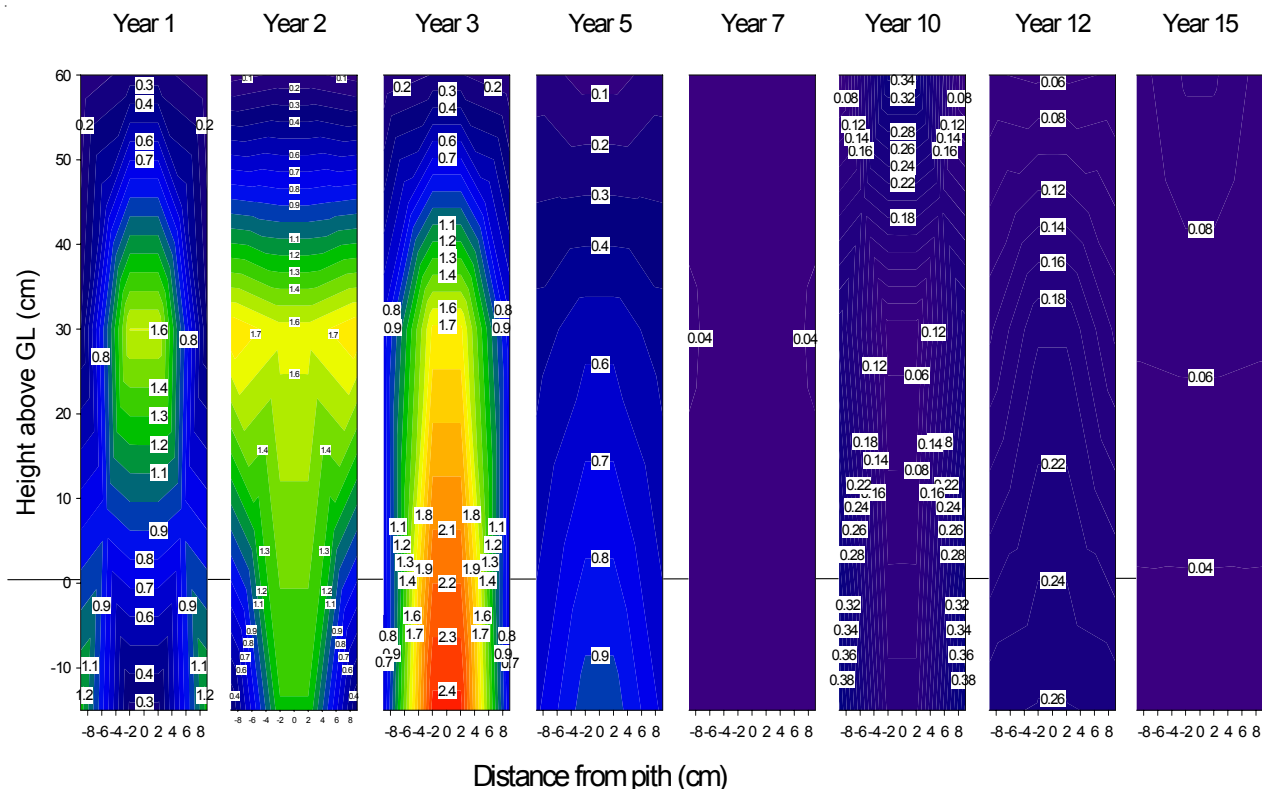
Figure I-20. Boron content in Douglas-fir pole sections 1 to 15 years after treatment with 6 fluoride/boron rods applied to holes at a 90 degree spacing. Dark blue indicates boron levels below the threshold for fungal attack. Light blue and other colors indicate boron levels above the lethal threshold.

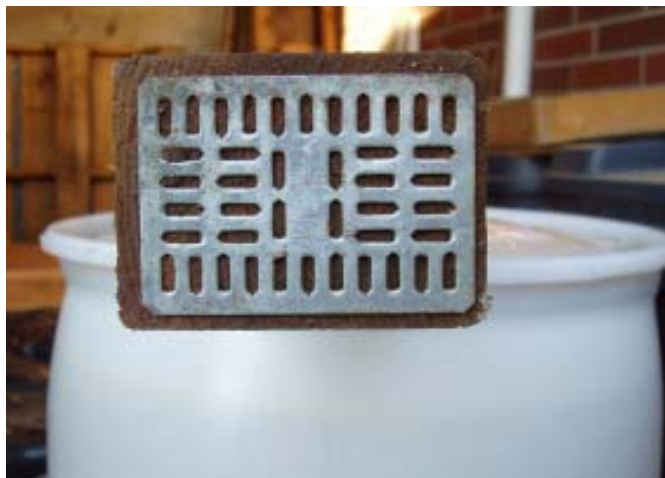
Figure III-2. Example of an end-plate on a penta treated Douglas-fir cross arm.

Thirteen pentachlorophenol treated Douglas-fir cross arm sections (87.5 mm by 112.5 mm by 1.2 m) long were end-plated on both ends then cut in half to leave one plated end and one non-plated end on each arm (Figure III-2). The objective was to compare checking with and without plates on comparable wood samples. The plates were developed by Brooks Manufacturing (Bellingham, WA). The arms were initially examined for the presence of checks. The arms were then immersed in water for 30 days before

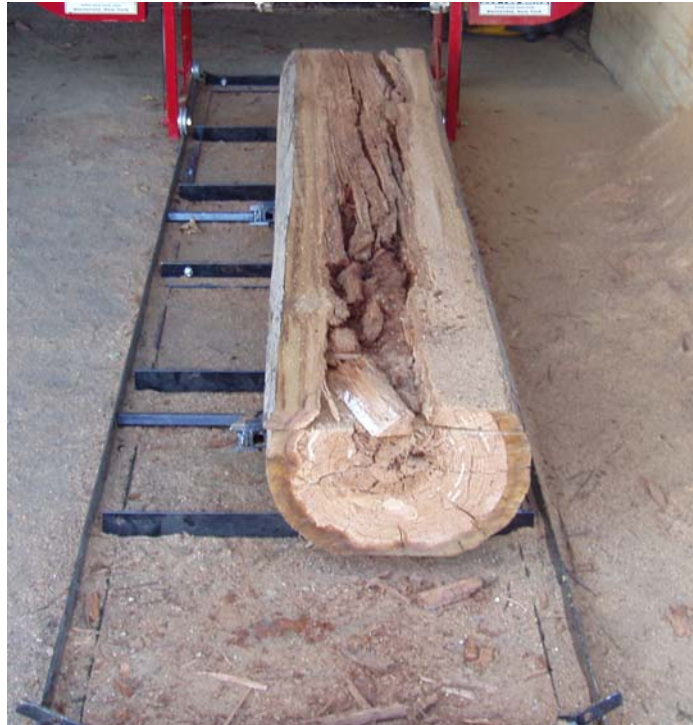
Figure III-4. Example of a section through a Douglas-fir pole showing internal decay.

The poles sampled to date have a number of visible defects including obvious internal decay (Figure III-4). Most notable is the presence of buprestid beetle attack in a number of locations as well as Pileated woodpecker (*Dryocopus pileatus*) attack on most of the poles.

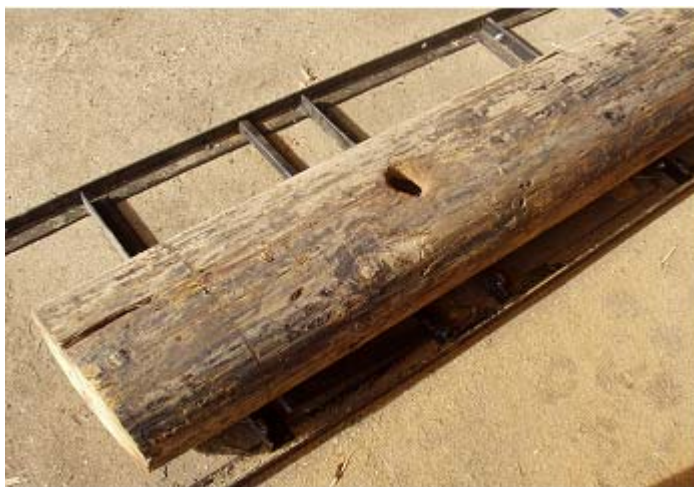
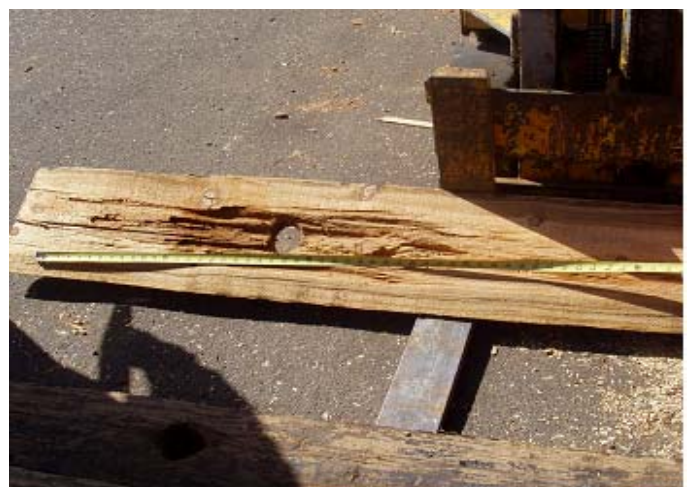
Figure III-5. Example of sections through a Douglas-fir pole showing a woodpecker hole on the surface and the extent of the internal damage associated with the hole.

As we have cut the poles, we have first noted the extensive damage associated with woodpecker galleries. Often a single hole is connected to a decay pocket extending 0.9 or more meters downward from the opening (Figure III-5).

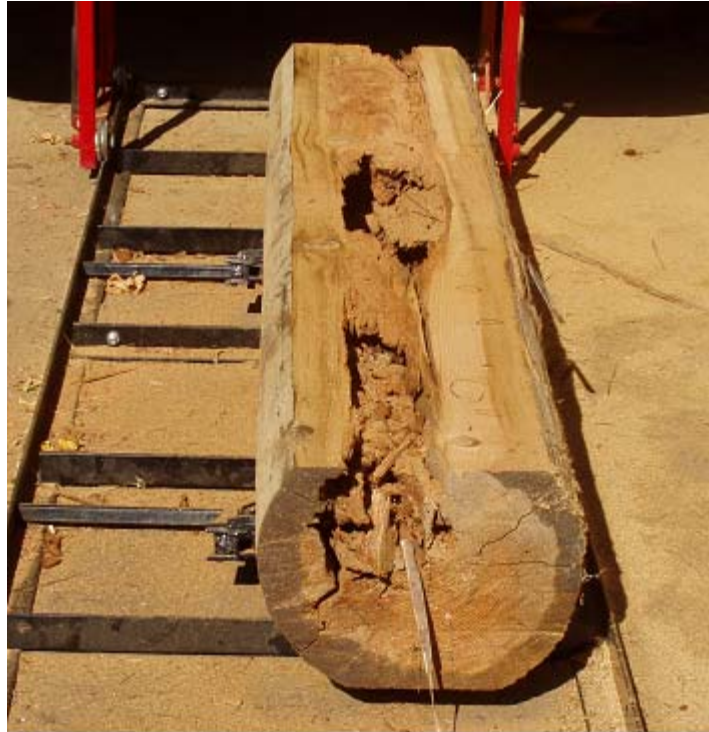
Figure III-6. Example of a section through a Douglas-fir pole showing an association between golden buprestid galleries (circled areas) and dampwood termites.

Further examination also revealed additional evidence of damage. We often found evidence of buprestid beetle attack in the woodpecker affected sections. The beetle attack appears to precede woodpecker attack, suggesting that the birds excavated the poles in search of the beetle larvae. In addition, we have generally found dampwood termite (*Zootermopsis angusticollis* (Hagen)) galleries associated with these defects (Figure III-6).

The presence of dampwood termites was most surprising because the defects are located 6 to 12 m above the groundline. Dampwood termites, as their name implies, require very wet wood and we generally do not think pole moisture contents are suitable for colonization this far above ground. We suspect that the woodpecker openings allow for extensive moisture entry during our wet winter months and that these galleries are then invaded by dampwood termite reproductives that initiate colonies. If correct, we have a sequence that begins with a buprestid gallery, progresses through woodpecker excavation in search of the larvae and then finally termite attack through the now opened pole.

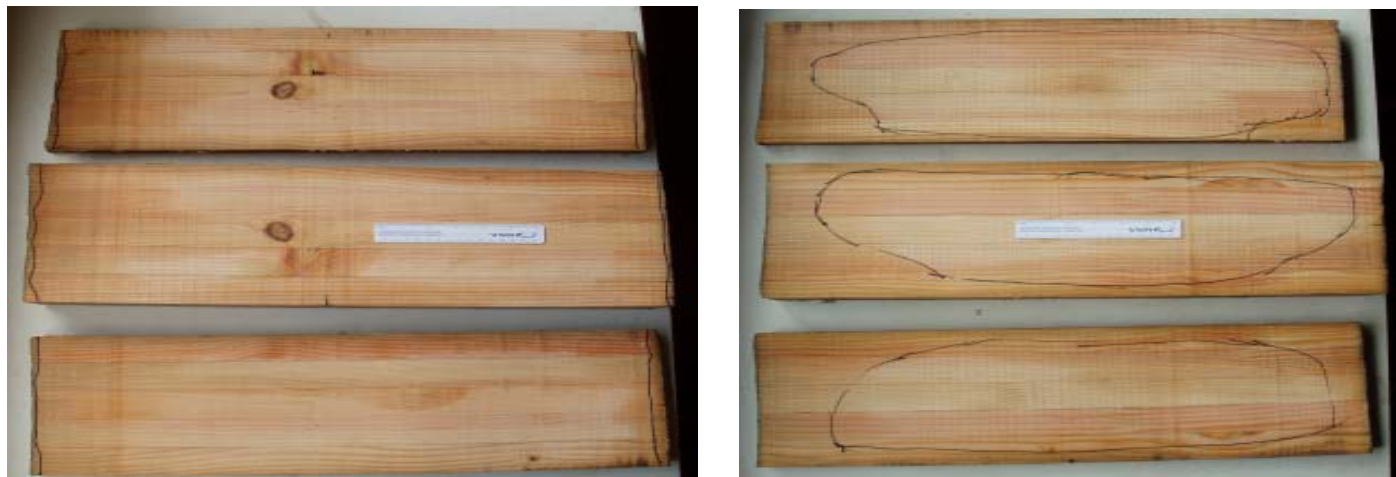
Figure III-10. Preservative penetration in laminated timber sections without through-boring and pressure treated with pentachlorophenol.

Penetration in the through-bored specimens was far greater than was found in the control samples (Figures III-9 to III-14). Penetration tended to be higher in the sections with holes at 150 mm spacing compared with those at the 300 mm spacing, but both patterns produced well treated sections. The advantage of the closer spacing would be more uniform treatment, however, this improved treatment would need to be weighed against the potential for reduced strength. There tended to be small skips or gaps in all of the through-bored timbers. These untreated zones are also present in many through-bored poles, and are generally not a concern because they are surrounded by deep zones of well treated wood. Even in the unlikely possibility that these skips in treatment were to become decayed, the relatively small area of damage should not adversely affect overall performance of the timber.

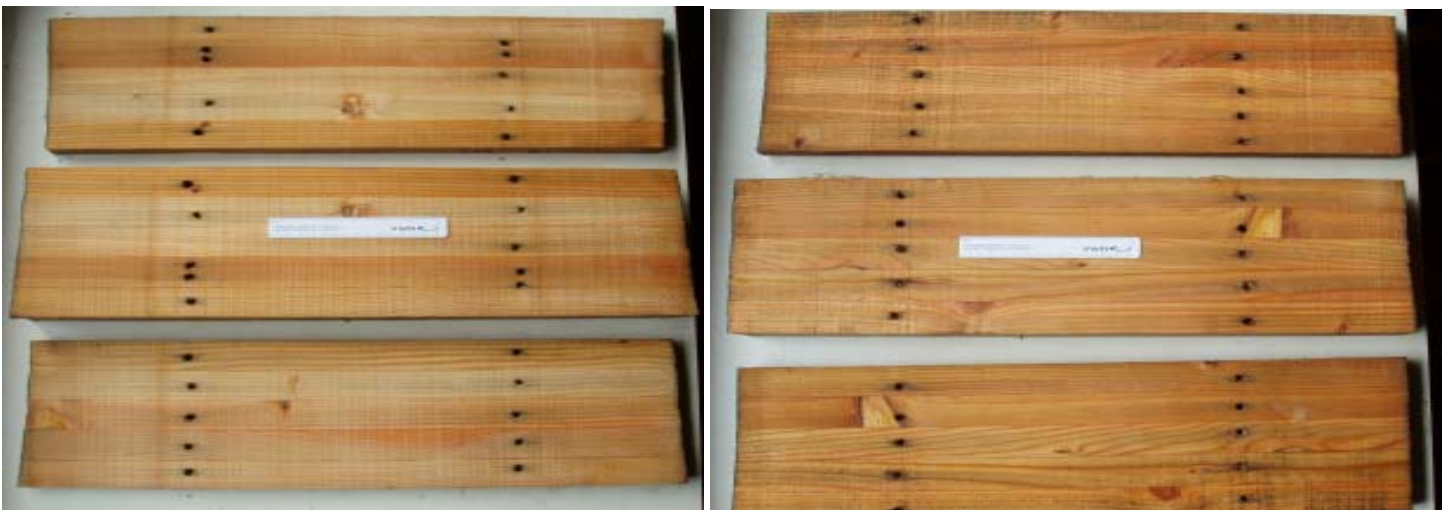
Figure III-12. Preservative penetration in laminated timber sections through-bored at 300 mm intervals and pressure treated with pentachlorophenol.

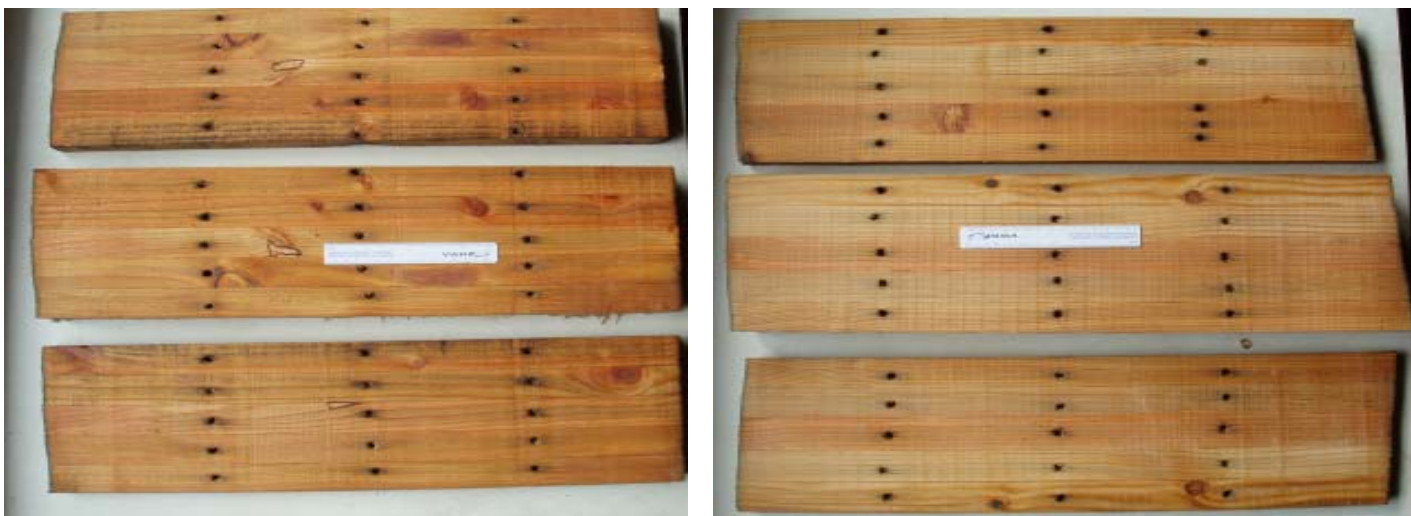
Figure III-14. Preservative penetration in laminated timber sections through-bored at 150 mm intervals and pressure treated with pentachlorophenol.

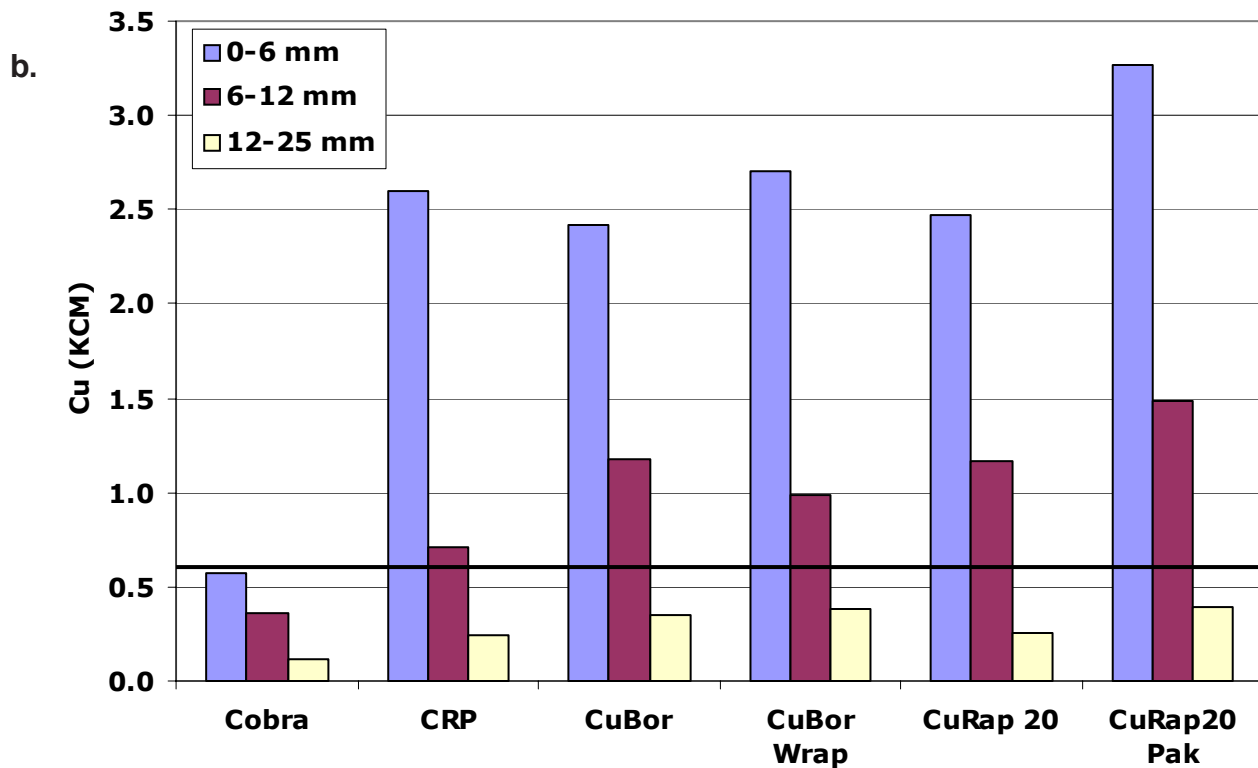
Figure IV-1. Residual copper levels at selected distances from the wood surface 150 mm below ground on southern pine poles 3 years after treatment with copper containing pastes or bandages as determined by a) x-ray fluorescence or b) ion-coupled plasma spectroscopy.

The ICP analyses were consistently higher than those found by XRF (Figure IV-1). As a result, we have re-analyzed all the samples taken after 3 years. Copper values in the outer zones of all treatments except the Cobra system were well above the threshold for protection ( $0.6 \text{ kg/m}^3$  as Cu). Copper levels in the Cobra wrap treatment are just below the threshold in the outer zone at the three year point. These results led us to re-evaluate our analytical procedures. We performed additional tests on our residual dust and found that we had excellent agreement between XRF and ICP when we did not dilute samples (Figure IV-2). We have now changed our procedures and will combine all of the wood from a given assay zone for the poles in a single treatment (i.e. treated with a given groundline system) to ensure that we have a sufficient amount of wood for analysis. The disadvantage of this approach is that we will now have only two replicate analyses per treatment, but this is outweighed by the more accurate analysis. Unfortunately, we do not have the wood from the 1 or 2 year sample for this test. The uncertainty of the methodology used to analyze the 1 and 2 year samples leads us to discount these results. We had considered a correction factor; however, we have no samples from either of these years to verify the correction factor and believe the most prudent move is to use only the 3 year data for the copper from this test.

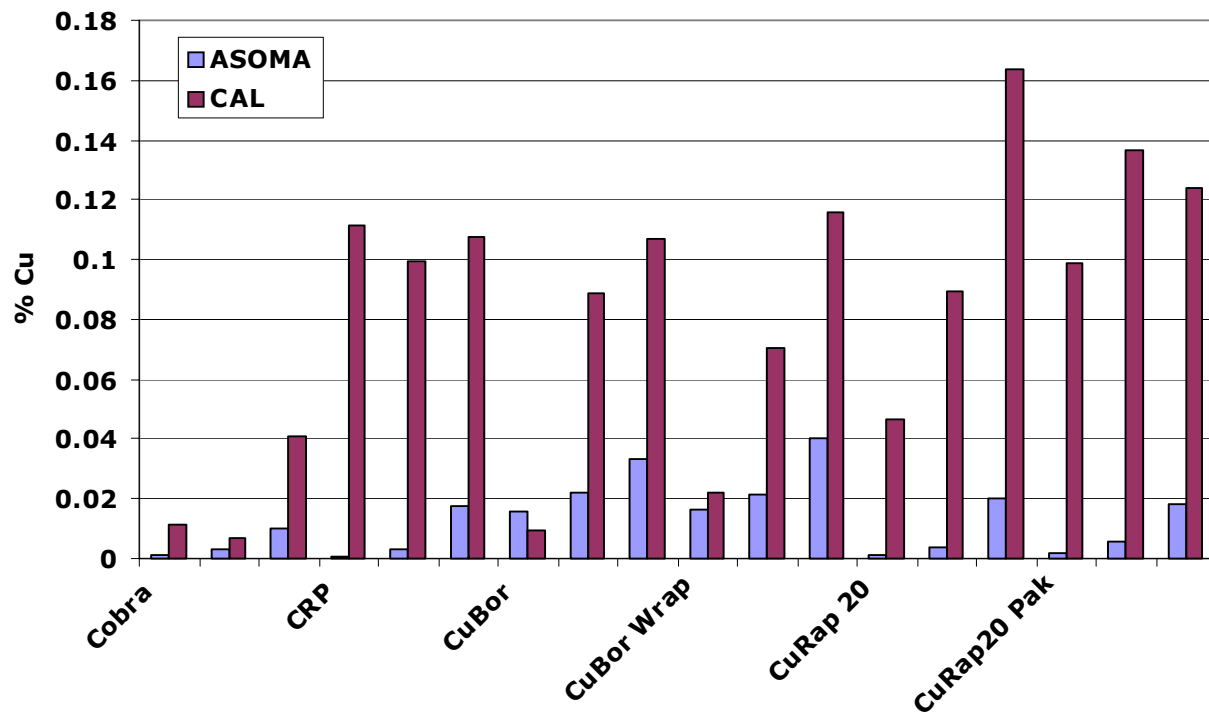
Figure IV-2. Comparison between ICP and XRF analysis for wood removed from poles 3 years after treatment with various supplemental groundline preservative systems. XRF was performed, then the wood was digested and analyzed by ICP.

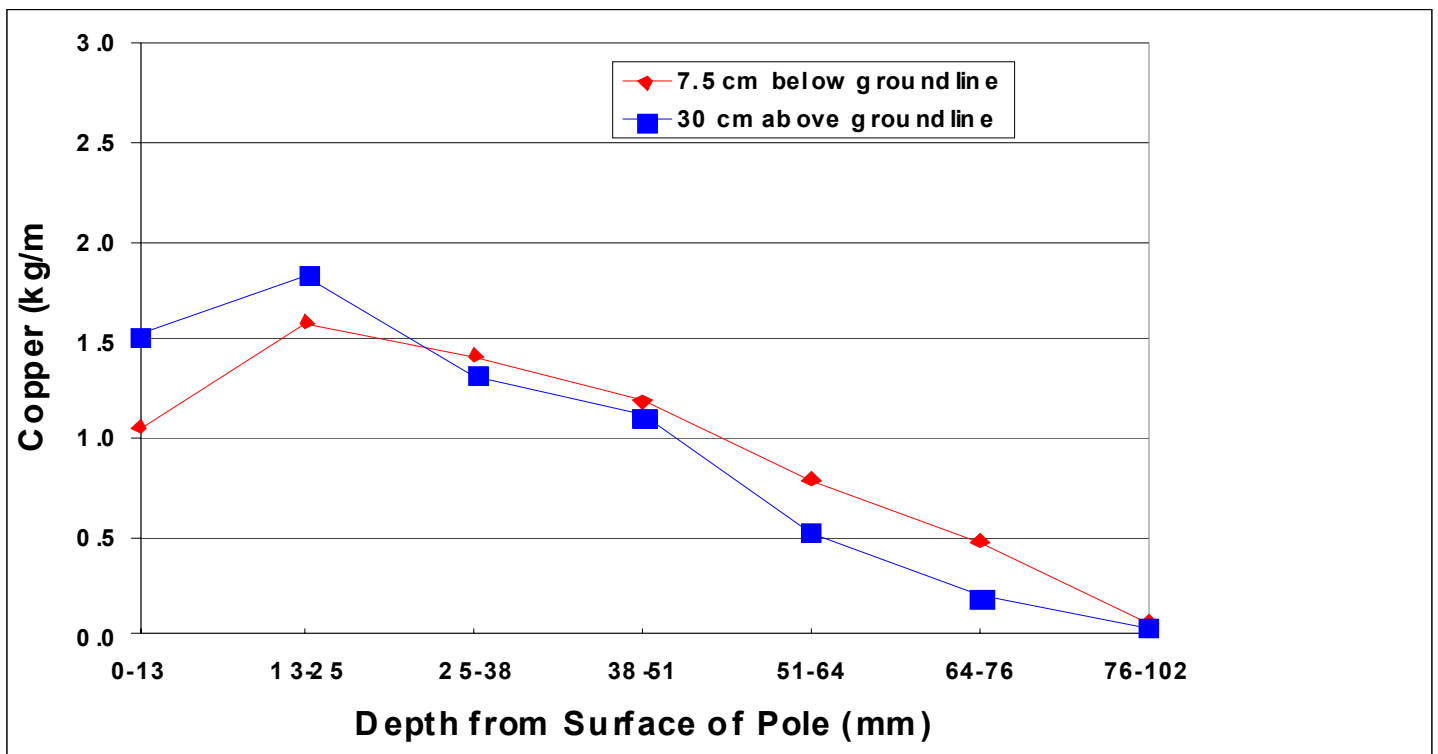
Figure V-3. Copper levels at selected distances from the wood surface in six radially-drilled copper naphthenate-treated Douglas-fir poles 10 years after installation in Lacombe, OR.

The results from the 1998 sampling are presented for comparative purposes only (Figure V-3 to V-12). They showed that copper was present at high loadings in a majority of the poles and there was no evidence of surface decay on any poles. Decay fungi were isolated from the interiors of two Cellon treated poles, but no decay fungi were present in any poles treated with copper naphthenate in conventional heavy oil. These results confirmed that the 10 year old copper naphthenate treated poles were performing well in a variety of conditions across the Western U.S.

Copper levels in the outer zones of poles sampled in 1998 averaged  $1.1 \text{ kg/m}^3$  75 mm above groundline and  $1.5 \text{ kg/m}^3$  300 mm above groundline in the Lacombe sample. Copper levels were slightly higher in the 13 to 25 mm zone, then steadily declined with distance from that zone. The higher copper levels 13-25 mm from the surface suggest that some surface depletion of copper has occurred. Although there is no evidence of any decay on the wood surface and copper levels on the surface remain well above the threshold for copper naphthenate performance, these results suggest that continued monitoring of these poles is warranted to ensure that copper levels remain stable.

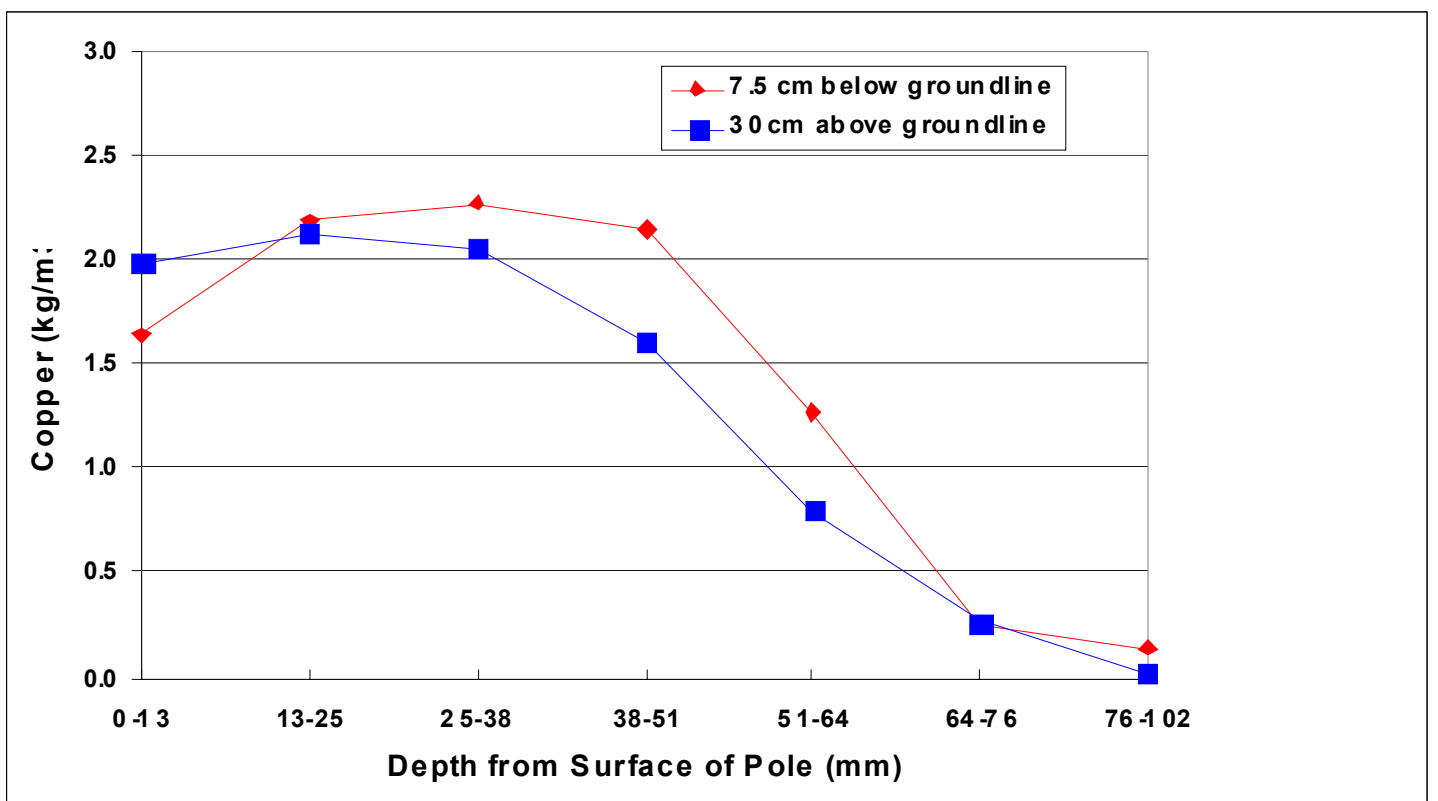
Figure V-4. Copper levels at selected distances from the wood surface in five radially-drilled copper naphthenate-treated Douglas-fir poles 10 years after installation in Peoria, OR.

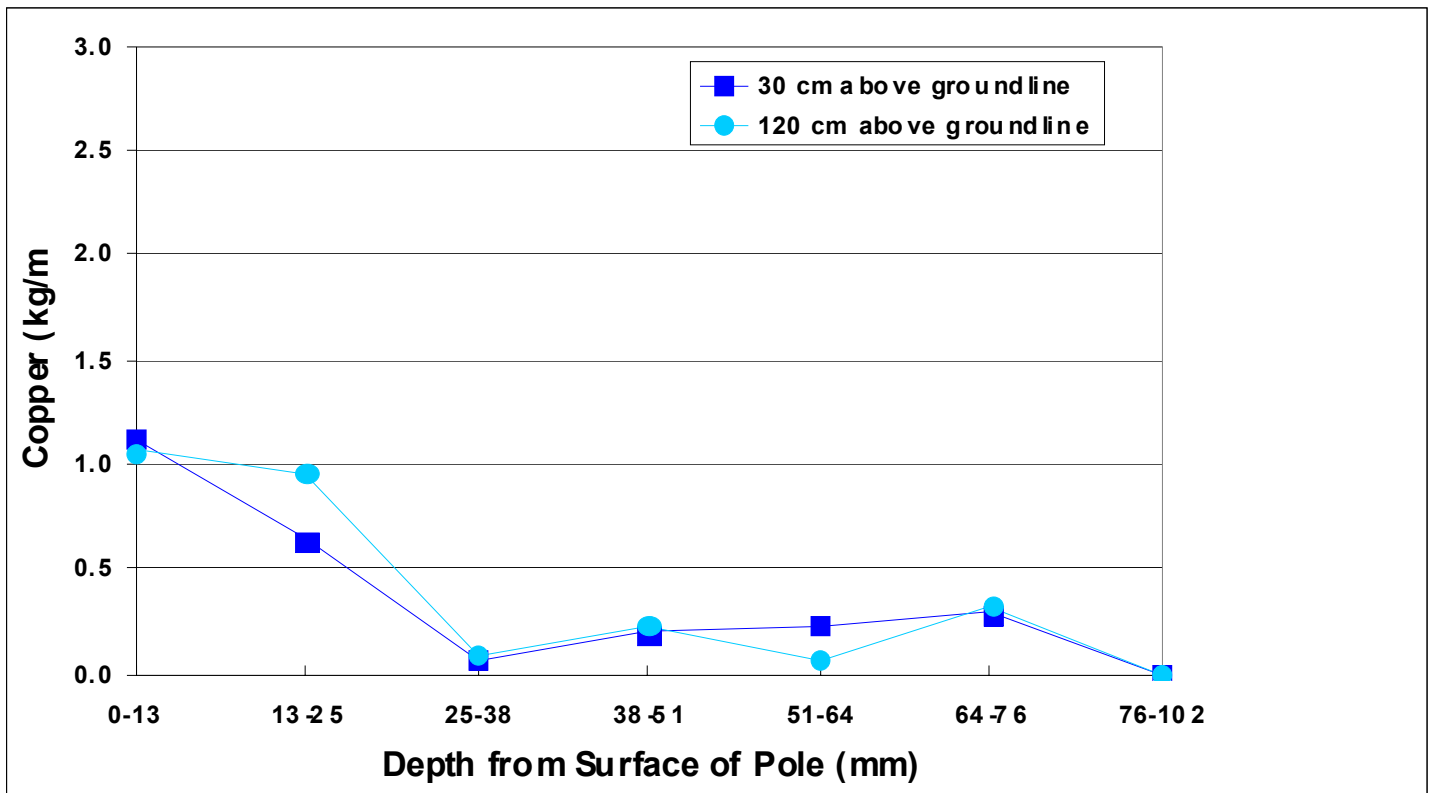
Figure V-10. Copper levels at selected distances from the wood surface in one copper naphthenate in oil-treated Douglas-fir pole 10 years after installation near San Ramon, CA.

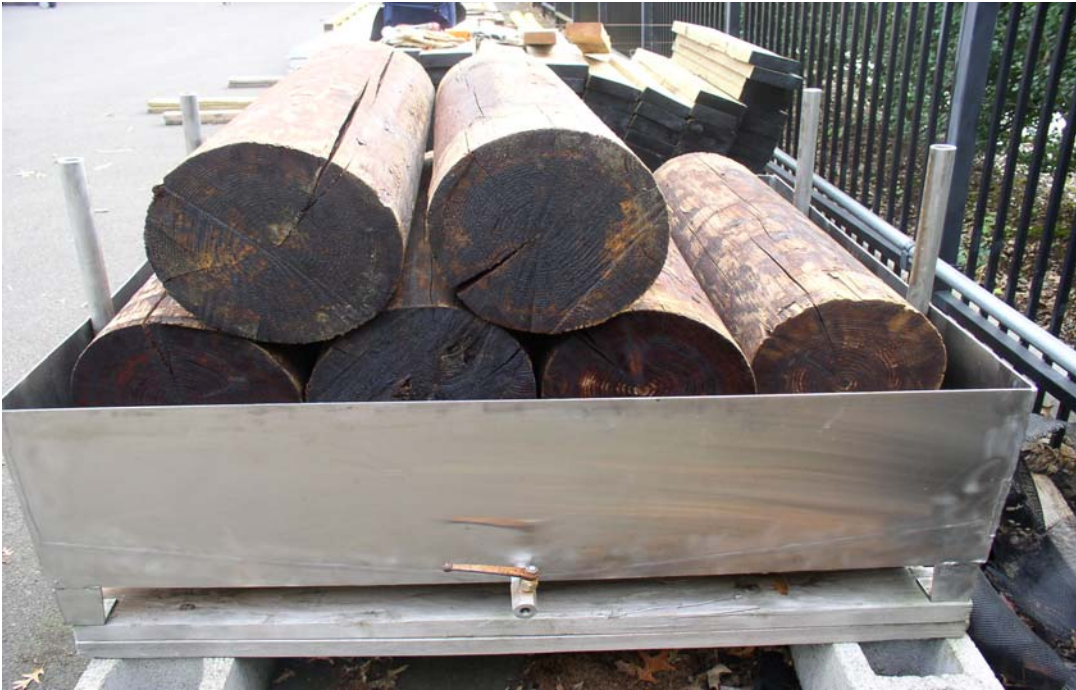
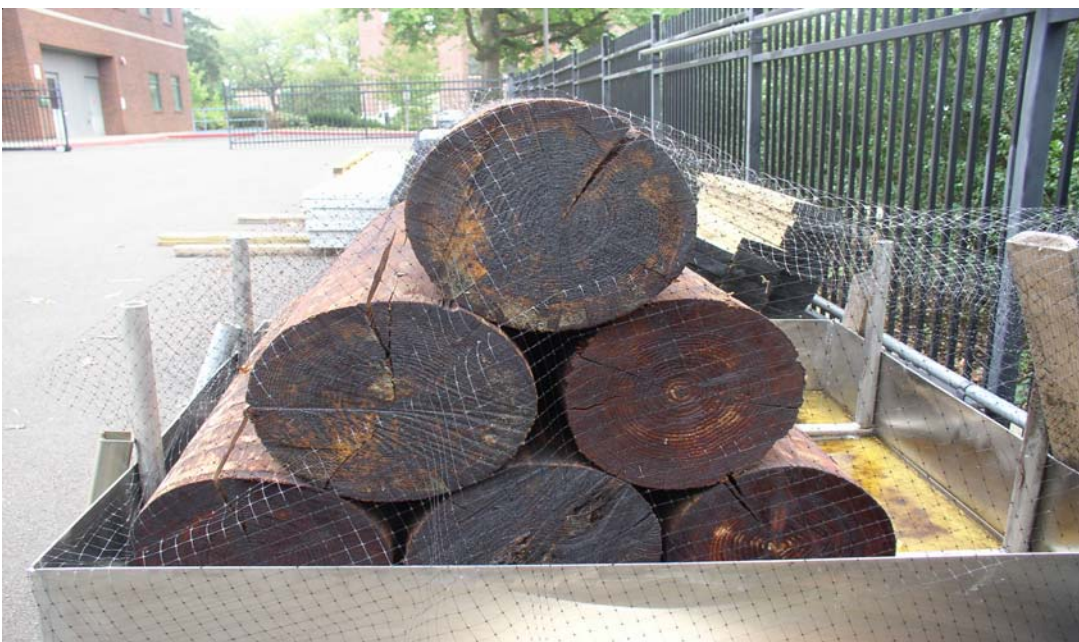
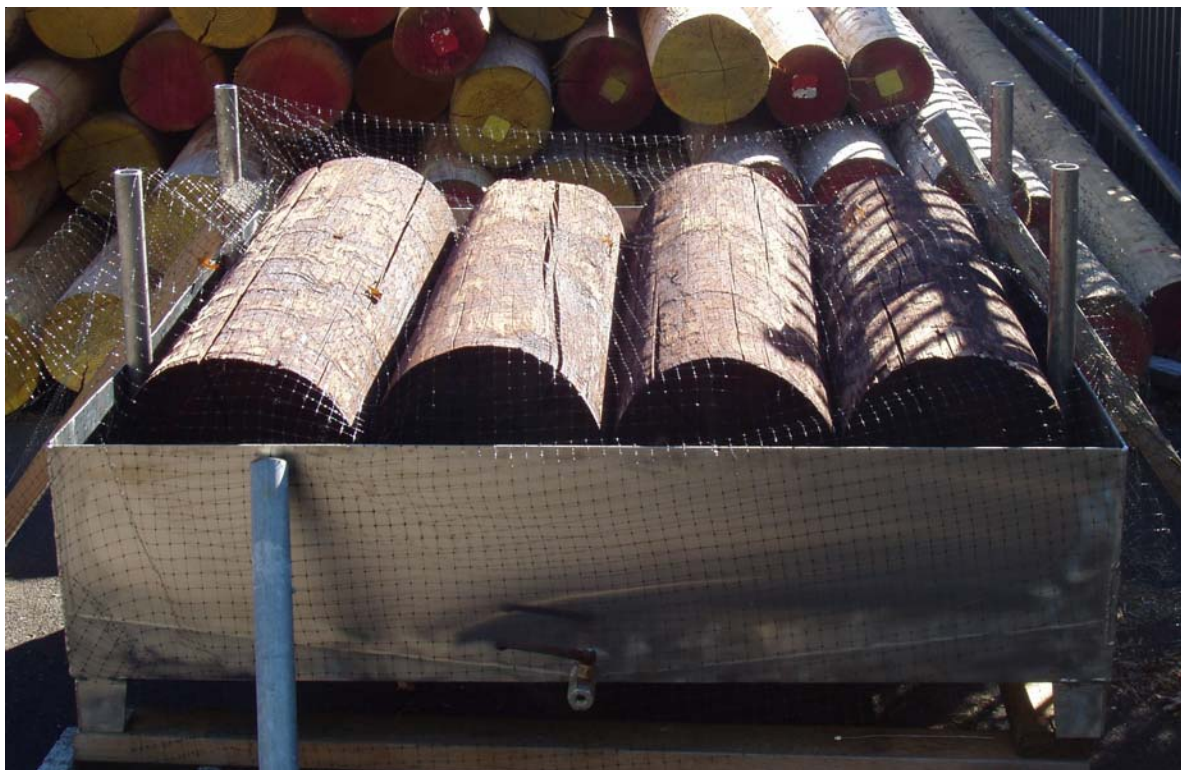
Figure VI-1. Photo showing the two six-pole configurations a) configuration 1, b) configuration 2, and c) the four-pole configuration evaluated in our small scale preservative migration chamber.

Figure VI-1 (cont.). Photo showing the two six-pole configurations a) configuration 1, b) configuration 2, and c) the four-pole configuration evaluated in our small scale preservative migration chamber.

Three pole configurations have been examined using this system (Figure VI-1). These configurations were designed to vary the surface area exposed directly to rainfall. We altered our design to produce varying amounts of exposed treated wood after it appeared that penta water solubility was the primary factor in runoff concentrations.
