# WOOD POLE MAINTENANCE MANUAL: 2012 EDITION

JEFFREY J. MORRELL

The specification, inspection, and remedial treatment of utility poles are addressed. Included are discussions of enhancing specifications for improved performance, techniques for detecting decay and other defects, and chemical treatments available for arresting decay of poles in service.

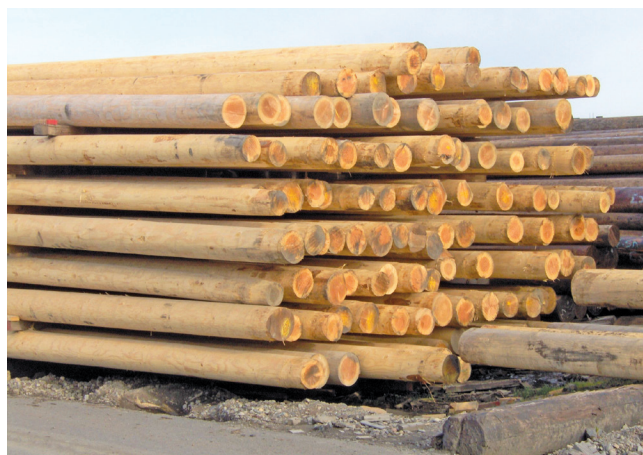
Figure 3. Air seasoning poles.

Wood poles that are treated with preservatives must be dried either before or during preservative treatment. The simplest moisture removal method is air seasoning, in which poles are stacked in well-ventilated piles for 1 to 12 mo (Figure 3). Air seasoning is inexpensive because it requires little equipment and minimal handling of the wood. This method does necessitate a large storage area for poles, and it includes the cost of carrying a large white, or untreated, wood stock in anticipation of orders. It also permits the entry of fungi and insects into the wet wood. Despite these drawbacks, air seasoning remains a common method for drying Douglas-fir and western redcedar poles before treatment. Air seasoning is less frequently used for southern pine because pine is much more susceptible to decay. Poles to be air seasoned should be placed

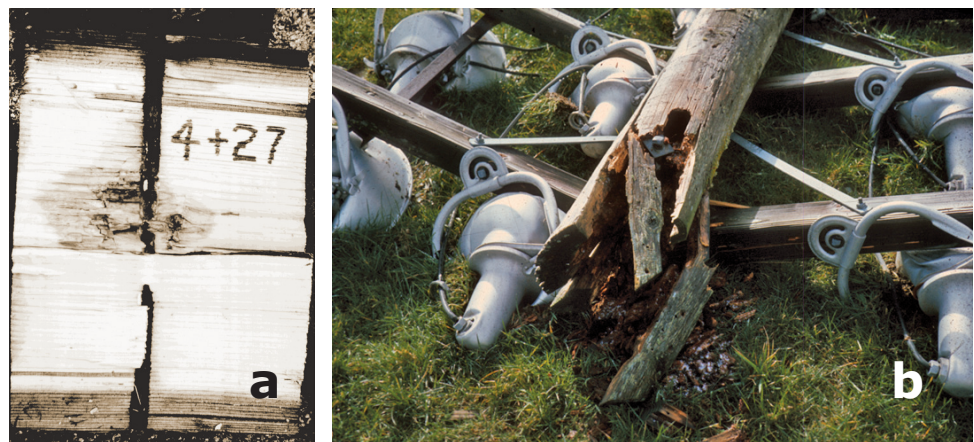
Figure 4. (a) Decay at the bolt hole and (b) pole failure caused by decay in a field-drilled hole.

Pre-boring all holes used for attachments such as guy wires or cross-arms helps to protect the preservative-treated shell from damage. Field drilling exposes untreated wood, creating the potential for aboveground decay (Figure 4).

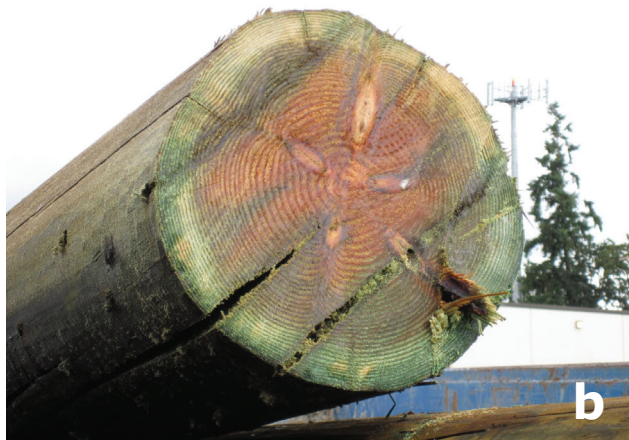
Figure 5. Incising and through-boring can markedly improve preservative penetration. (a) Cross section of a deep-incised pole and (b) a copper naphthenate through-bored pole.

more easily along the grain, and incising exposes more longitudinal flow paths, thereby improving treatment (Figure 5). Incising is recommended for western redcedar poles; utilities also incise Douglas-fir, lodgepole pine (*Pinus contorta*), and western larch (*Larix occidentalis*), particularly in the groundline zone.

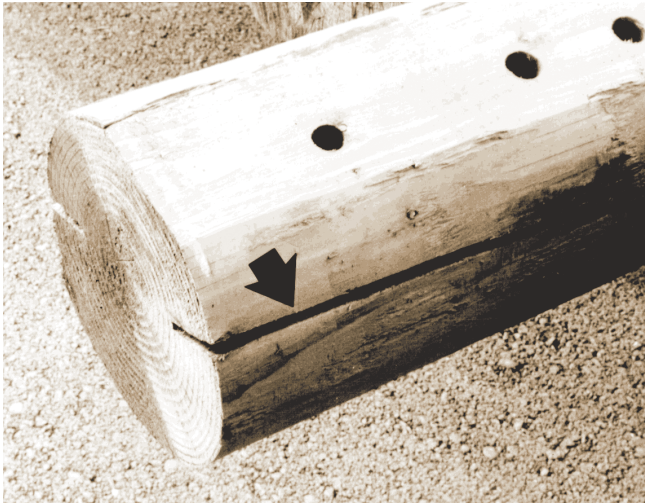
Figure 7. Kerfing (arrow) can be used to control checking of poles, thereby reducing internal decay in service.

Kerfing involves making a saw cut to the pith of the pole prior to treatment (Figures 6 and 7). Once treated, the kerf acts to relieve subsequent drying stress, preventing the development of checks that penetrate beyond the treated shell. It is important to note that decay can occur above the kerfed zone; however, kerfing markedly reduces the incidence of internal decay in thin sapwood species around the groundline.

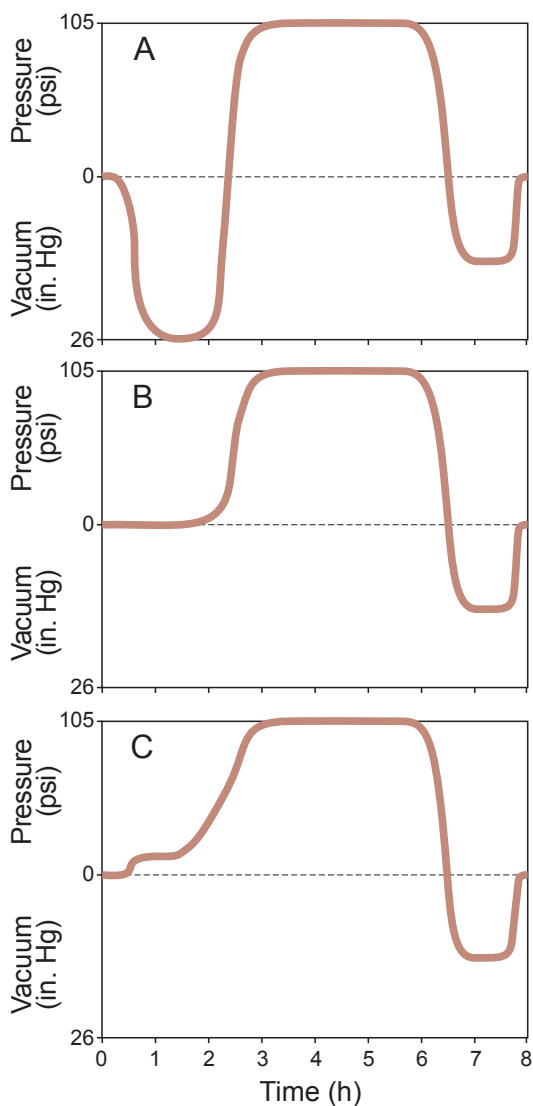
Figure 10. Typical vacuum pressure cycles used to impregnate wood poles with preservative. (A) Full-cell, (B) Rueping, and (C) Lowry processes.

poles for drier or cooler climates, where the decay hazard is lower. The other two treatment methods use elevated pressure in a treatment vessel or retort to force chemical into the wood to the required depth (Figure 10).

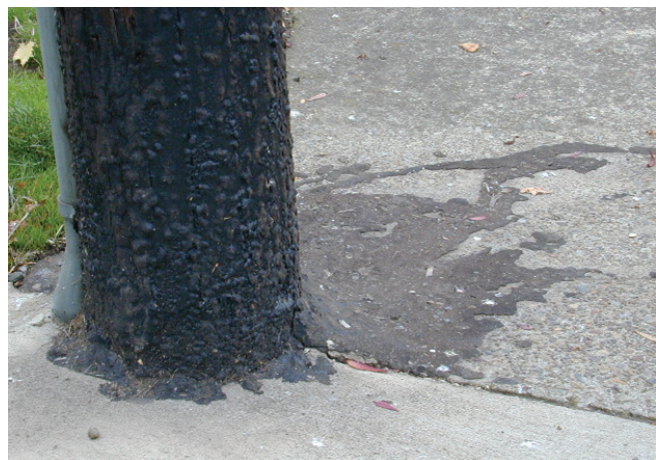
Figure 11. Example of bleeding from a creosote-treated pole.

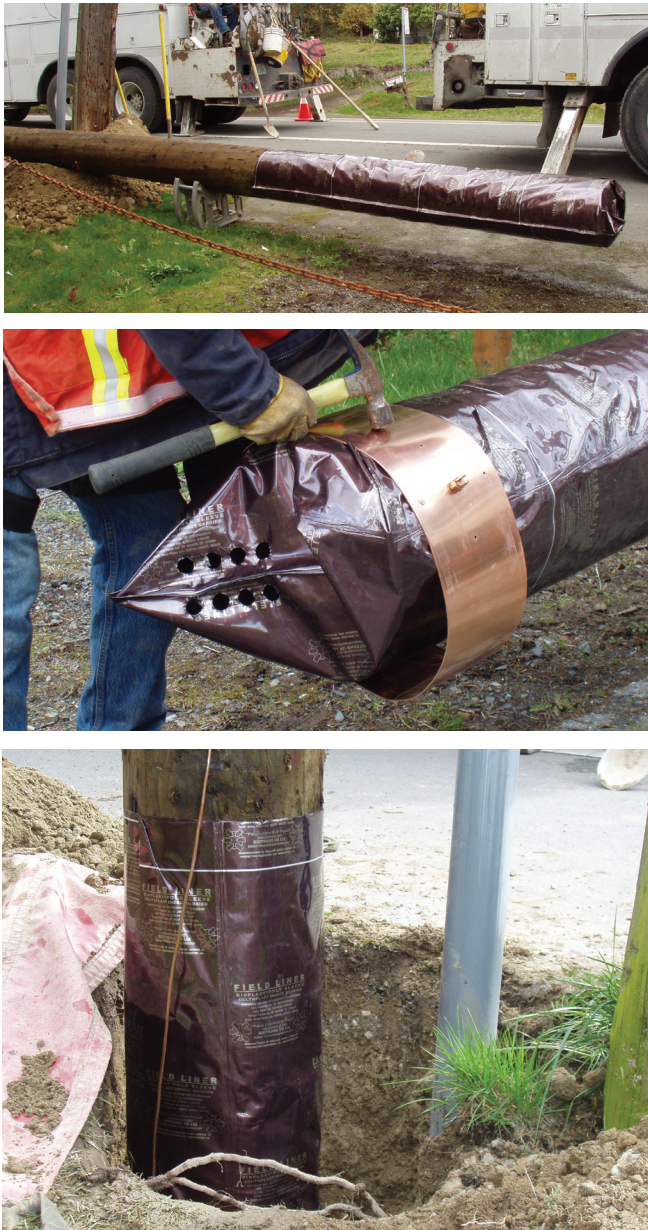
Figure 12. Example of a commercially applied pole barrier used to protect the belowground portion of a pole.

A variety of barrier products have recently emerged that are applied to the area below the

groundline (Figure 12). These systems do not contain any biocides and are designed to limit preservative migration from the pole and to limit soil contact. These two activities should improve pole performance. Barrier systems include sock-like materials that are applied prior to pole installation and polyurea coatings that are applied at the treating plant. These systems have the greatest potential use where poles are used in sensitive environments or where poles might be

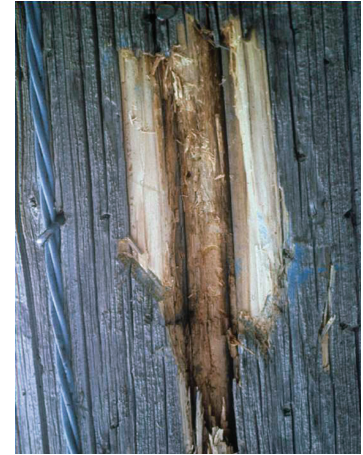
Figure 14. Weathering of a cedar pole turns the surface grey, but the wood underneath is unaffected.

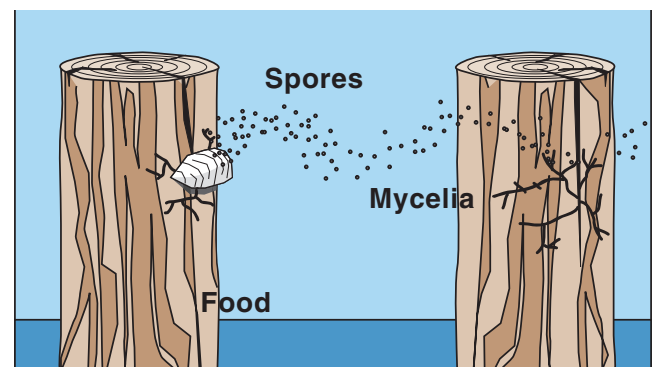
Figure 16. The conk (fruit body) of a decay fungus produces microscopic spores that, finding suitable conditions for growth, infect other wood products. Fungal threads spread decay through moist wood.

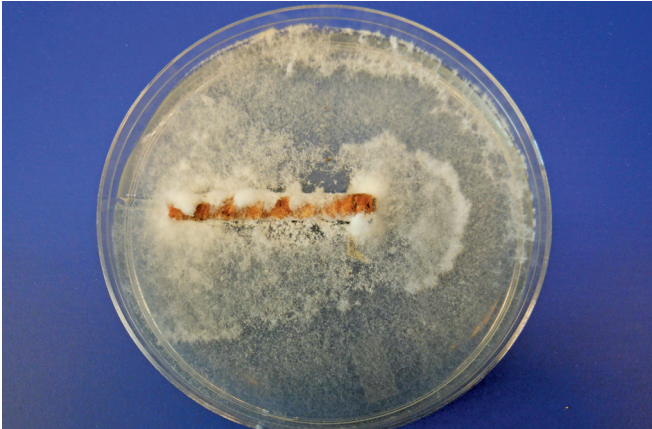
Figure 17. A decay fungus growing over malt agar from a sound-appearing increment core is a positive sign of decay, even though the pole may contain no visible rot.

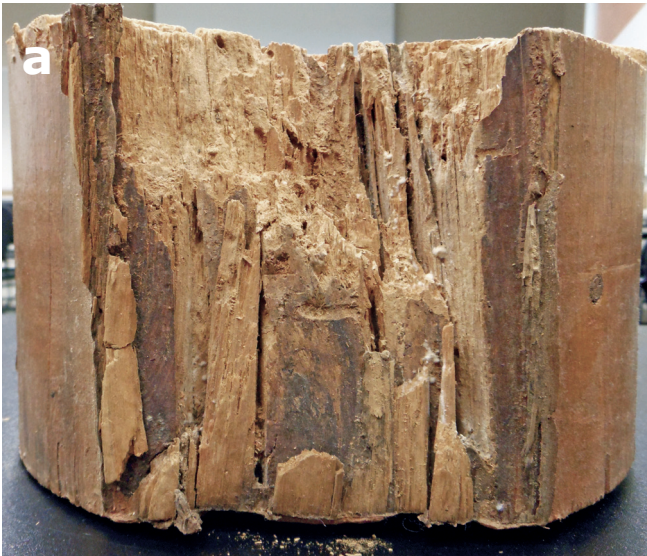
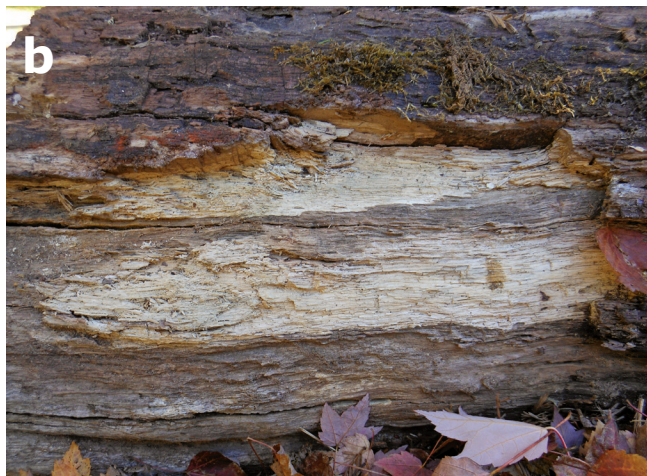
noticeably changes in color; eventually, it may be completely destroyed. Wood that is visibly decayed, greatly weakened, and conspicuously brash or soft is in the advanced stage of decay called rot. Three groups of fungi, brown rot, white rot, and soft rot, cause wood degradation; each affects the wood in a different manner (Figure 18).

Brown rot is a brown, advanced decay that crumbles when dry and is common in most softwoods. Although it is called “dry rot,” this nomenclature is misleading because at one time the wood must have been wet enough to support fungal growth. At very early stages of decay, brown rot fungi preferentially remove cellulose from the wood, producing extensive strength loss and significantly damaging the wood’s utility. Brown rot fungi are important because they cause very substantial strength losses at the early stages of decay.

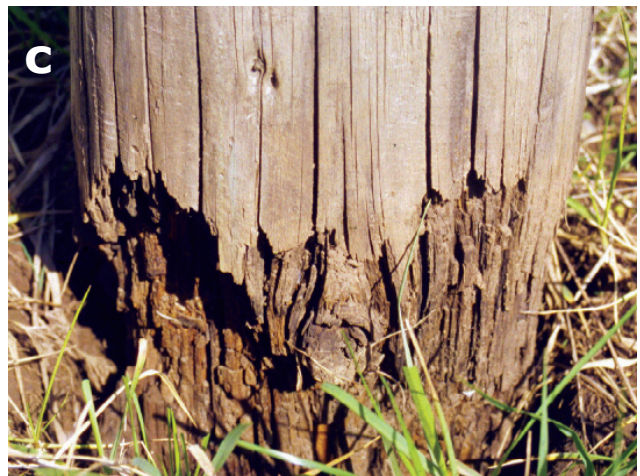
Figure 18. (a) Brown, (b) white, and (c) soft rot.

Brown and white rot fungi tend to be inside the pole where moisture conditions are more stable. They are often associated with deep checks that penetrated past the original treatment zone. While their damage is important, they can generally be controlled by the application of volatile or water diffusible treatments. The end result of internal decay is a shell of treatment surrounding a hollow core. The thickness of that

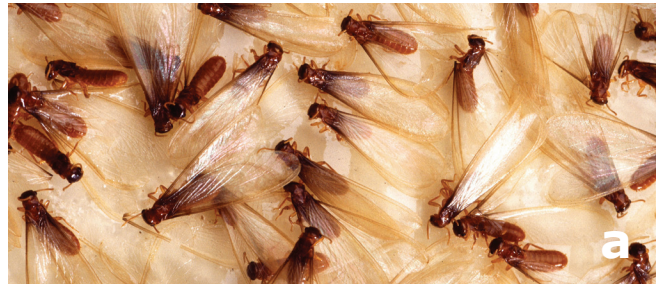
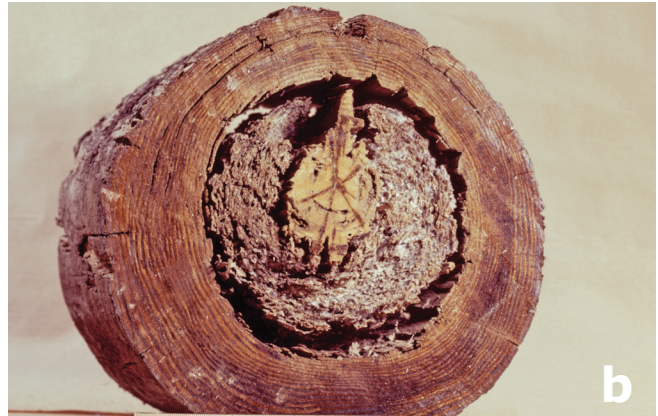
Figure 19. A termite colony includes many workers that burrow in wood for food and shelter, soldiers that protect the colony from other insects, and one egg-laying queen. (a) These reproductives later will fly from the nest to initiate new colonies (photo credit: Scott Bauer, USDA Agricultural Research Service, Bugwood.org). (b) Usually poles show no sign of termites until the reproductives emerge, discard their wings, and mate to start new colonies (photo credit: Gerald J. Lenhard, Louisiana State University, Bugwood.org).

million workers. Collections of wings outside the nest in checks or other collection areas, discarded by reproductives (alates) as they mate to start new colonies, may be the first indicator of termite presence. Some species also produce mud tubes up the pole surface or inside checks that indicate the presence of an infestation. Although their lengths vary from 1/4 inch or less (subterranean and drywood) to 3/4 inch (dampwood), termites have bodies of fairly uniform width; the reproductives have wings of equal length (Figure 19).

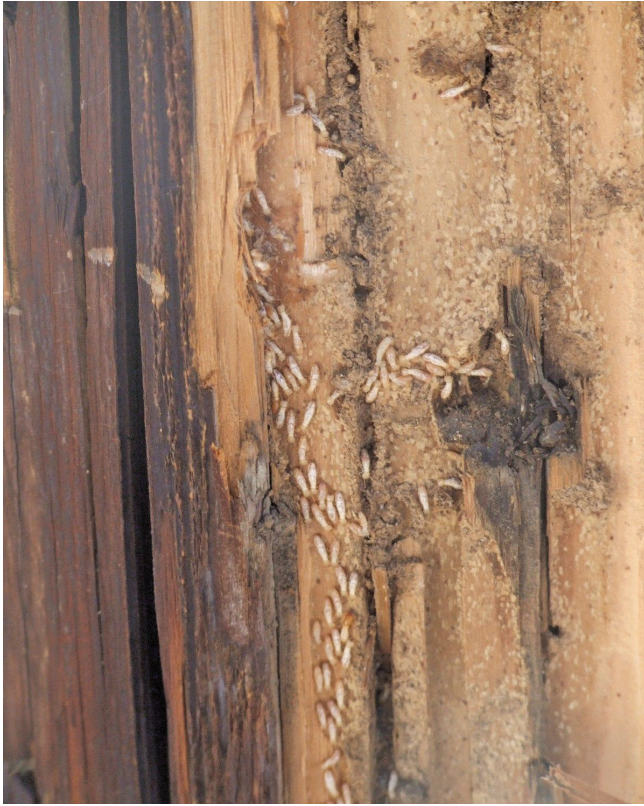
Figure 20. Example of termite damage to wood. Note the debris and termite excrement on the wood.

Subterranean termites are wide-spread and cause extensive damage, especially in southern states but they are also present in drier parts of the country. Sure signs of their presence are the mud tunnels that the termite workers build from their nests in the ground up across treated wood or concrete to non-treated wood above. Subterranean termites are distributed between 50° N and 50° S latitude although there may be

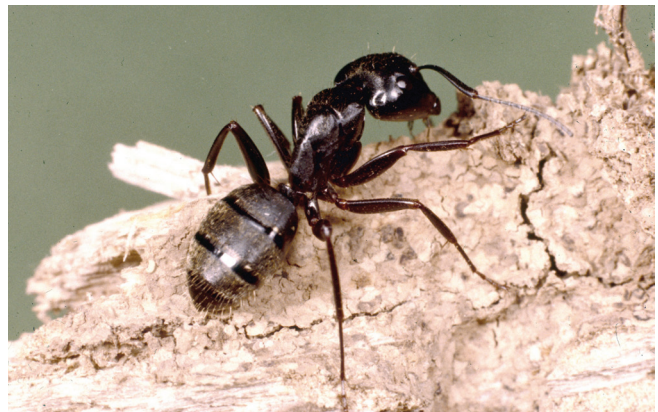
Figure 21. In contrast to termites, carpenter ants (*Camponotus* sp.) have restricted waists and reproductives have shorter wings of unequal length (photo credit: Clemson University - USDA Cooperative Extension Slide Series, Bugwood.org).

Carpenter ants are also social insects with a queen and major or minor workers (Figure 21). The ants have a restricted waist, and the reproductives have wings of unequal length. The dark-colored ants grow as long as 3/4 inch. Unlike termites, which eat wood, ants hollow out wood only for shelter, forming piles of "sawdust" at the base of poles, which attest to their presence in the wood (Figure 22). Ants must leave the nest to find food and are frequently seen scurrying around poles particularly at night (they are nocturnal). They are difficult to control because they do not eat the wood. They also tend to have a main nest along with satellite nests. This makes it

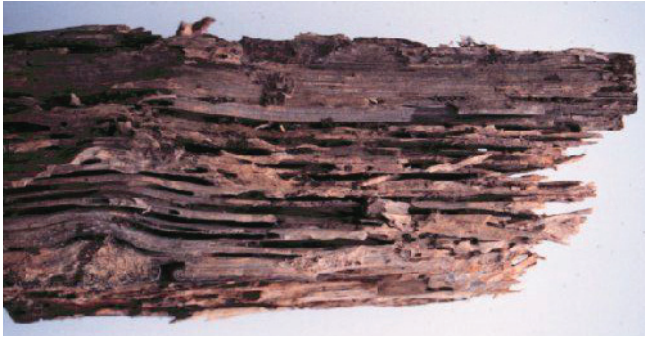
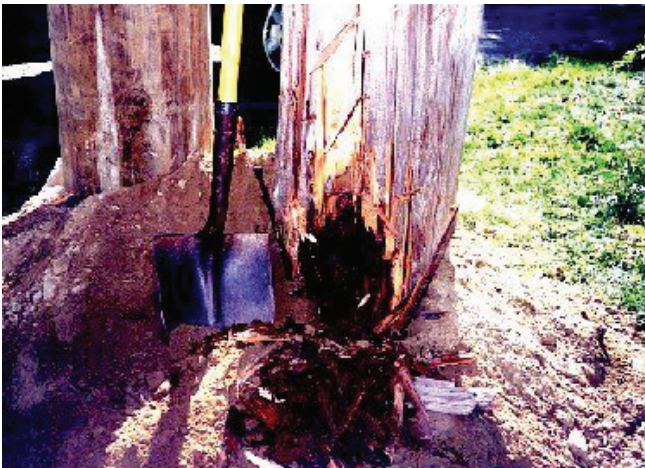
Figure 22. Carpenter ant damage in poles. Carpenter ants also live in colonies, hollowing out nests in poles for shelter. A pile of sawdust at the base of the pole is a sure sign of their presence.

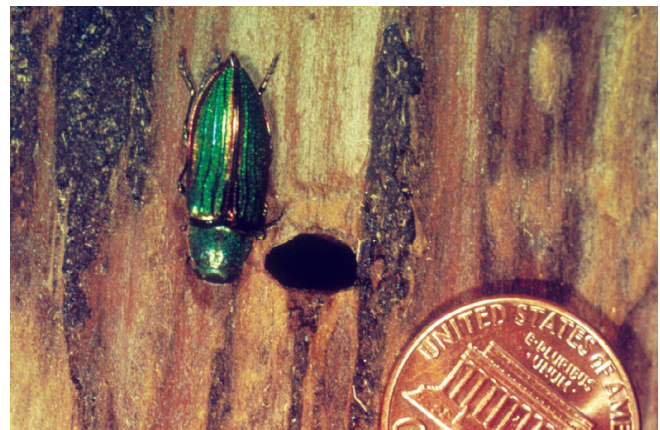
Figure 23. Golden buprestid beetle (*Buprestis aurulenta*). As an indication of internal rot in the aboveground portion of poles, look for the oval holes (0.5 in. long), that the buprestid beetle leaves as it emerges from wood. Many holes could mean an unsafe pole.

Beetle damage, while not always a long-term problem, can be an indicator of poor handling. As a result, the ANSI specifications reject poles with beetle holes.

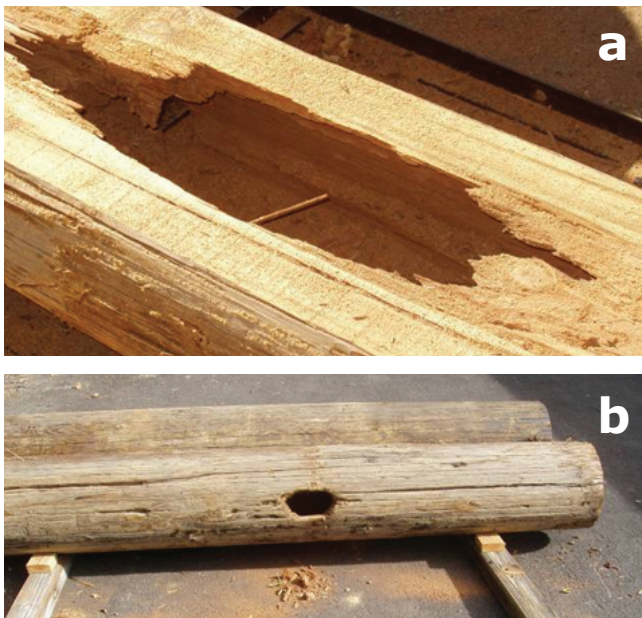
Figure 24. (a) Example of a woodpecker hole on the pole surface and (b) the extent of void associated with a nest.

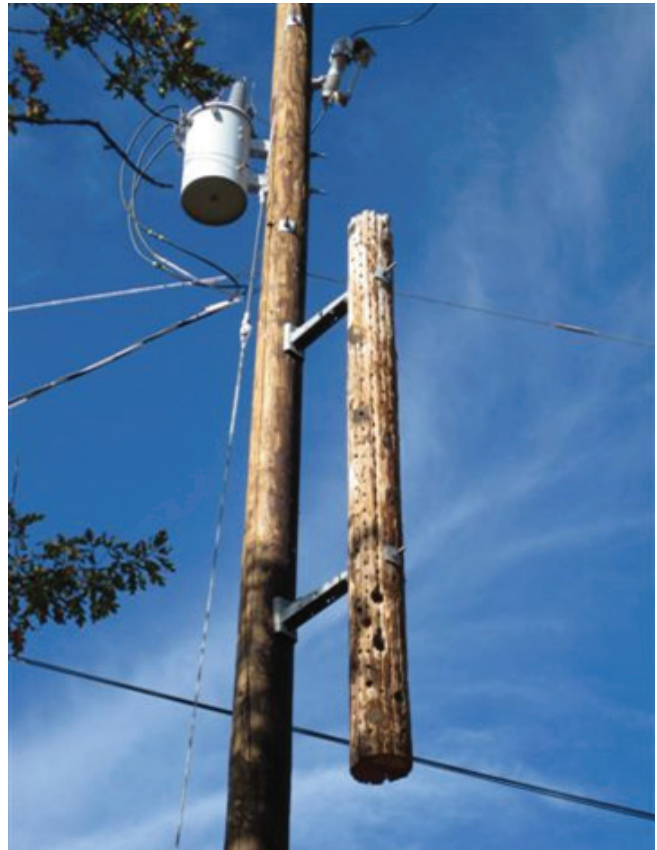
Figure 25. A section of old pole containing a woodpecker nest attached to a new pole in hopes of discouraging new attack.

Chemical repellents, plastic wraps that deny the birds a toehold and stuffed owls have been tried as woodpecker deterrents. When poles with woodpecker damage have been replaced, the pole section containing the nest cavity has even been retained and attached to the new pole at its original height (Figure 25). These methods, however, usually do not prevent woodpecker damage.

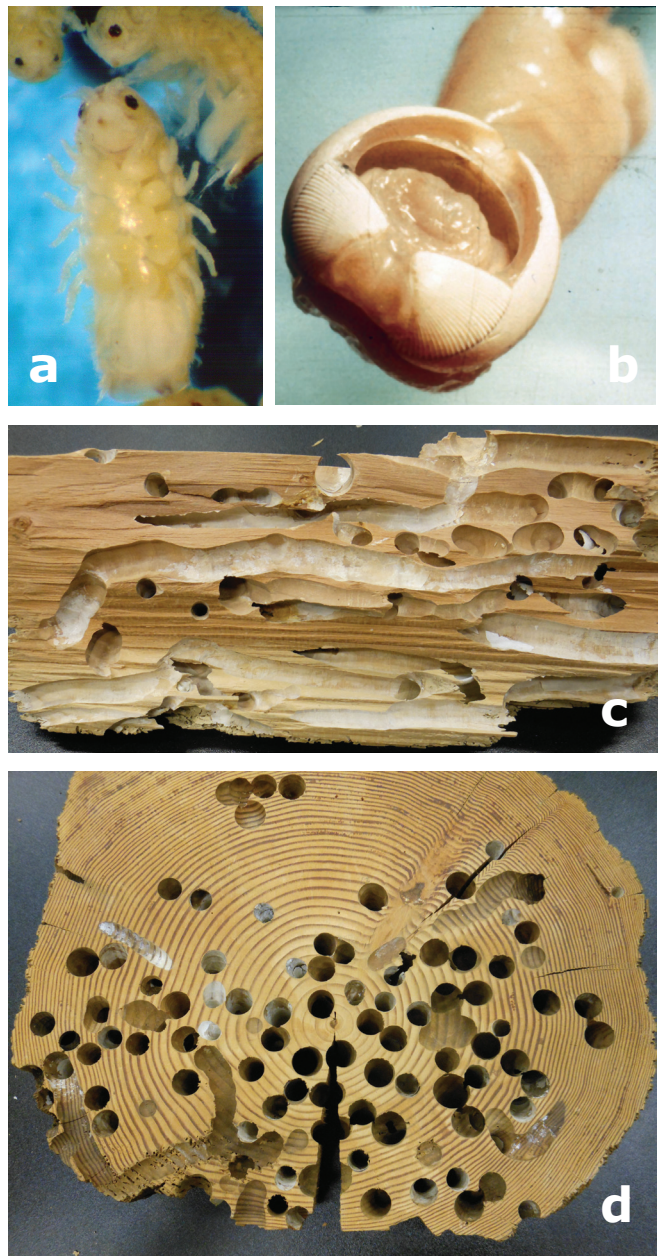
Figure 26. Marine borers attack wood in coastal waters where salinity and oxygen supply are favorable. Gribbles (a) make smaller tunnels near the surface (photo courtesy Wikimedia Commons). Shipworms (b) are marine borers that make long tunnels (c,d).

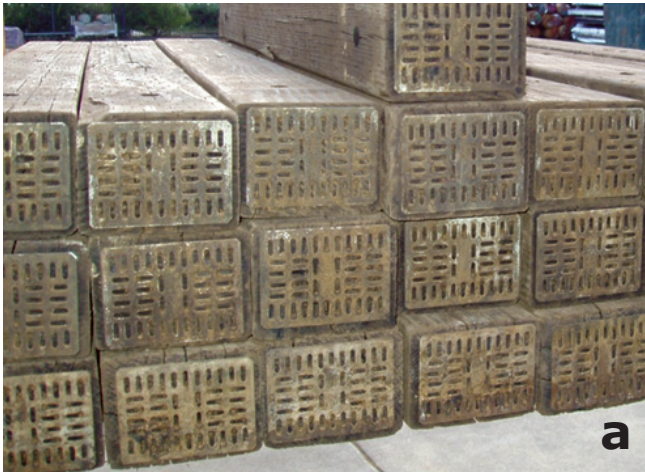
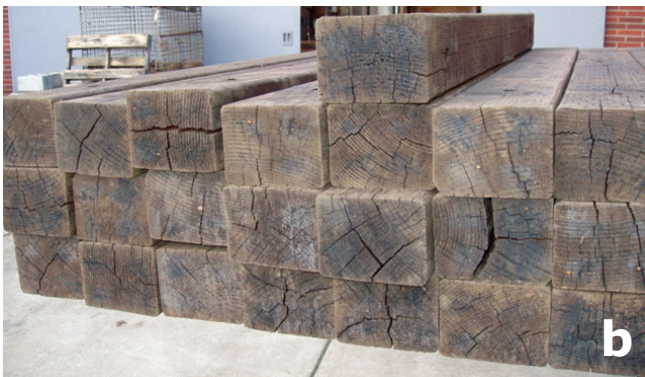
Figure 27. Crossarms (a) with and (b) without end-plates that limit end-checking. Note the large checks on non-plated ends.

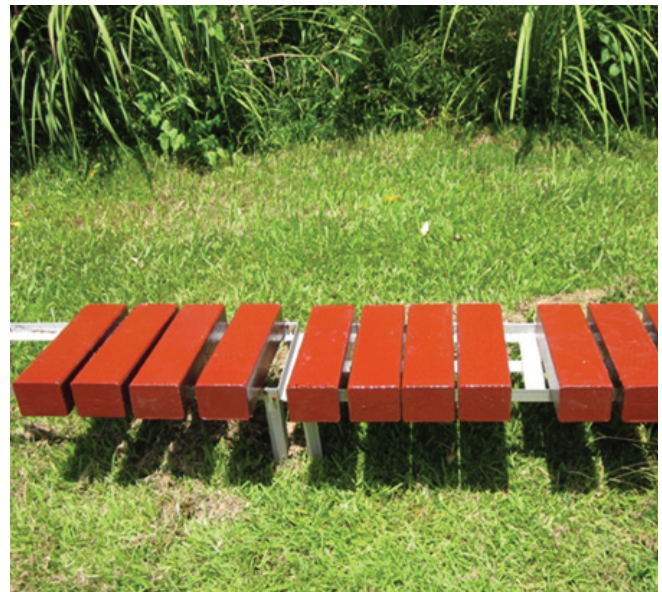
Figure 28. Polyurea-coated arms designed to reduce the risk of checks developing on the upper surface.

The other types of damage incurred by crossarms are splits or deep checks. These splits can widen to the point that insulator bolts fall out of the arm. Field trials indicate that end-plates can markedly reduce this checking (Figure 27). Arm damage can also be limited by the application of polyurea coatings (Figure 28).

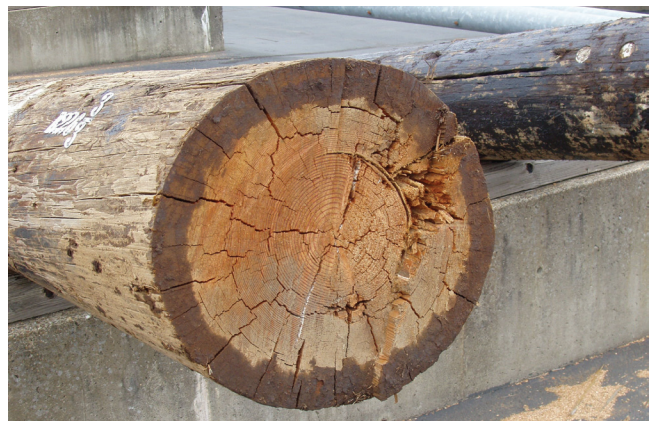
Figure 31. Internal decay.

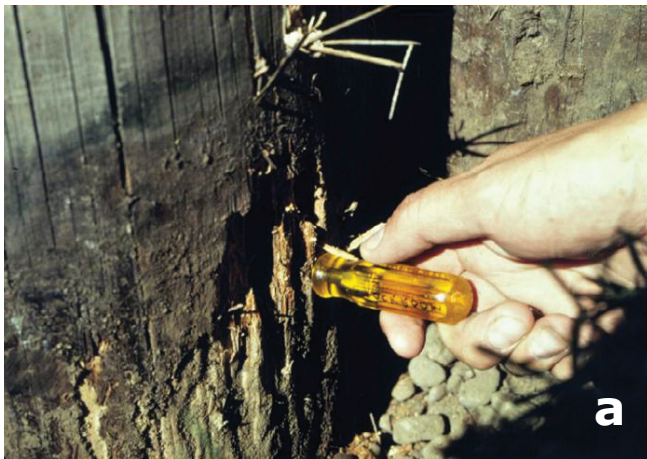
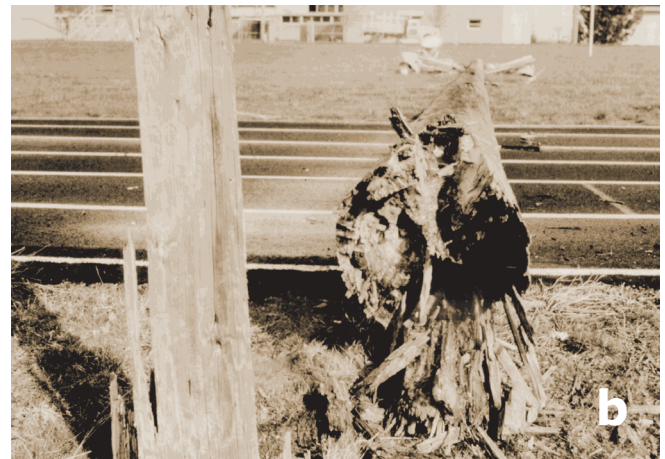
Figure 32. Both external (a) and internal decay (b).

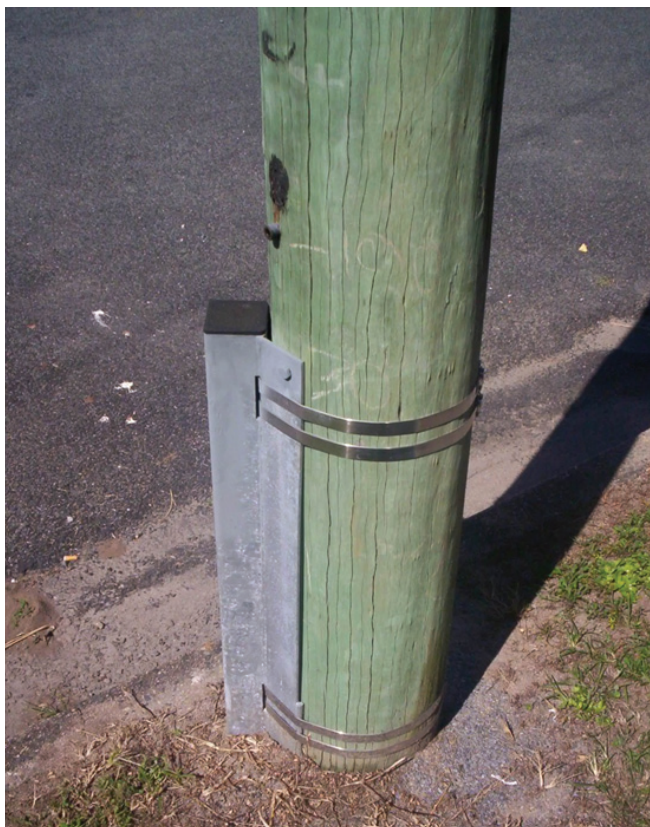
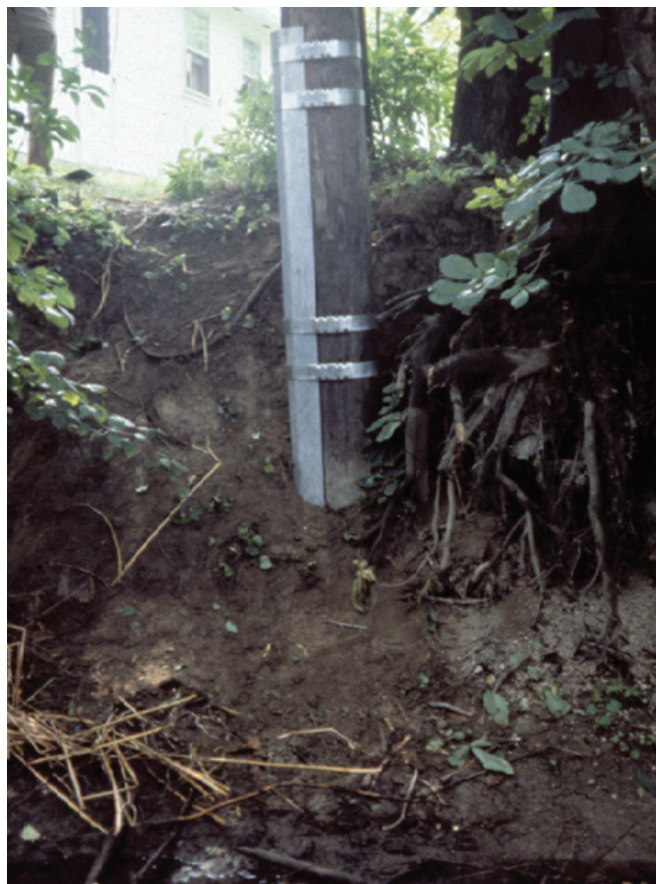
Figure 33. Examples of steel trusses used to reinforce deteriorated poles.

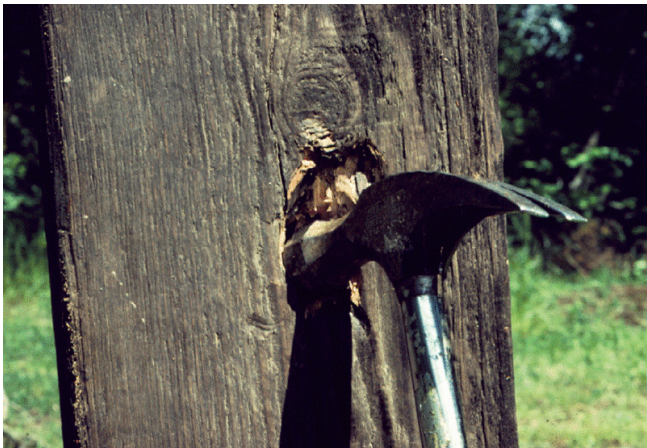
Surface rot can be detected by scraping, probing with a dull tool, or visually examining the wood. Internal decay is detected by sounding, drilling, coring, measuring electrical resistance, or feeling within a drilled hole with a metal gauge

with a hook as it is pulled across the growth rings. Poles with extensive rot are easy to detect, but detection becomes more difficult as the extent of the rot decreases. The sooner decay can be detected, the earlier remedial treatments can be applied to arrest the attack and retain the structural integrity and strength of poles. Field personnel should practice scraping, probing, lifting slivers, drilling, and coring both sound and decaying poles to develop and improve their ability to detect rot. Use pole sections removed from service to verify predictions by boring, then cutting, the cross section to see the actual damage. Select the equipment that best meets your needs. Some sources of equipment are listed in the Equipment Appendix.

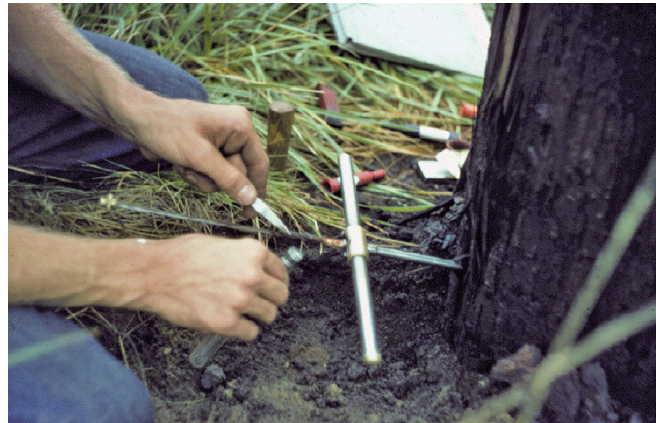
*Figure 35. Cores extracted with an increment borer permit detection of rot, as well as measurement of shell thickness and depth of preservative penetration. Cores can be retained and cultured for fungi.*

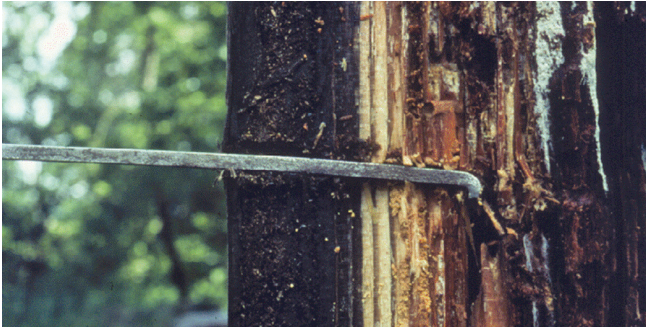
Figure 36. A shell-thickness indicator detects rot in poles by "feeling" growth rings in sound, but not rotten, wood when inserted or removed from snug-fitting holes.

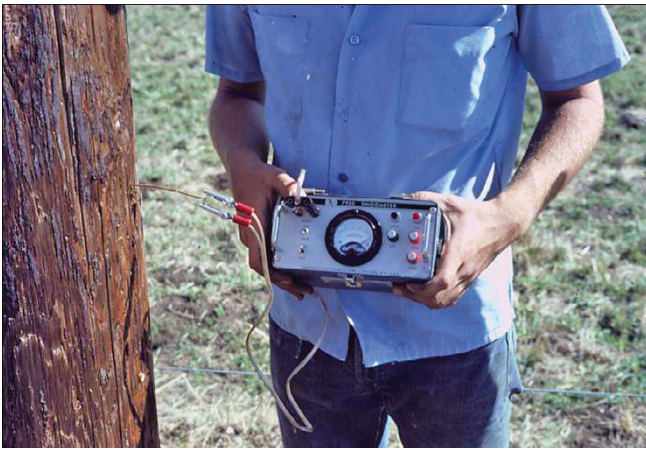
Figure 37. The Shigometer™ measures electrical resistance to detect rot in poles. Use an increment borer to determine the nature of the defect.

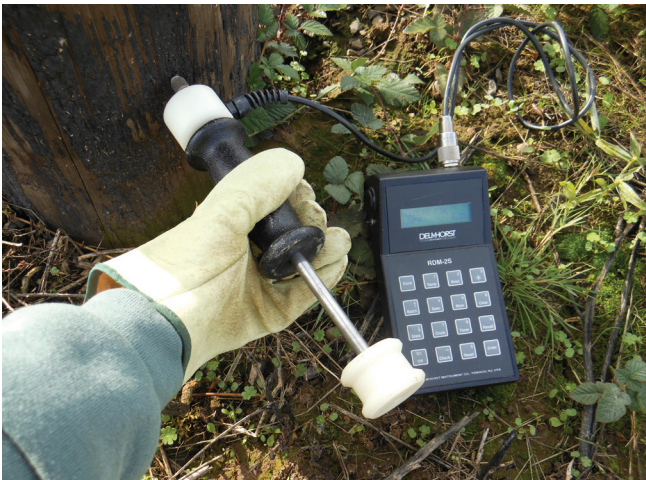
Figure 38. A resistance-type meter can be useful for detecting MC levels that are high enough (over 20%) for decay. As a sliding hammer drives two electrodes into the wood, a ruler emerging from the top of the hammer measures their depth. Shanks of the electrodes are coated so moisture readings are made between the uninsulated points.

Moisture content also can be determined with a moisture meter that measures the electrical resistance between two probes driven into the wood with a sliding hammer (Salamon 1971, James 1975). Because a moisture gradient indicates moisture distribution in a pole much better than does a single reading at a specified depth, the 3-inch-long probes with uncoated tips should

be driven into the wood so that the meter is read every 1/2 inch. The uncoated pins read MC only at the tip. Before driving the probes into the wood, be sure that they are parallel to each other and are aligned with the long fibers of the wood; that way, the probes will not break off and the data will be more accurate. The meter is useful for a MC range of 7% to 25%, but accuracy decreases rapidly outside this range (Graham et al. 1969). Creosote and oil-based preservatives have little effect on meter readings, but inorganic water-based preservatives may cause large errors (James 1976).

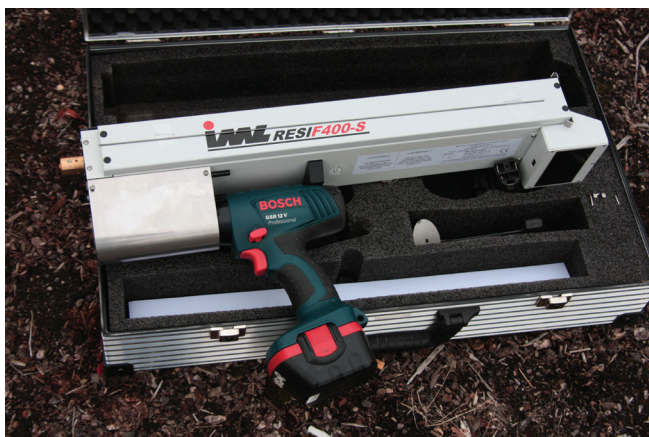
Figure 39. The resistograph drill uses a very fine bit to detect voids or softer wood that may be decayed.

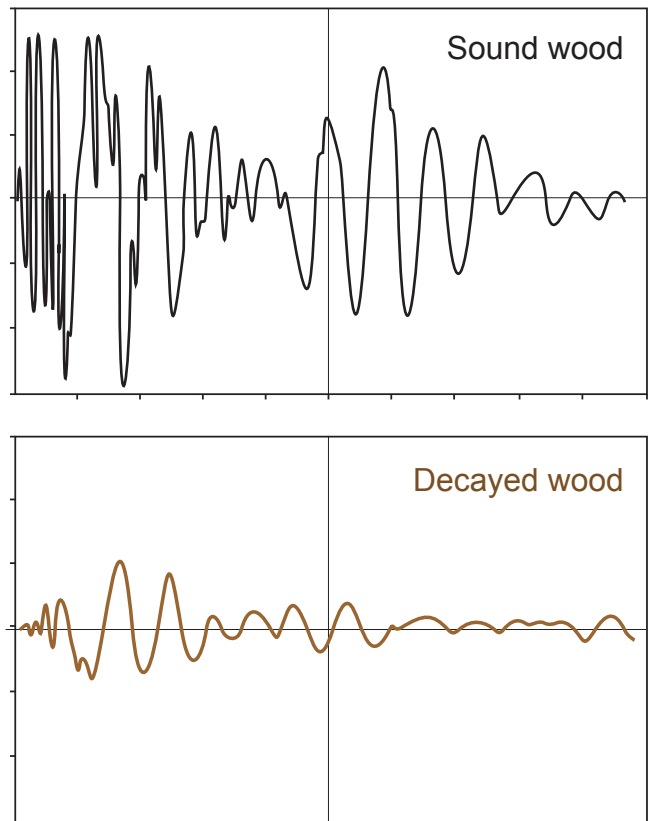
Figure 40. Strong and weak acoustic signals showing sound and weak wood, respectively.

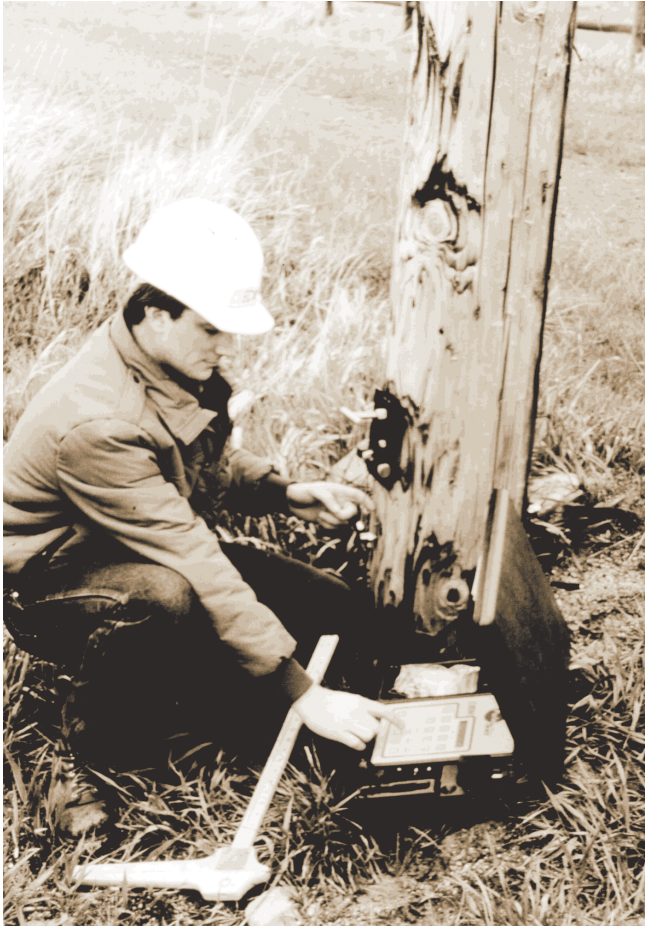
Figure 41. Pole test with an acoustic inspection device.

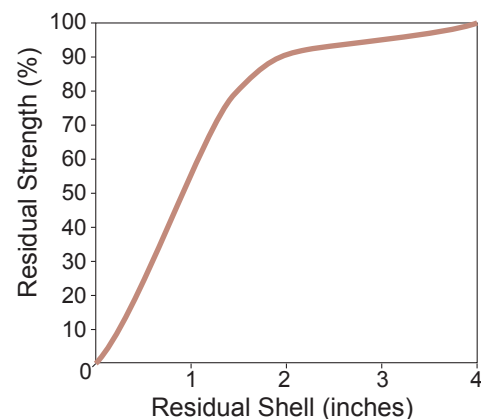
Figure 44. Theoretical strength vs. residual shell thickness of a pole.

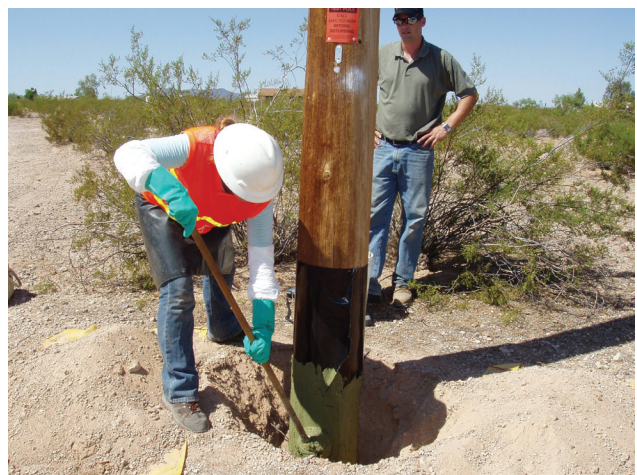
Figure 45. Applying groundline treatment.

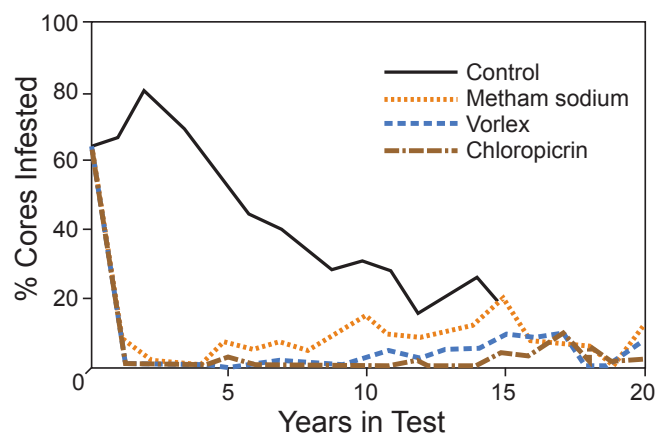
Figure 46. Ability of selected fumigant treatments to eliminate decay fungi in Douglas-fir poles.
