CONSERVING ENERGY BY ENVIRONMENTALLY ACCEPTABLE PRACTICES IN MAINTAINING AND PROCURING TRANSMISSION POLES

# OBJECTIVE I

## DEVELOP SAFER CHEMICALS FOR CONTROLLING INTERNAL DECAY OF WOOD POLES

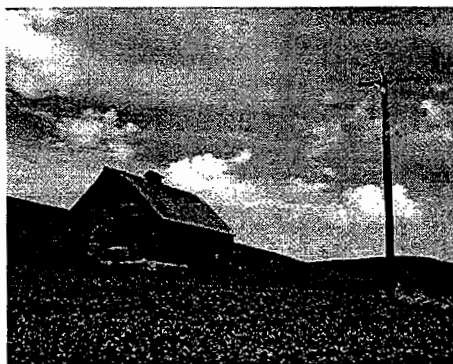
Table I-8. Residual methylisothiocyanate levels in Douglas-fir and ponderosa pine distribution poles in San Jose, California; 1 and 2 years after treatment with 475 ml metham sodium.

MITC levels in ponderosa pine poles increased in the inner zone 0.3 m above groundline, but declined in the outer zone. More importantly, MITC levels declined in both the inner and outer zones 0.6 and 1.2 m above groundline. The reasons for these declines are unclear. Ponderosa pine is often considered to be similar to southern pine in terms of its permeability and treatment characteristics. Our results suggest that metham sodium will be less effective in ponderosa pine. As a result, shorter treatment cycle may be required where this species is used under more severe decay conditions.

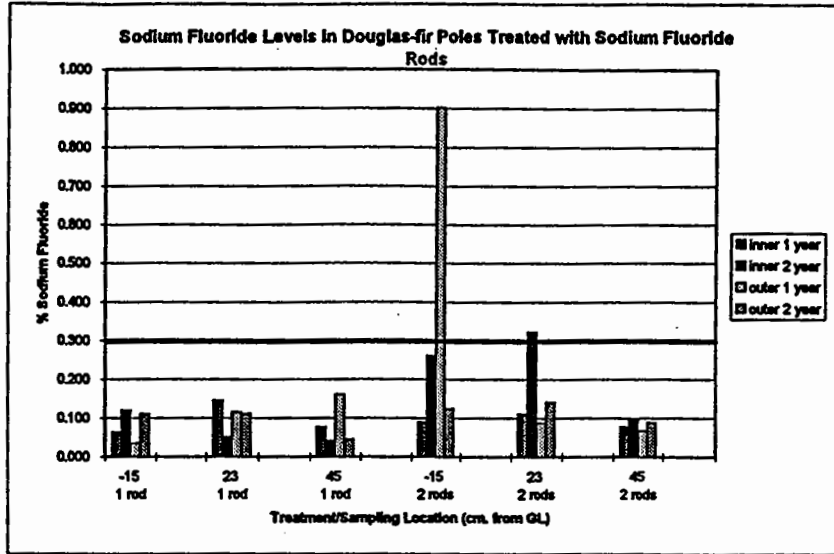
Figure I-5. Residual fluoride levels at selected distances from the groundline of Douglas-fir poles 1 or 2 years after treatment with 3 or 6 sodium fluoride rods distributed between three holes drilled around the groundline.

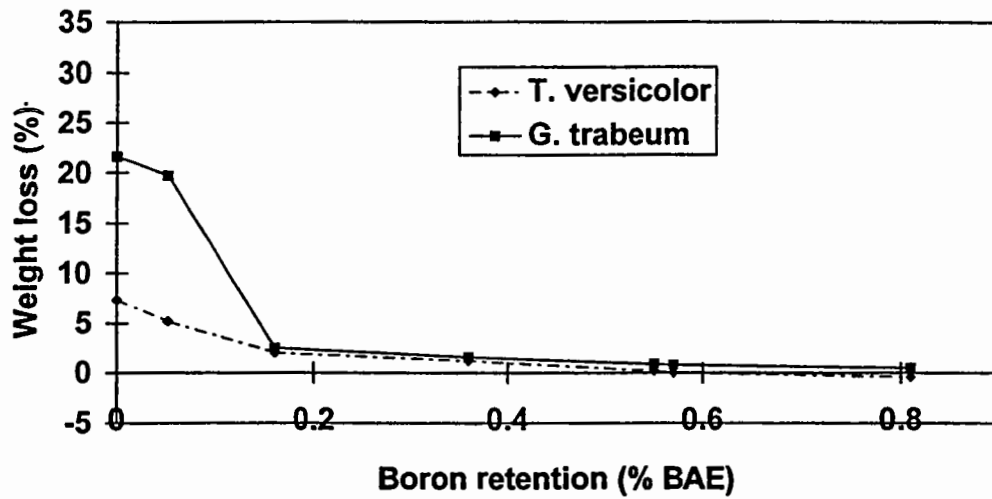
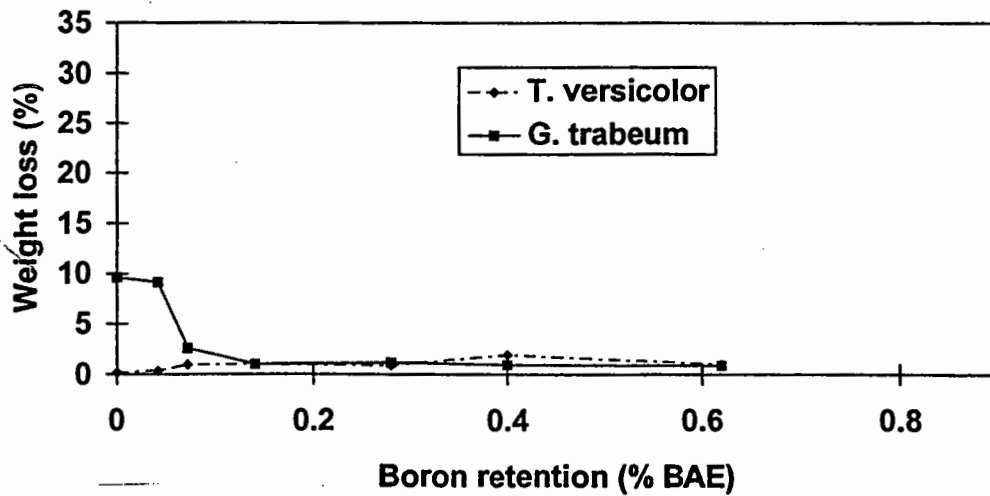
### Weight loss of Boron treated Douglas-fir sapwood

### Weight loss of Boron treated Douglas-fir heartwood

Figure I-8. Weight losses in non-treated and borate treated Douglas-fir sapwood and heartwood blocks exposed to *G. trabeum* or *T. versicolor* in a non-soil contact decay test.

Hyphal growth became evident within 4 weeks on untreated wafers exposed to *G. trabeum* and after 8 to 10 weeks on wafers exposed to *T. versicolor* (Figure I-8). Weight losses for untreated control wafers exposed to the two test fungi varied widely. The highest weight losses were found with exposure of Douglas-fir sapwood to *G. trabeum*, while Douglas-fir heartwood wafers exposed to *T. versicolor* experienced little or no weight loss (Table I-14). Weight losses were generally lower with Douglas-fir heartwood than sapwood, reflecting the moderately durable heartwood characteristic of this species (Scheffer and Cowling, 1966).

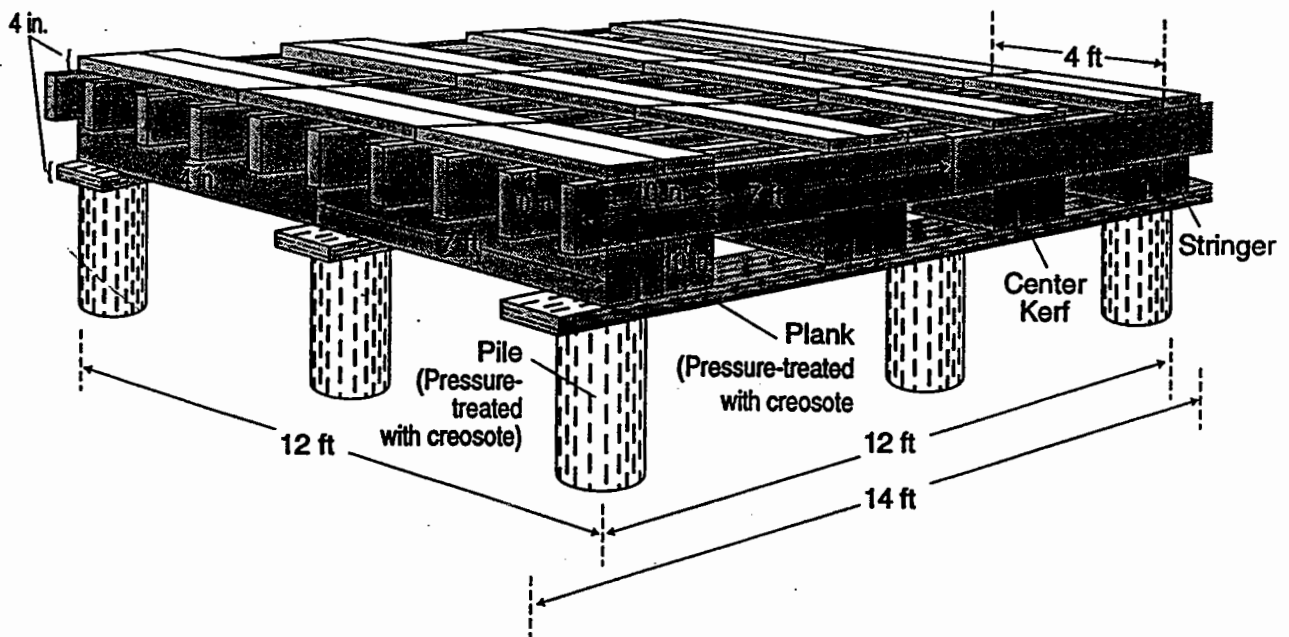
Figure II-2: Simulated pier structures used to evaluate remedial treatments for preventing fungal decay.

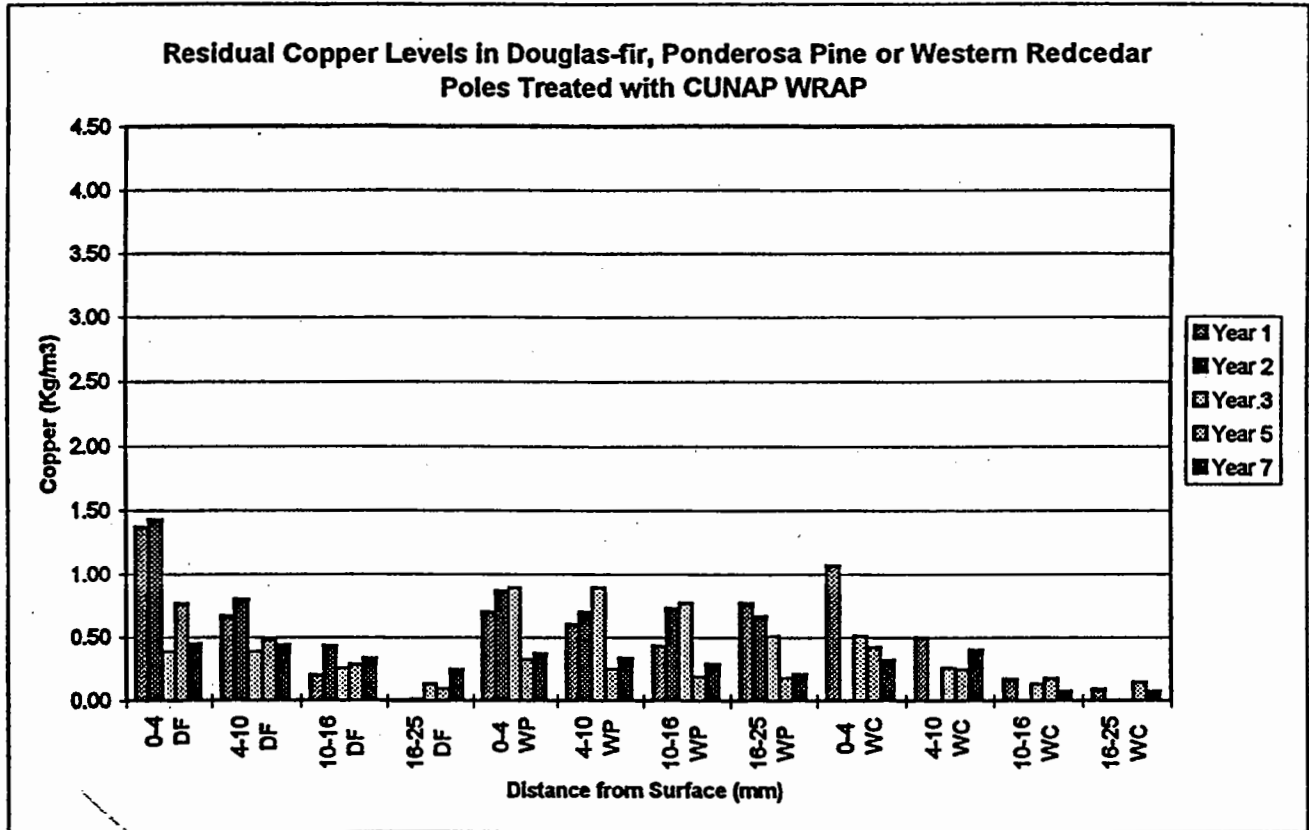
Figure IV-1. Copper levels in at selected distances from the wood surface in the below ground region of Douglas-fir, ponderosa pine, and western redcedar poles 1 to 7 years after application of Cunap wrap

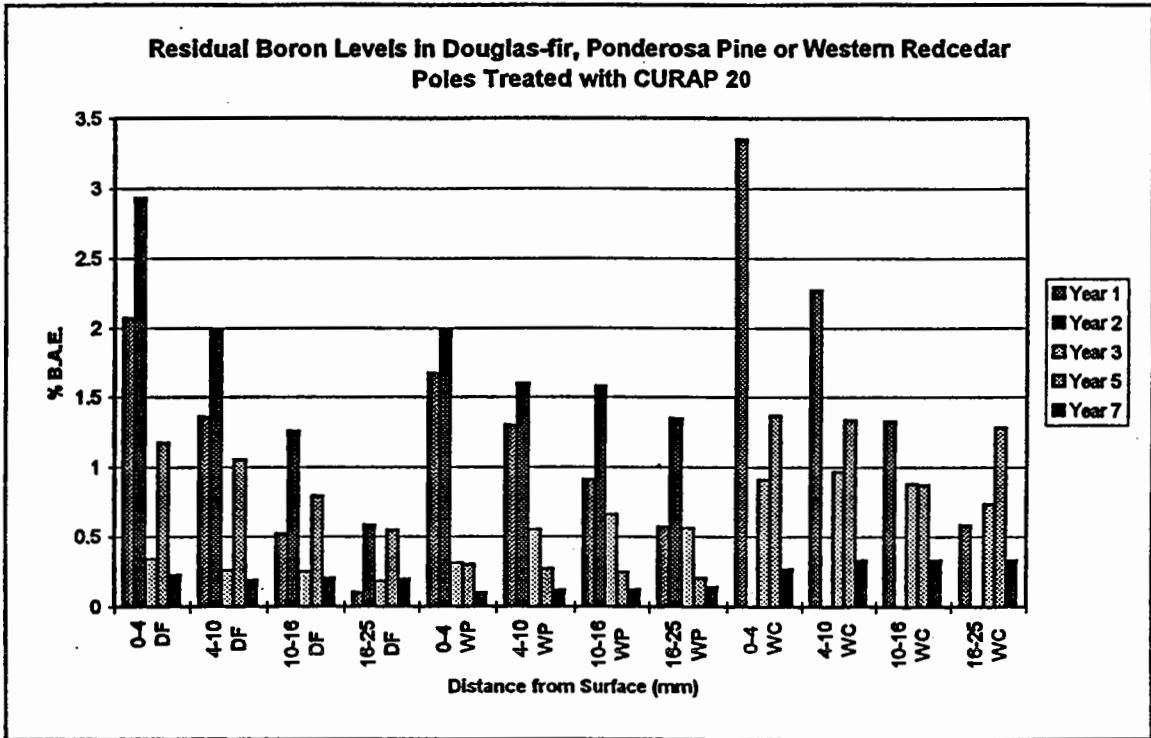
Figure IV-2. Copper and boron levels in at selected distances from the wood surface in the below ground region of Douglas-fir, ponderosa pine, and western redcedar poles 1 to 7 years after application of CuRap 20.

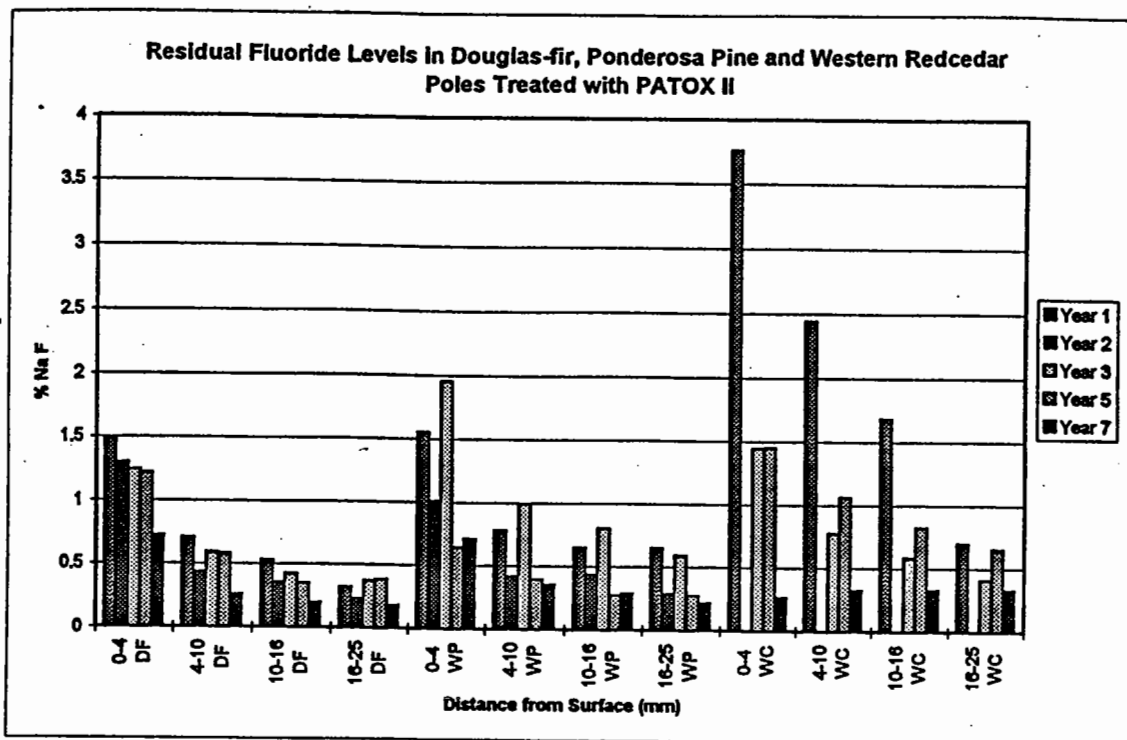
Figure IV-3. Fluoride levels in at selected distances from the wood surface in the below ground region of Douglas-fir, ponderosa pine, and western redcedar poles 1 to 7 years after application of Pattox II.

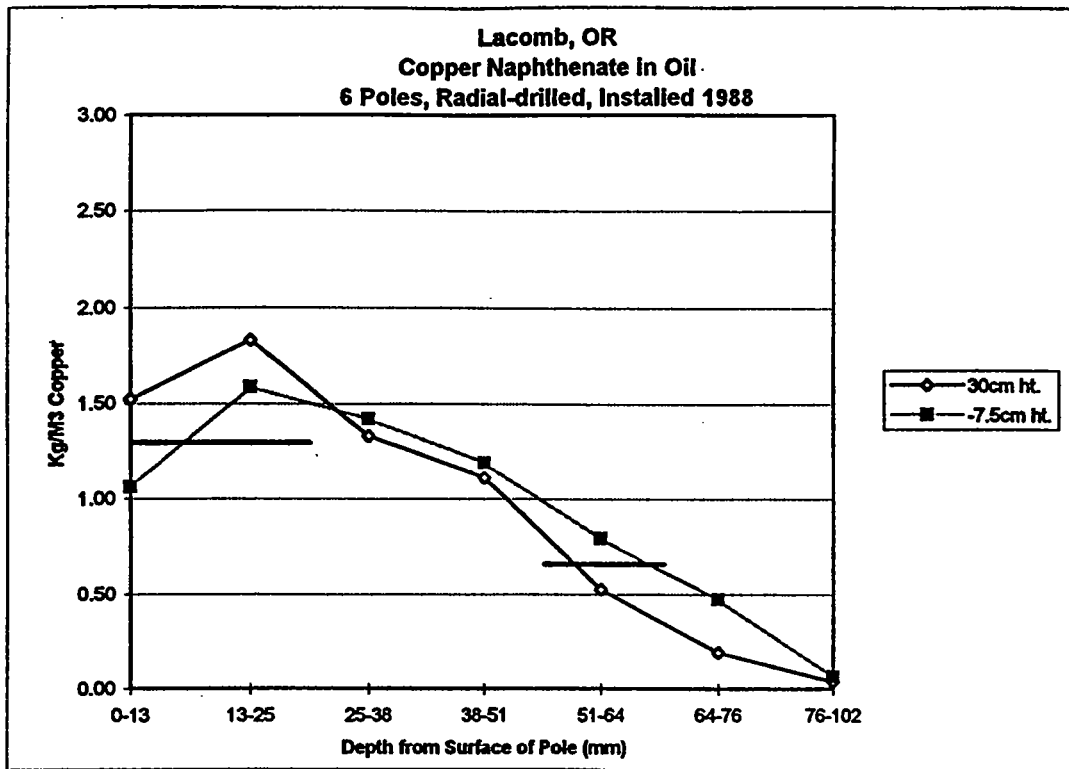
Figure V-1. Copper levels at selected depths in six radially-drilled copper naphthenate-treated Douglas-fir poles 10 years after installation in Lacomb, Oregon.

The results suggest that the oilborne copper naphthenate treated Douglas-fir poles in both California and Oregon are performing well with little or no evidence of either excessive preservative loss or fungal attack. We will continue to monitor copper naphthenate poles to ensure that they are performing as expected.

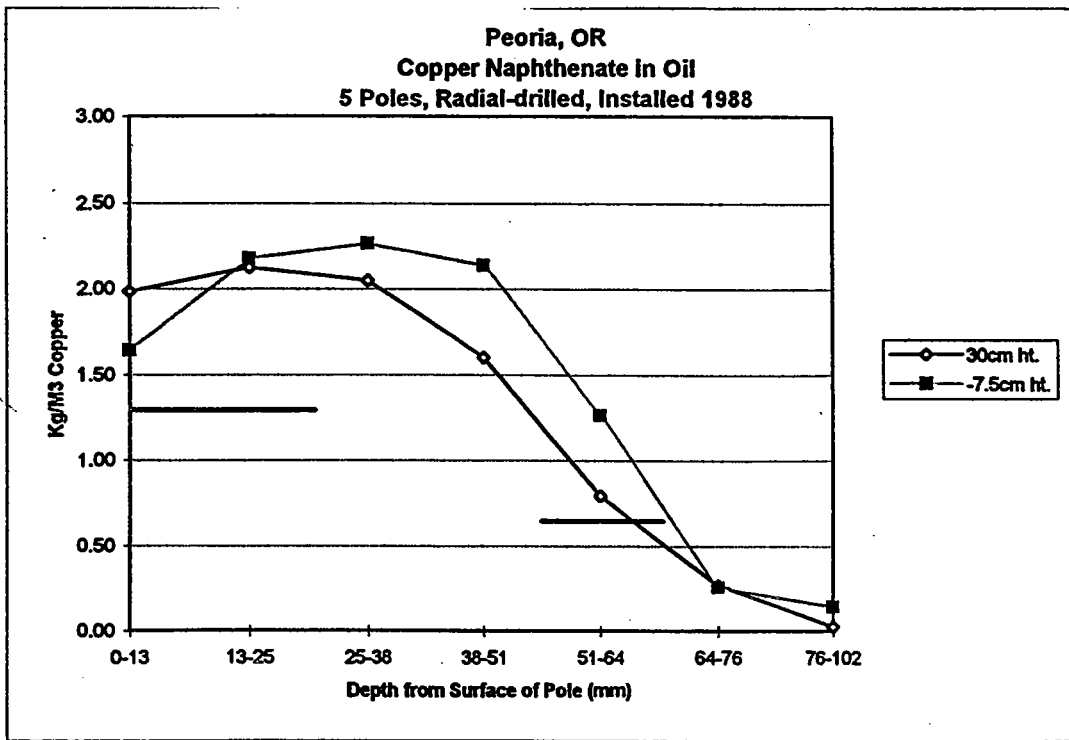
Figure V-2. Copper levels at selected depths in five radially-drilled copper naphthenate-treated Douglas-fir poles 10 years after installation in Peoria, Oregon.

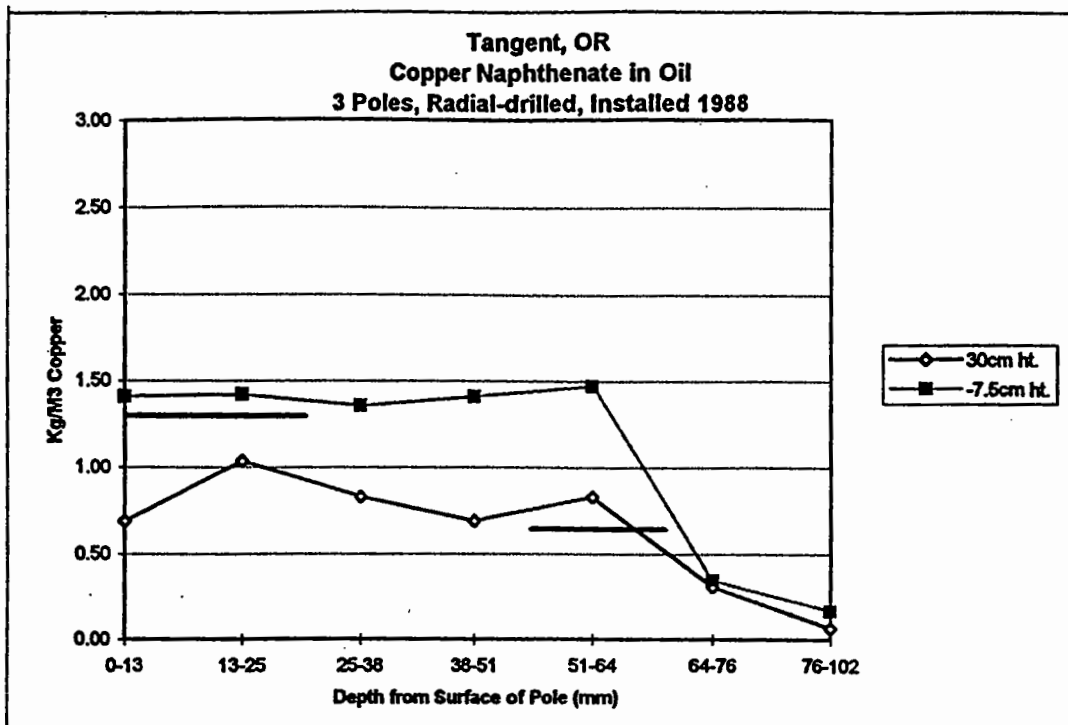
Figure V-3. Copper levels at selected depths in three radially-drilled copper-naphthenate treated Douglas-fir poles 10 years after installation in Tangent, Oregon.

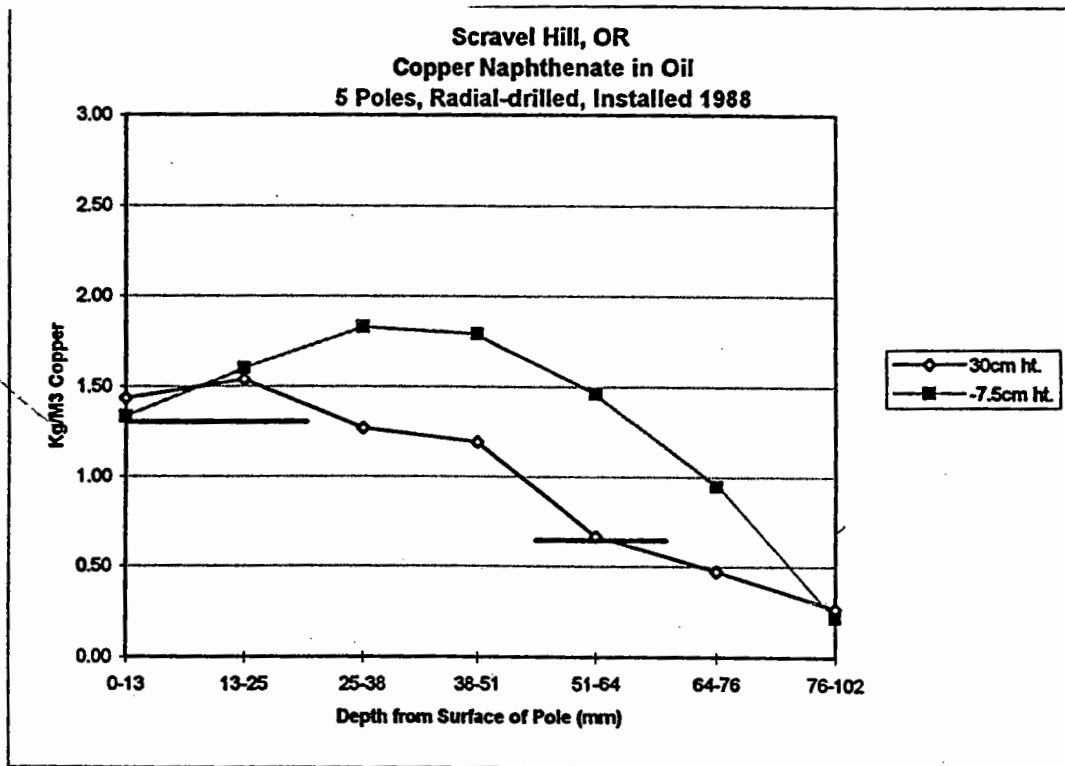
Figure V-4. Copper levels at selected depths in five radially-drilled copper naphthenate-treated Douglas-fir poles 10 years after installation in Scrael Hill, Oregon.

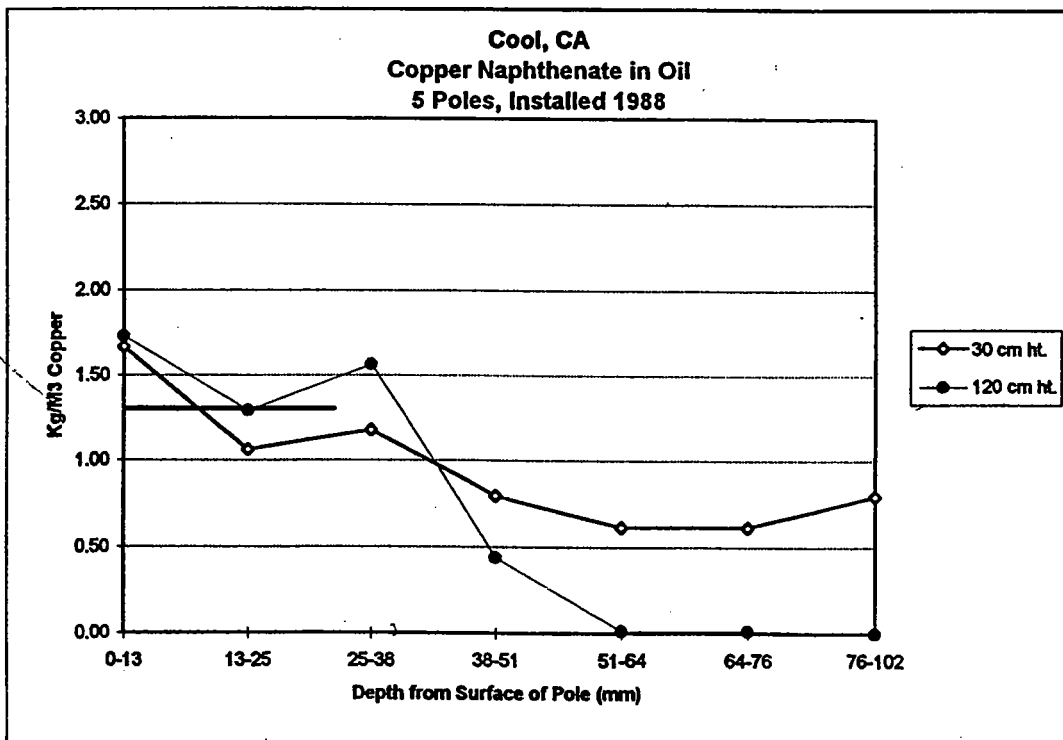
Figure V-6. Copper levels at selected depths in five copper naphthenate-treated Douglas-fir poles 10 years after installation in Cool, California.

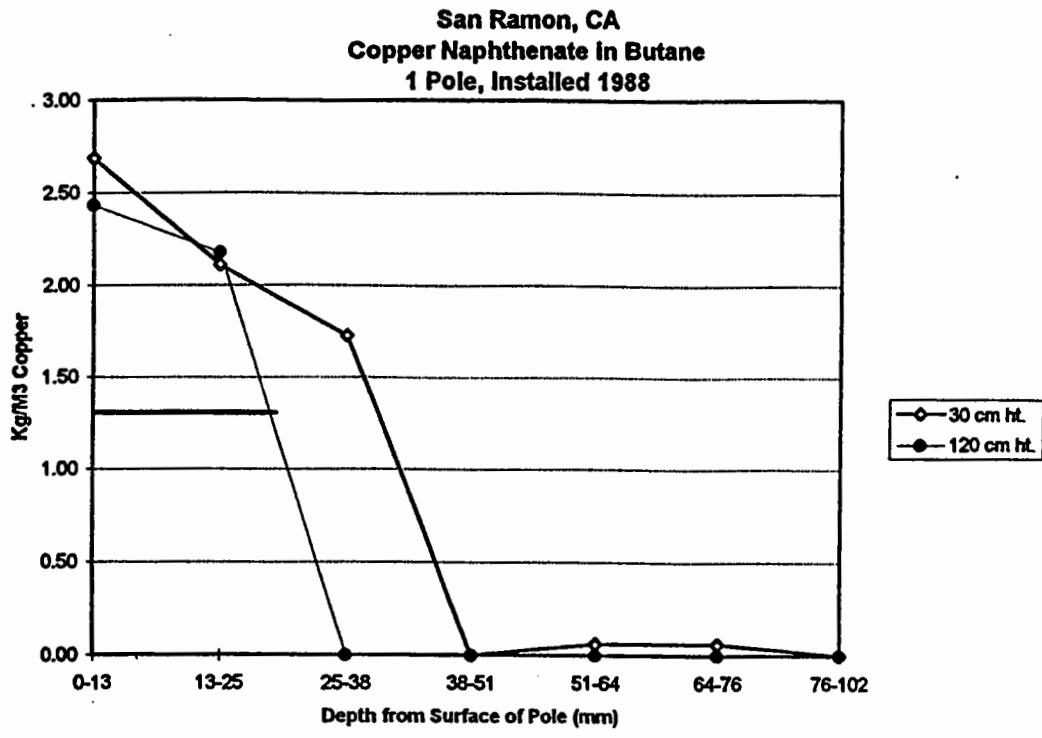
Figure V-9. Copper levels at selected depths in one copper naphthenate in liquified petroleum gas-treated Douglas-fir pole 10 years after installation in San Ramon, California.

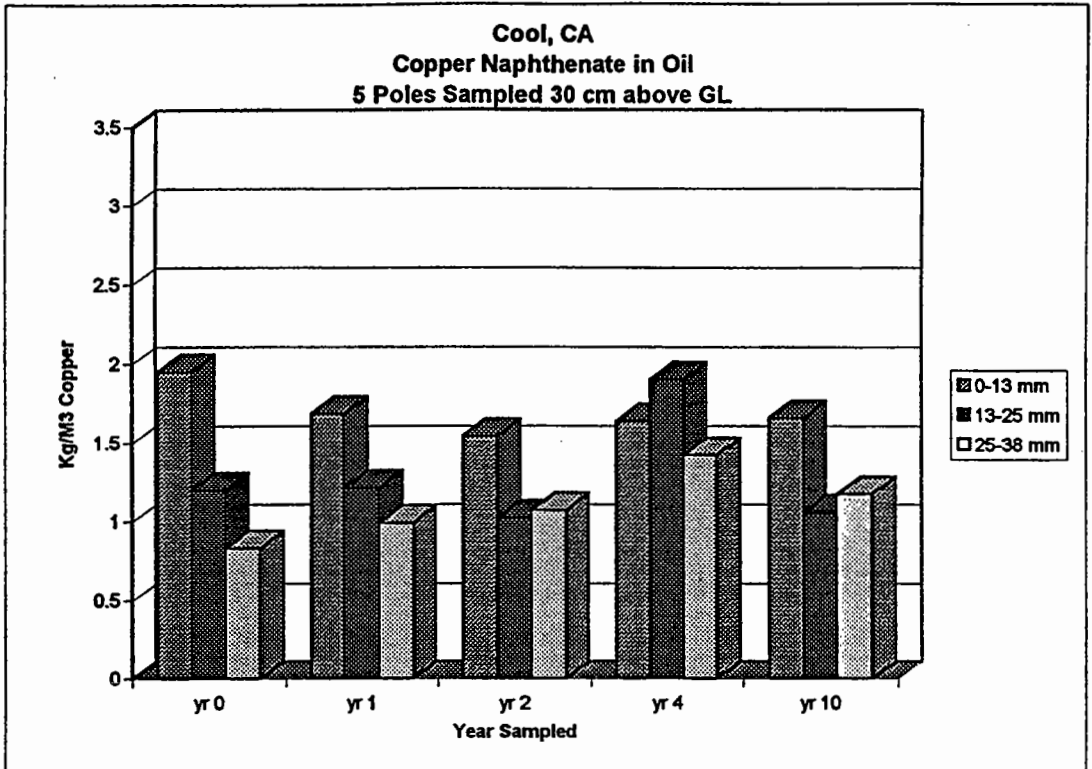
Figure V-11. Copper levels a) 30 or b) 120 cm above the groundline at selected distances from the wood surface of copper naphthenate-treated Douglas-fir poles 0 to 10 years after installation in Cool, California.
